Central Sierra Environmental Resource Center
2015 Stanislaus National Forest
Meadow Condition and Grazing Utilization Report

2015 Meadow Condition and Grazing Utilization Report

Stanislaus National Forest

Central Sierra Environmental Resource Center

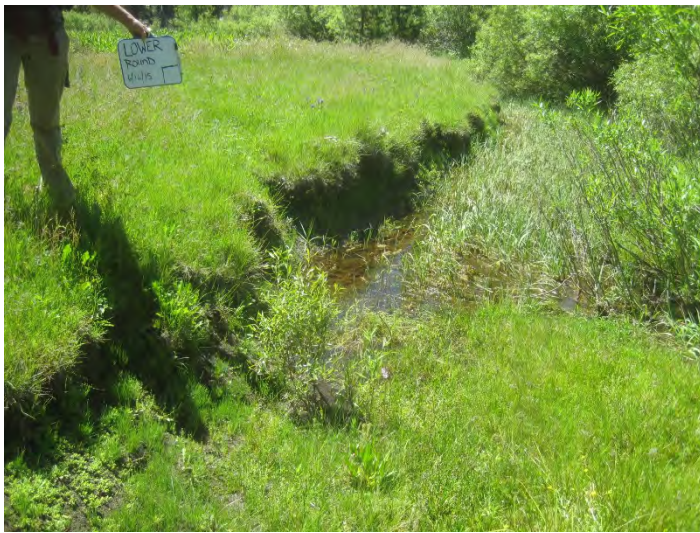
Above: Spring/possible fen in Lower Round – heavy pocking continues to degrade this special aquatic feature. Pictures show pre, mid and after grazing conditions.

A season of degradation: Three photos of the same streambank throughout the season (June, August, September) show the high levels of grazing and livestock sloughing and pocking that continue to contribute to the deeply entrenched stream channel in Lower Round Meadow.

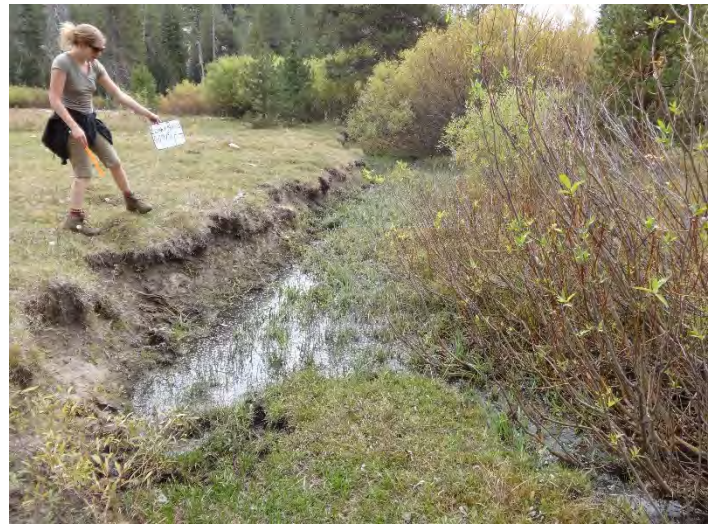
Lower Round Meadow: Before and after grazing 2015, photo point #2. Photo demonstrates overgrazed conditions in mesic areas of meadow.

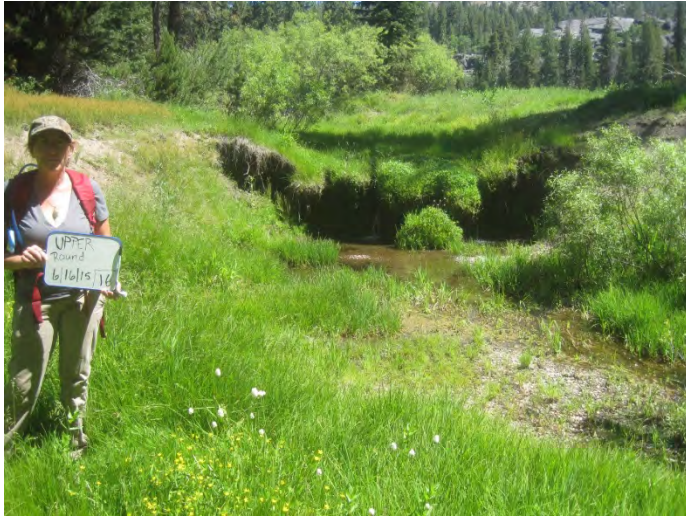
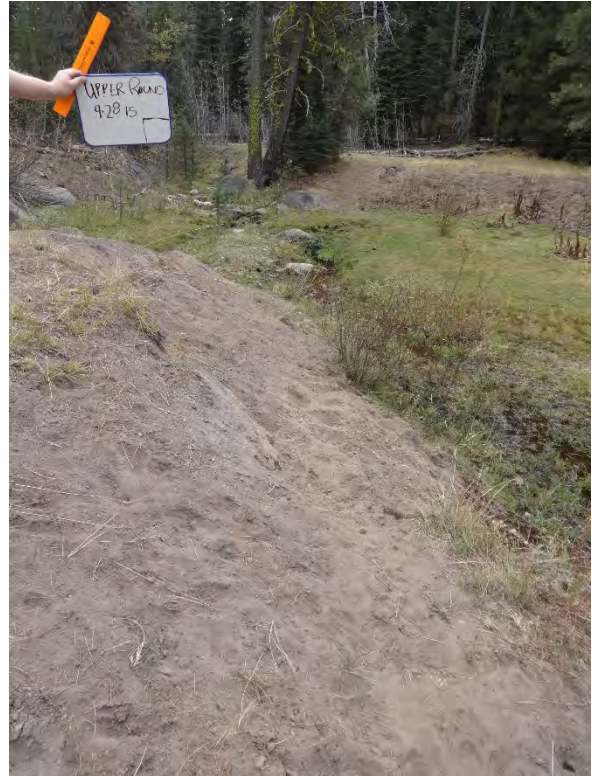
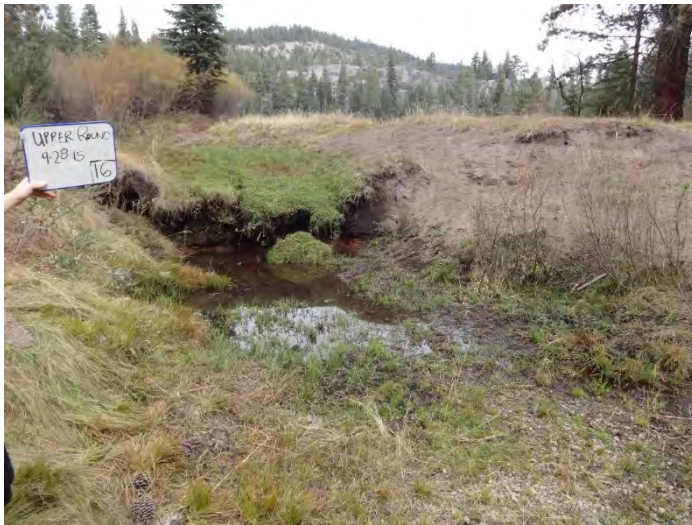
Pre and post season at one of many major headcuts in Upper Round shows a season worth of hoof damage and overgrazing making stream continually vulnerable to erosion and down-cutting. **AREA NEEDS TO BE FENCED TO BLOCK LIVESTOCK ACCESS.**

Headcut at base of Upper Round has visibly reduced greenline from the beginning to end of season. Major crossing point for livestock as they head downstream is right at this headcut, needs to be fenced and livestock re-directed to avoid further sloughing and downcutting on headcut.

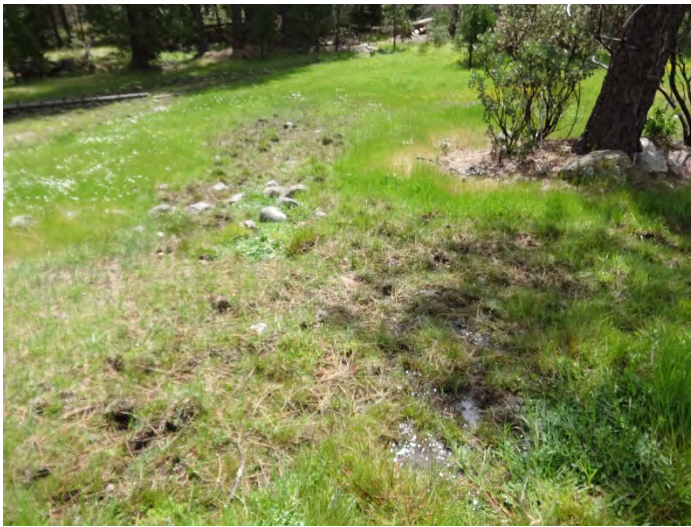
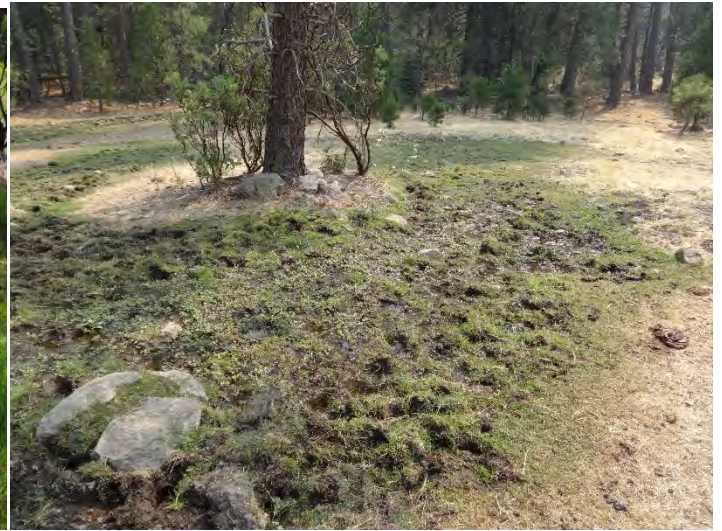
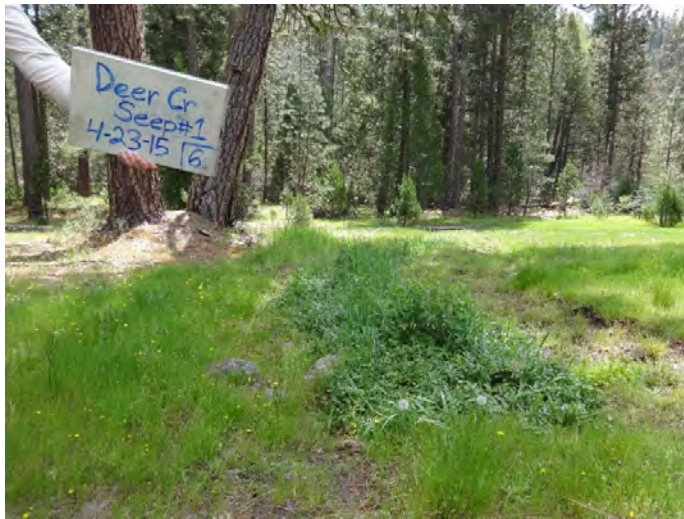
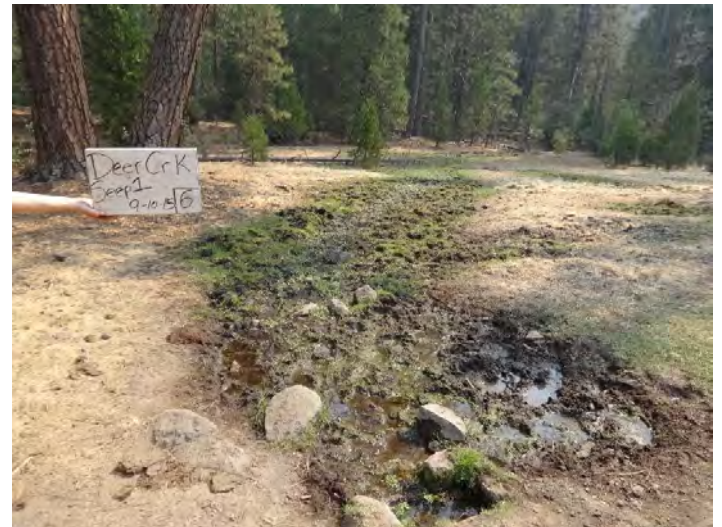
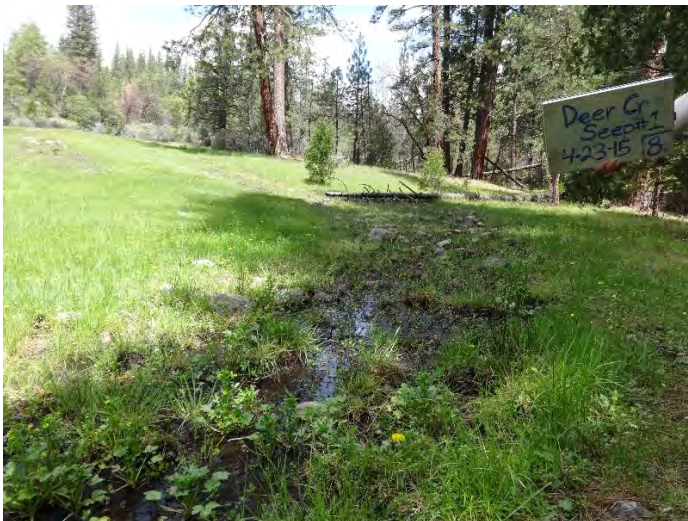
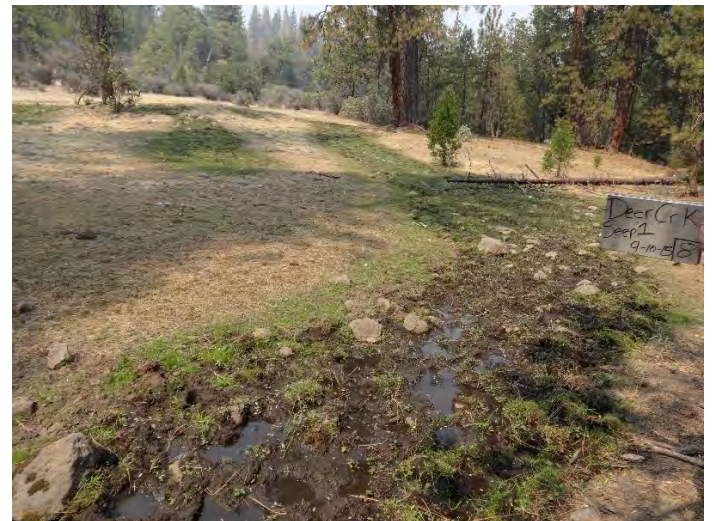
Seeps at Deer Creek 2015: Pocking and chiseling of these limited wetland habitats is further disabling their ability to retain water and are at a minimum in Functional-At-Risk condition, due to intense livestock utilization. This has been magnified during the drought. The wildlife and watershed value is significantly diminished and degraded, and need immediate protection and restoration.

Deer Creek, Seep #1, 2015: **Before (left) and after (right) photos at key photo points show the seasonal degradation caused by livestock pocking, trampling, defecating, and overgrazing in key Special Aquatic Features.** This damage has been reported by the CSERC staff to the Forest Service for several years, demonstrating both seasonal and cumulative damage, but the Forest is yet to take any action to better protect these wetland habitats that are so critical for wildlife.

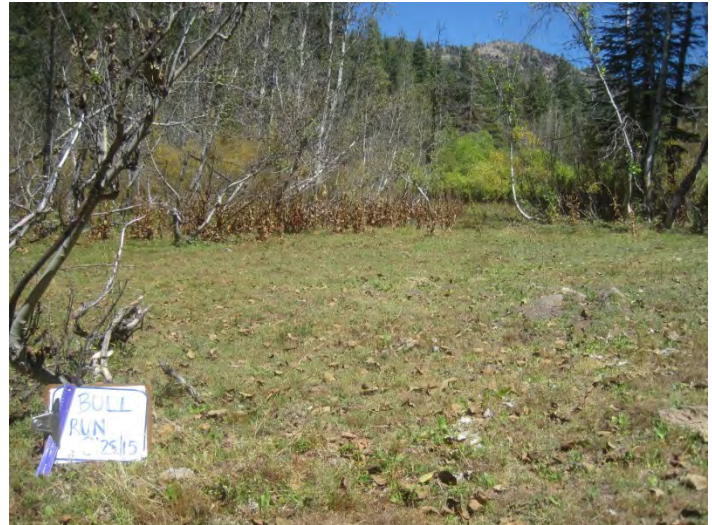
Bull Run 2015: Grazing damage was less than documented in the past several seasons due to reduced numbers and cows not being left in Bull Run all summer. However the level of grazing still exceeded utilization standards, and wetland areas continue to also not meet established regulations for protection of Special Aquatic Features.

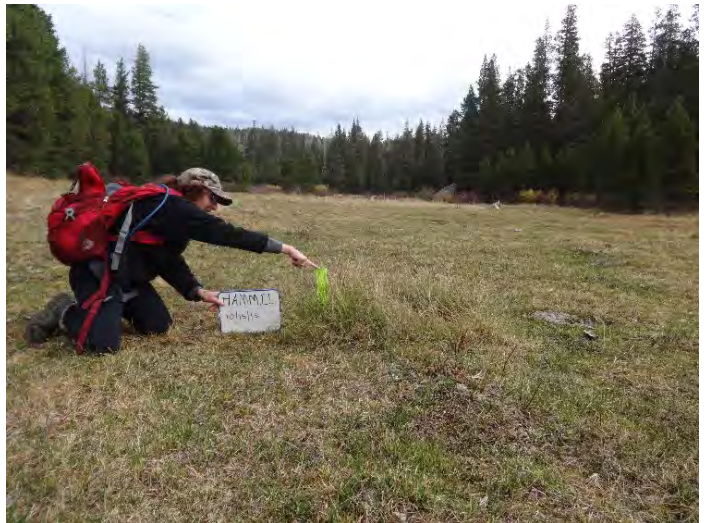
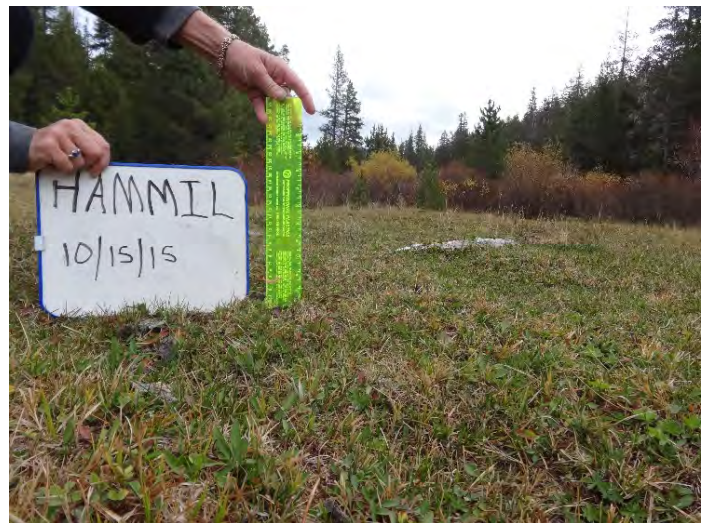
Hammil Canyon 2015: Mesic areas where cows concentrate were heavily grazed. Top photo shows where the exclusion cage was this season, and provides a visual for how heavy utilization was in that Hammil Canyon meadow.

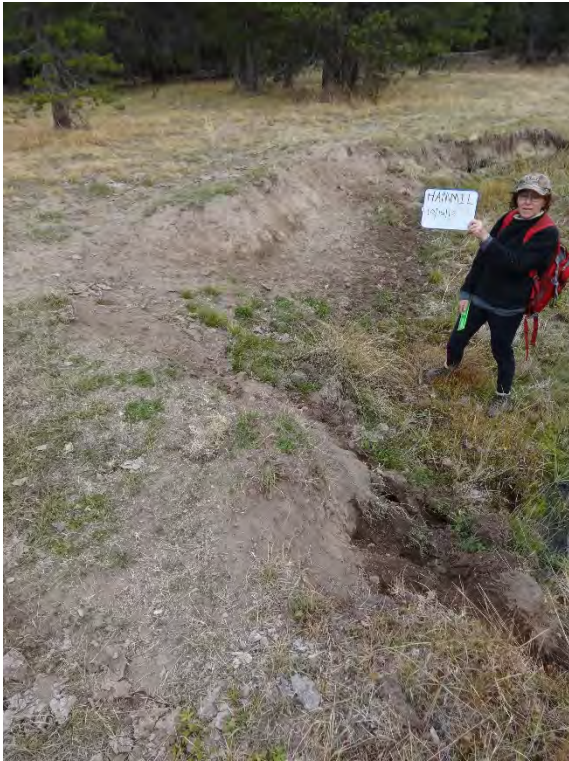
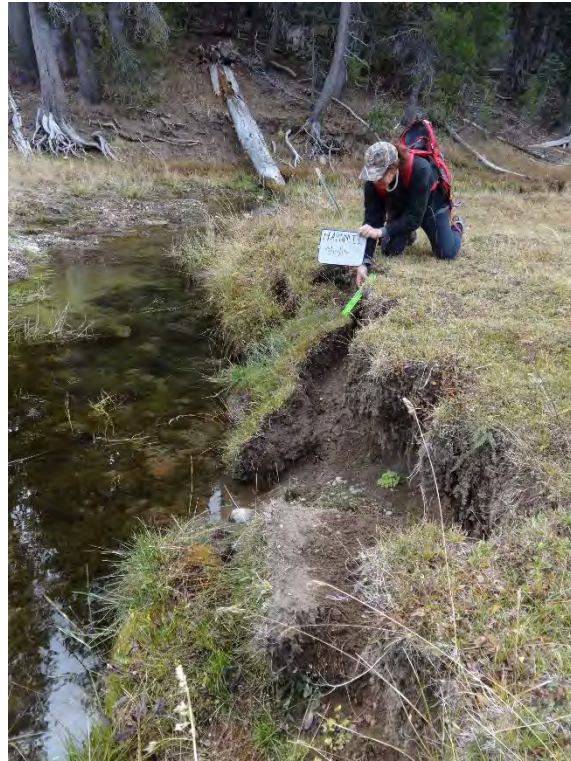
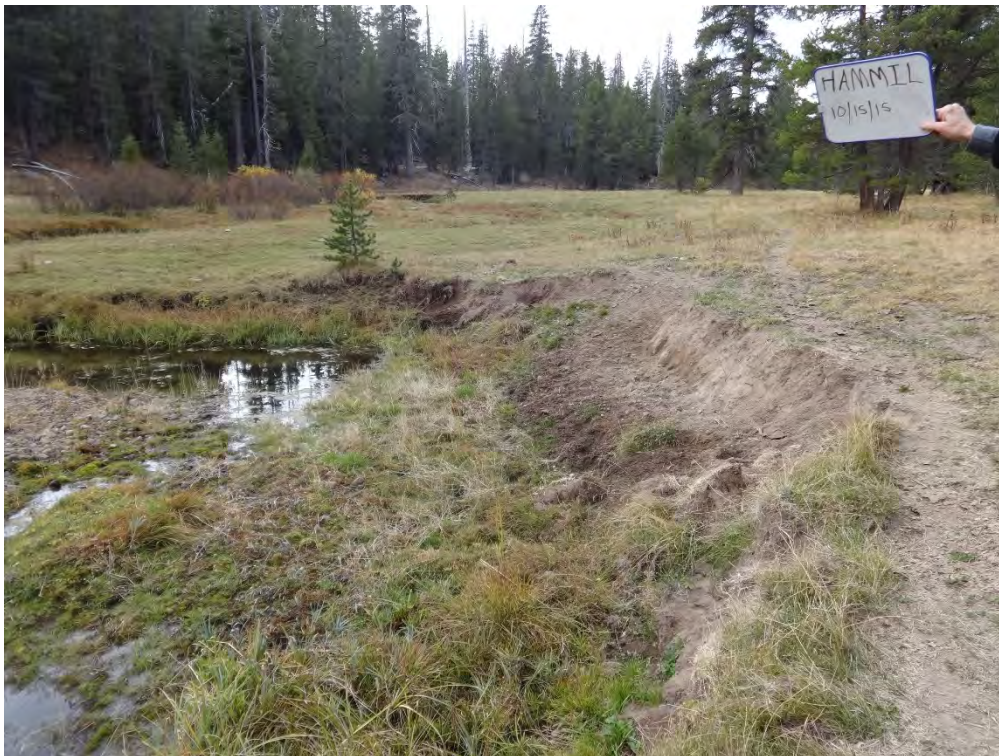
Hammil Canyon: Herring Creek streambanks are progressively deteriorating every season due to livestock sloughing (top right and bottom), collapse and chiseling (top right), and cattle trailing along stream edges and pocking along green line (bottom). Additionally, there are massive algae blooms throughout the creek, indicating high nutrient content possibly due to cow manure found all along creek edges. in wetland areas. and in water.

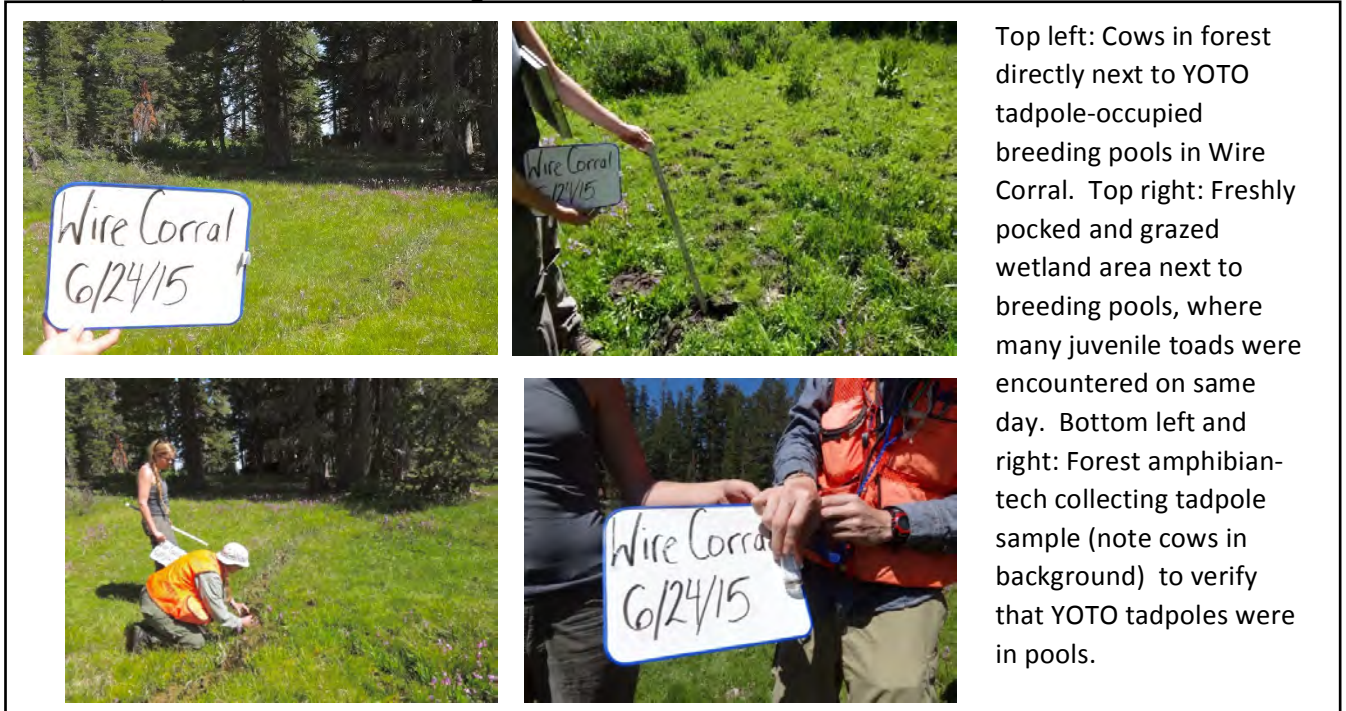
Top left: Cows in forest directly next to YOTO tadpole-occupied breeding pools in Wire Corral. Top right: Freshly pocked and grazed wetland area next to breeding pools, where many juvenile toads were encountered on same day. Bottom left and right: Forest amphibian-tech collecting tadpole sample (note cows in background) to verify that YOTO tadpoles were in pools.

Wire Corral 2015: CSERC staff found dozens of cows grazing multiple times in Wire Corral Meadow while Yosemite toad tadpoles still occupied the well-known breeding pools. After reporting the first documented violation and being reassured that cows were being moved, staff continued to find cows still in the meadow (pocking, grazing and defecating in breeding pools) before toads had metamorphosed in the following weeks. The issue finally escalated to the level of US Fish and Wildlife coming out for a field visit to see why toads weren't being protected in this meadow. For the rest of the summer cows were found in Wire Corral Meadow, even though much of the Allotment remained ungrazed due to reduced numbers of livestock being grazed by permittee. As a result of poor livestock movement management by the Forest, the juvenile and adult toads that are regularly found within the Meadow's boundaries faced non-stop deterioration of habitat and risks of being trampled all summer. This has commonly been the case in previous years in Wire Corral, yet corrective action has yet to be taken to address the issue. **This is a strong example of the need to exclude livestock from Yosemite toad habitat, as current management practices fail to protect them in all phases of their life.**

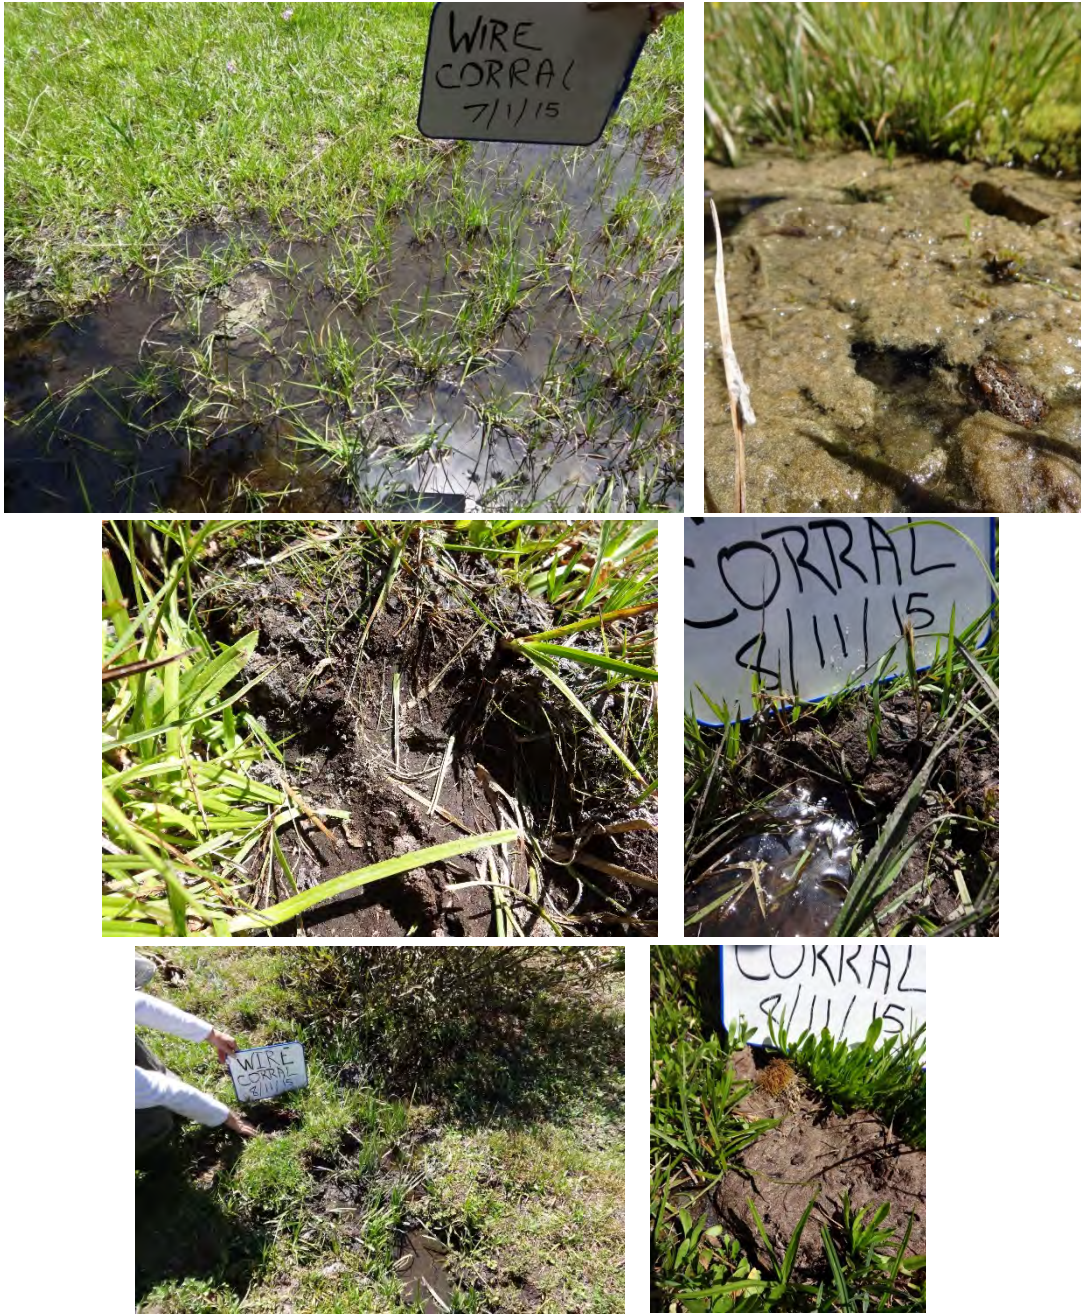
Wire Corral 2015: Yosemite toad faced many threats to vitality from wrongful and poor livestock management. Top left: Breeding pools in lower meadow still occupied by YOTO tadpoles, recently grazed, pocked, and defecated in. Top right: Algae blooms resulting from high fecal loading of wetland area were found in freshwater pools and effected the health of that water for toads and tadpoles. Middle left: Fresh hoof mark with recently metamorphosed YOTO in its print, emphasizing the risk of YOTO being trampled. Mid-right: Another fresh pock in wetland area with young YOTO next to it. Deep pocking can trap small amphibians. Bottom left: One of many spring areas where YOTO is commonly found every season, with fresh pocking and grazing degrading the health of the spring habitat. Not protecting the features of a meadow that allow a Yosemite toad to survive fails to protect the toad as well. Bottom right: Juvenile Yosemite toad on top of fresh cow manure. Manure puts YOTO at risk directly (possible crushing when feces drops, and indirectly (negatively affects water quality and habitat).

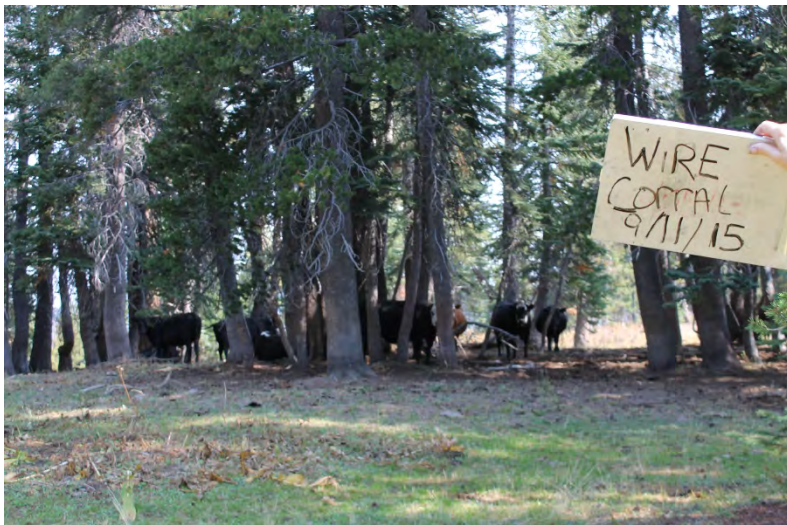
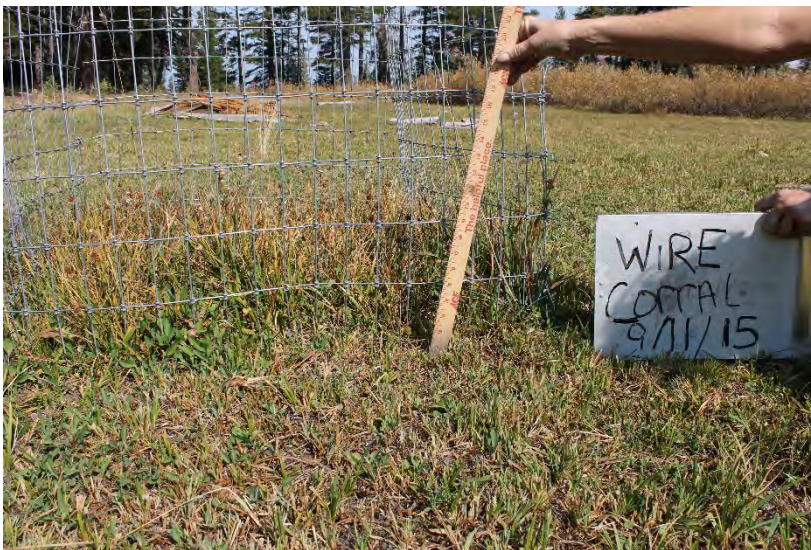
Wire Corral Meadow, 2015: The Forest installed several utilization cages in the bottom are of the meadow where YOTO are commonly found and near to the breeding pools. **Photos taken by CSERC staff throughout the season demonstrate the high level of grazing in Wire Corral this season.** Removal of vegetation is acknowledged by the Forest Service to be detrimental to YOTO as it makes them vulnerable to predation as well as to overheating from lack of shade. This is demonstrative of the poor management of livestock in the Herring Allotment this season as many other meadows remained largely untouched by grazing, yet cows were allowed to linger in and degrade one of the most highly populated locations for the Yosemite toad.

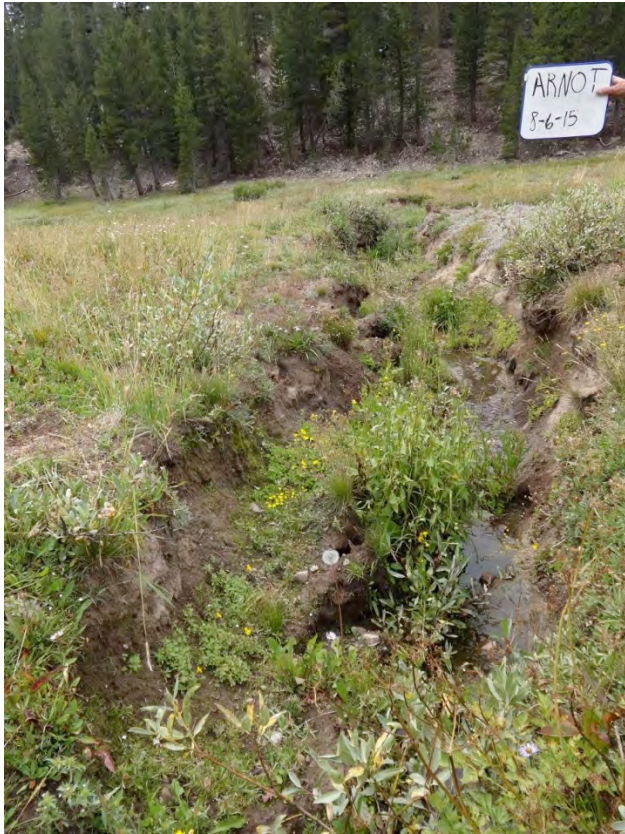
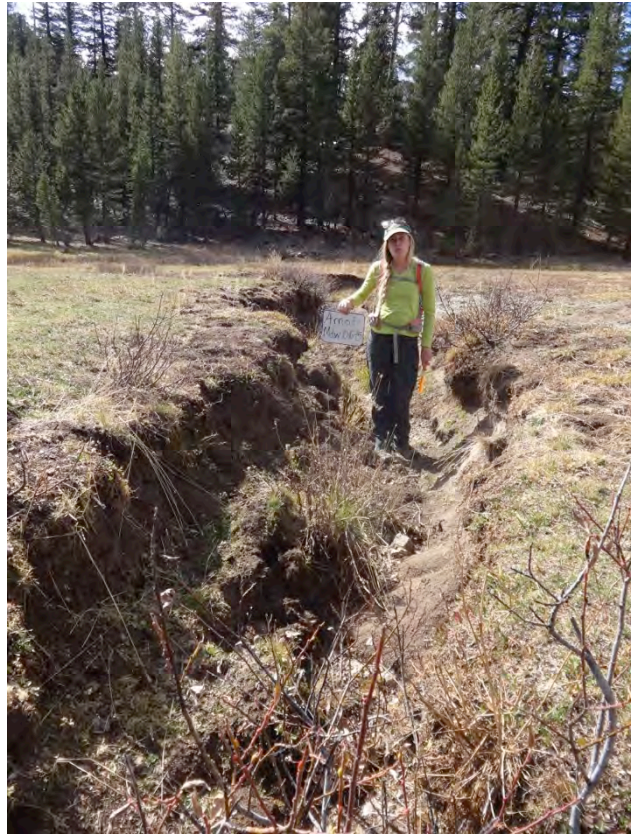
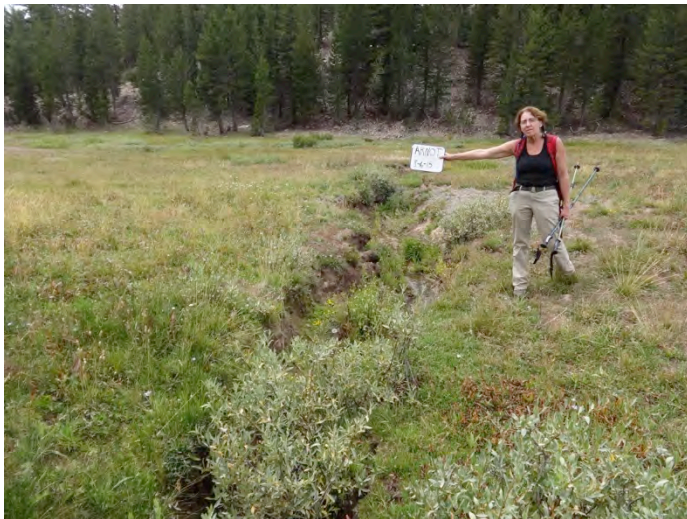
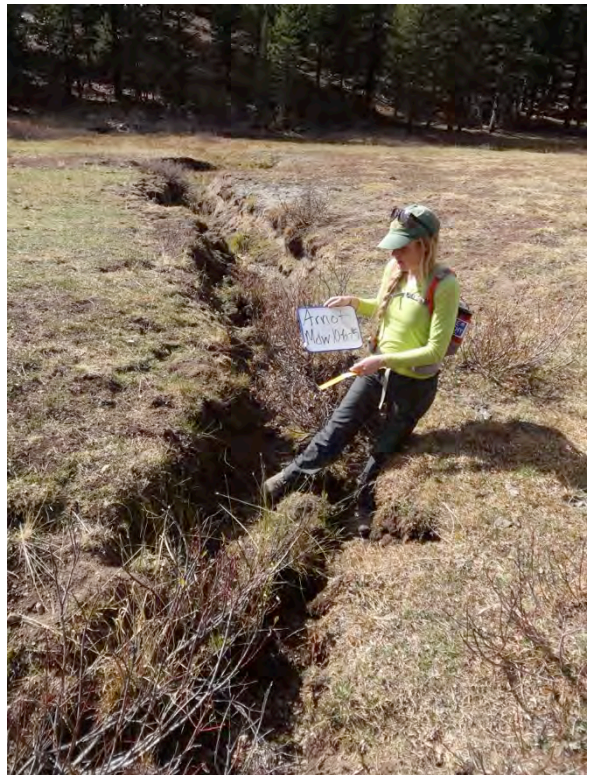
Arnot Meadow: Severely entrenched stream in Arnot continues to degrade. Before and after grazing photos document heavy willow browse, overgrazing of soil stabilizing vegetation, and more sloughing and chiseling of stream banks.

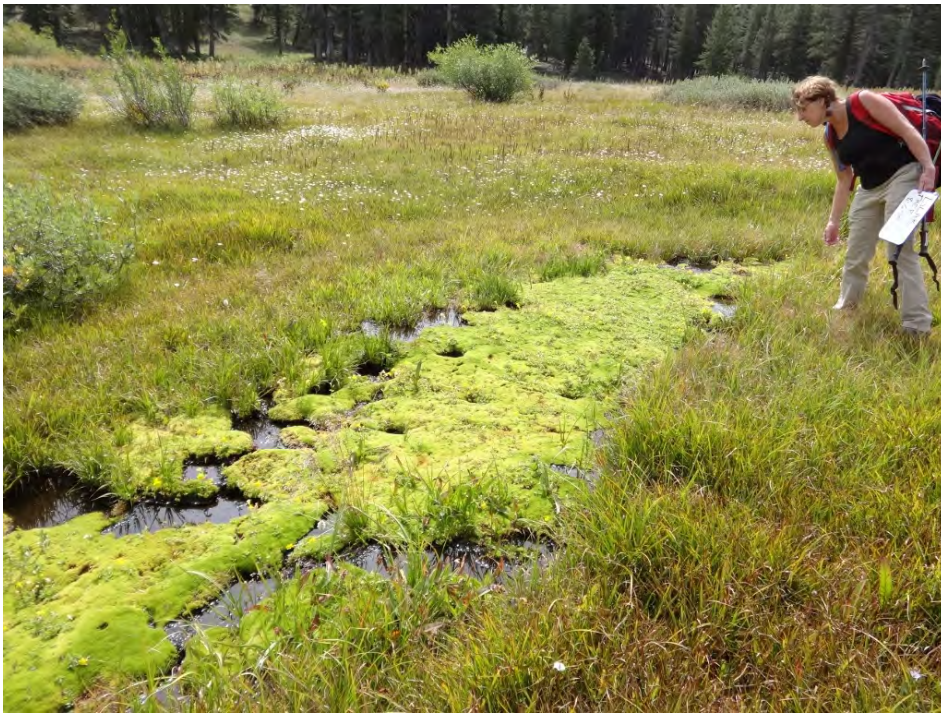
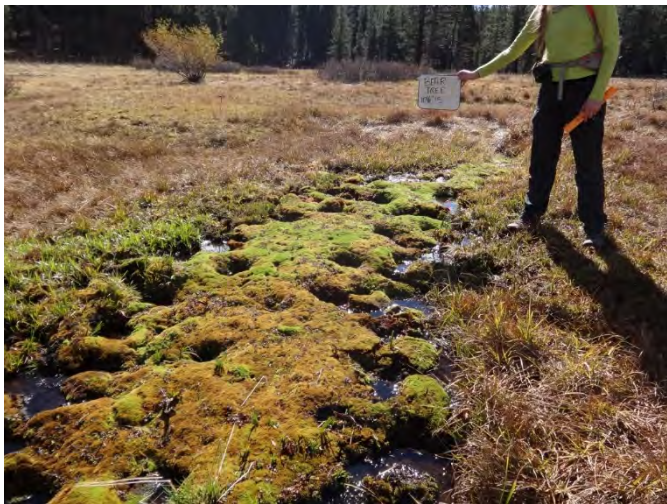
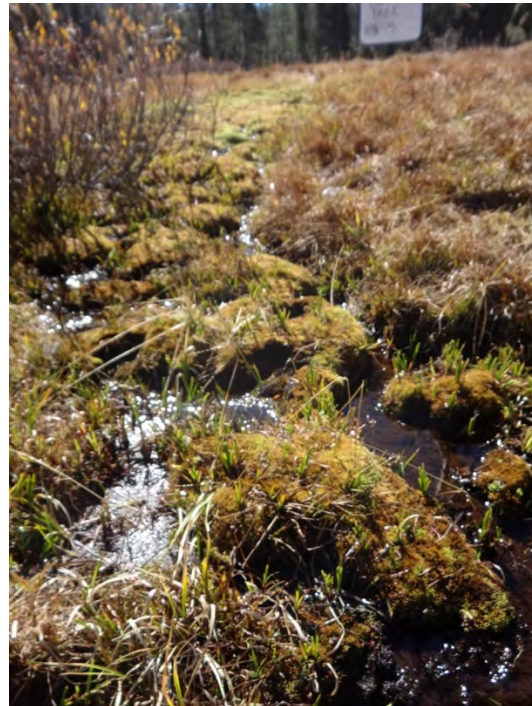
Bear Tree Meadow fen: pre-season condition on 8-6-15 (top left), and end of season condition on 10-6-15 (top right, and above). Extensive pocking of peat evident. Over-grazing around fen perimeter. This Special Aquatic Feature (SAF) is supposed to be protected according to Forest Standards and Guidelines.

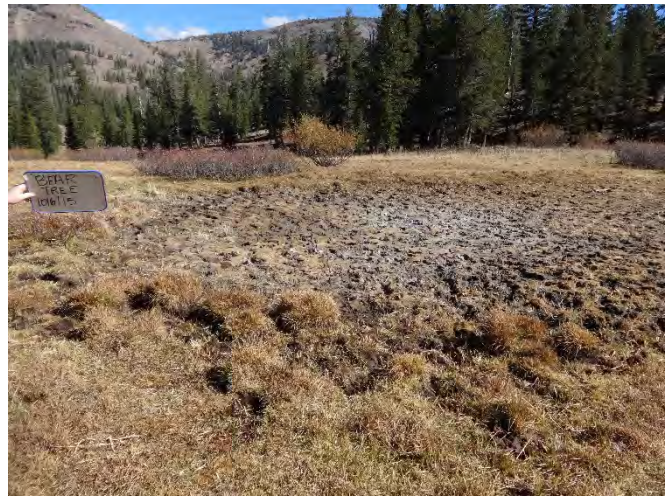
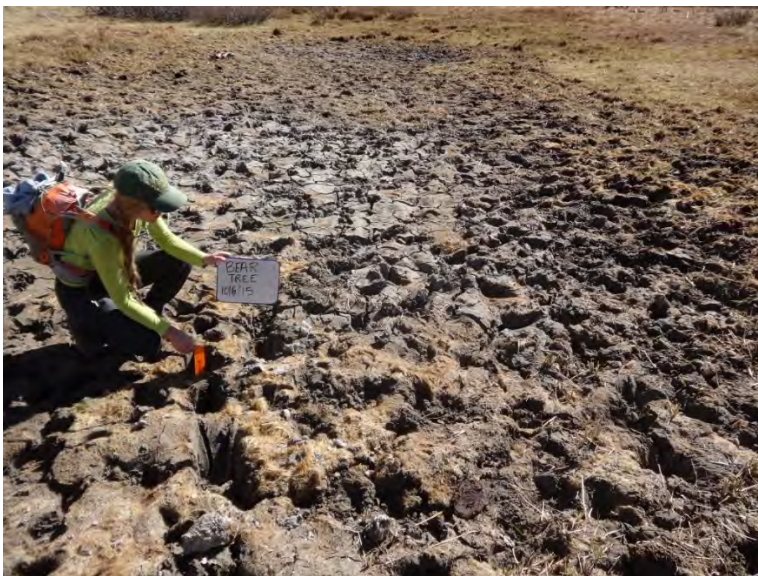
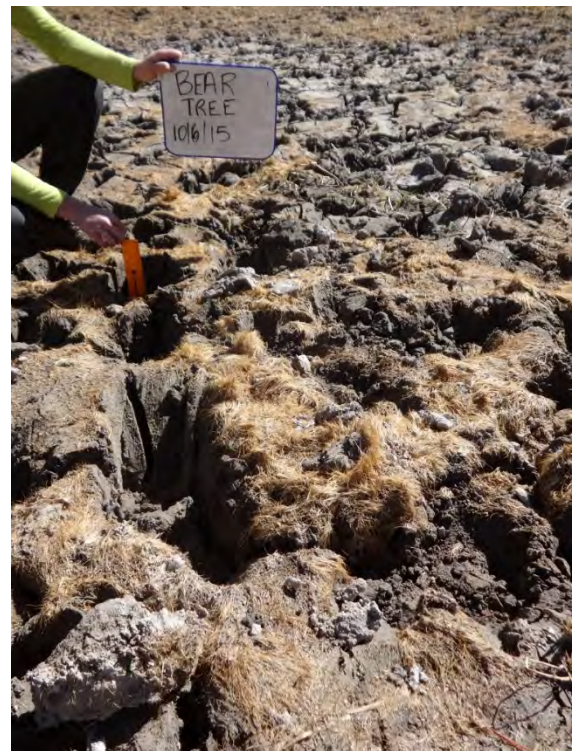
Bear Tree Meadow: Spring shown here is in upper meadow and is a confirmed Yosemite toad breeding pool, which undergoes extreme pocking, overgrazing, and contamination from feces every season, resulting in long-term cumulative damage to this essential habitat for a federally threatened species. Top left is pre-season (wrong year written on the board), and top right is post-season, 2015.

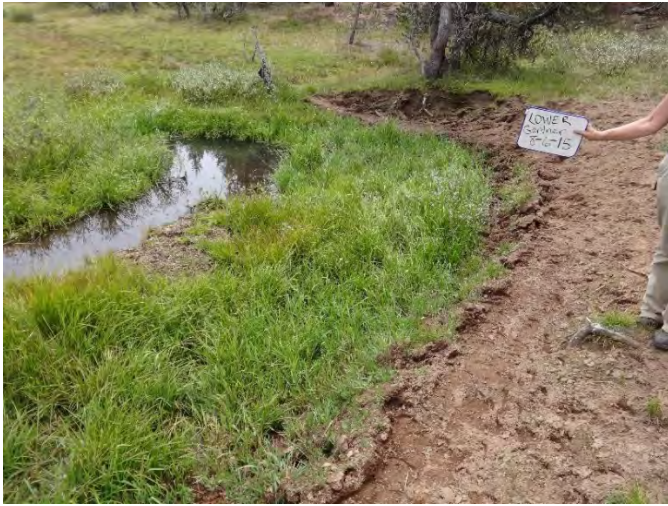
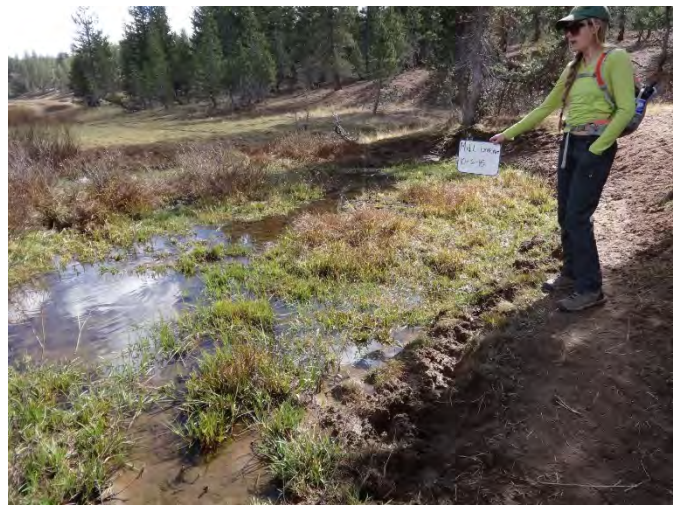
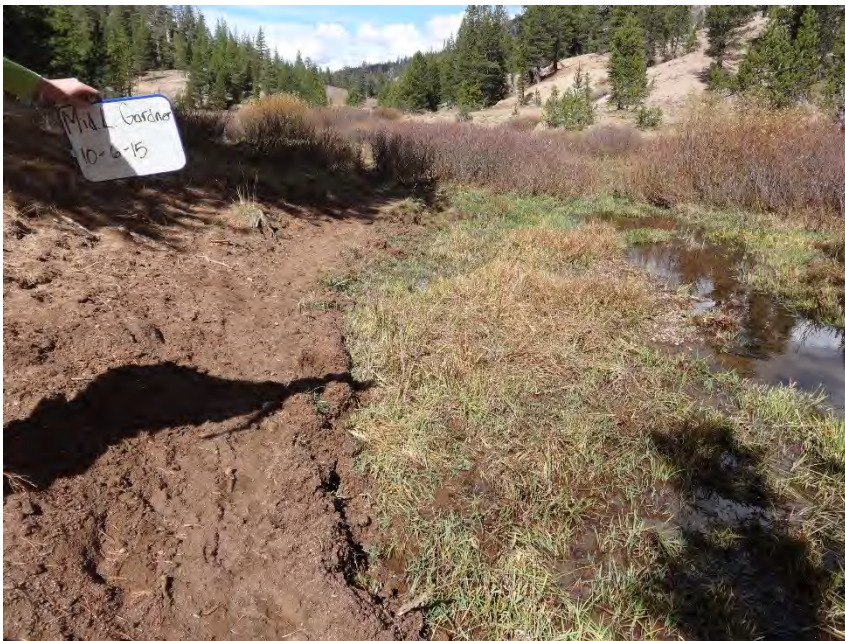
Tributary to North Fork Mokeulmne below Lower Lower Gardner: Before (left) and after (right) photos from 2015 show the high level of degradation to the stream bank that one season of livestock grazing, trampling, pocking, and sloughing has caused. Cumulative effects are also visible as the cattle trail and sloughing on the streambank causes channelization and soil compaction that are affecting the hydrological health of the meadow and creek.

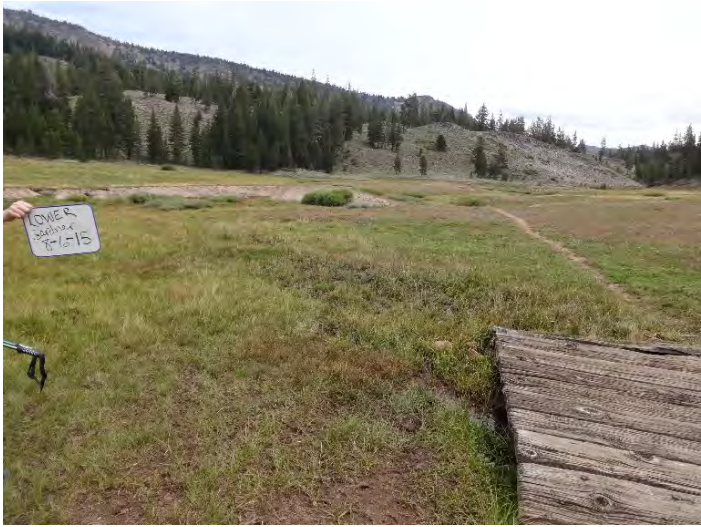
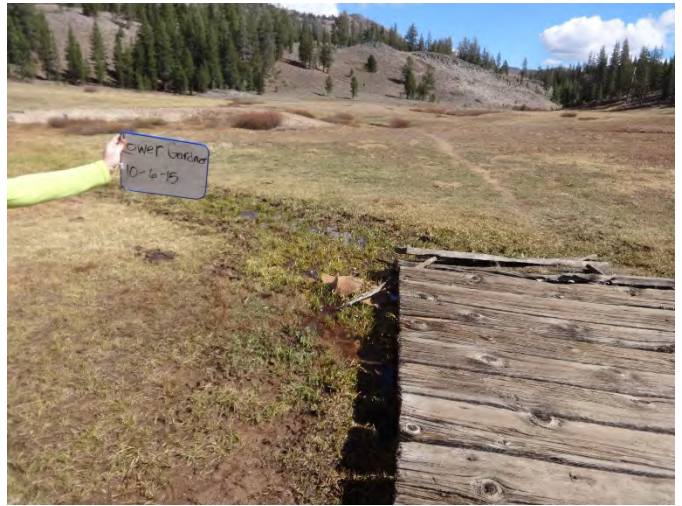
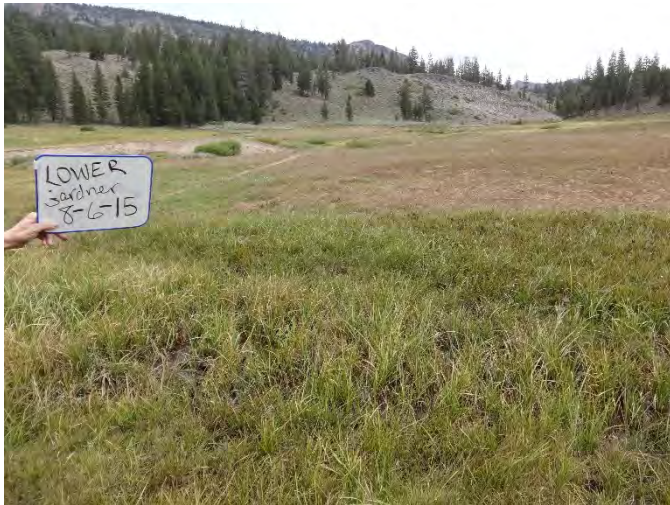
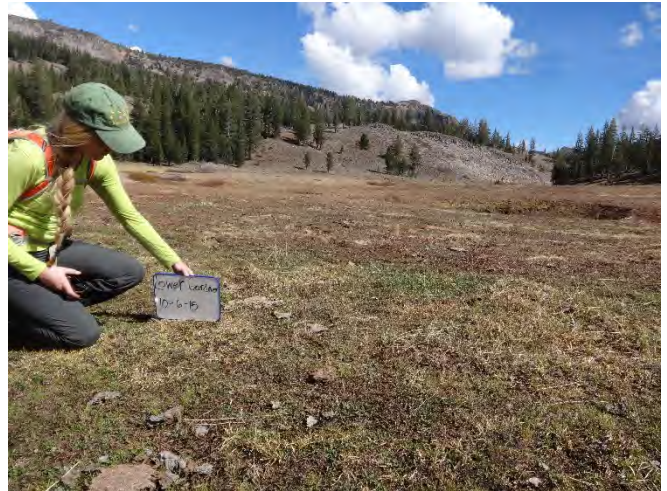
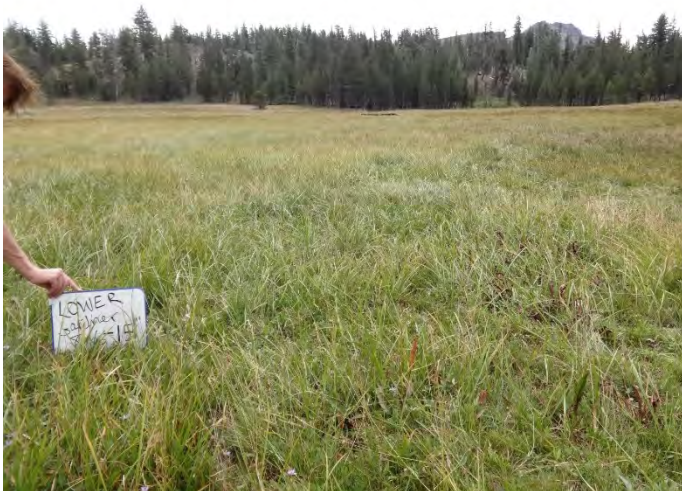
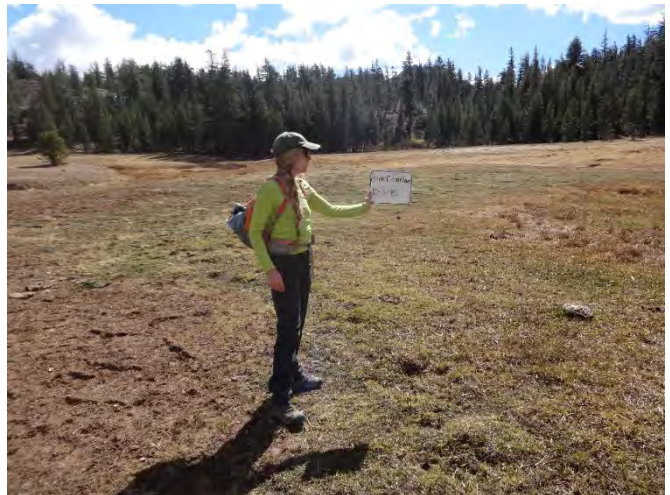
Lower Gardner: **before (left) and after (right) grazing. 2015. Visibly overgrazed beyond utilization standards.** Top left and right photos show Yosemite toad breeding habitat that is heavily grazed and trampled by the end of the season.

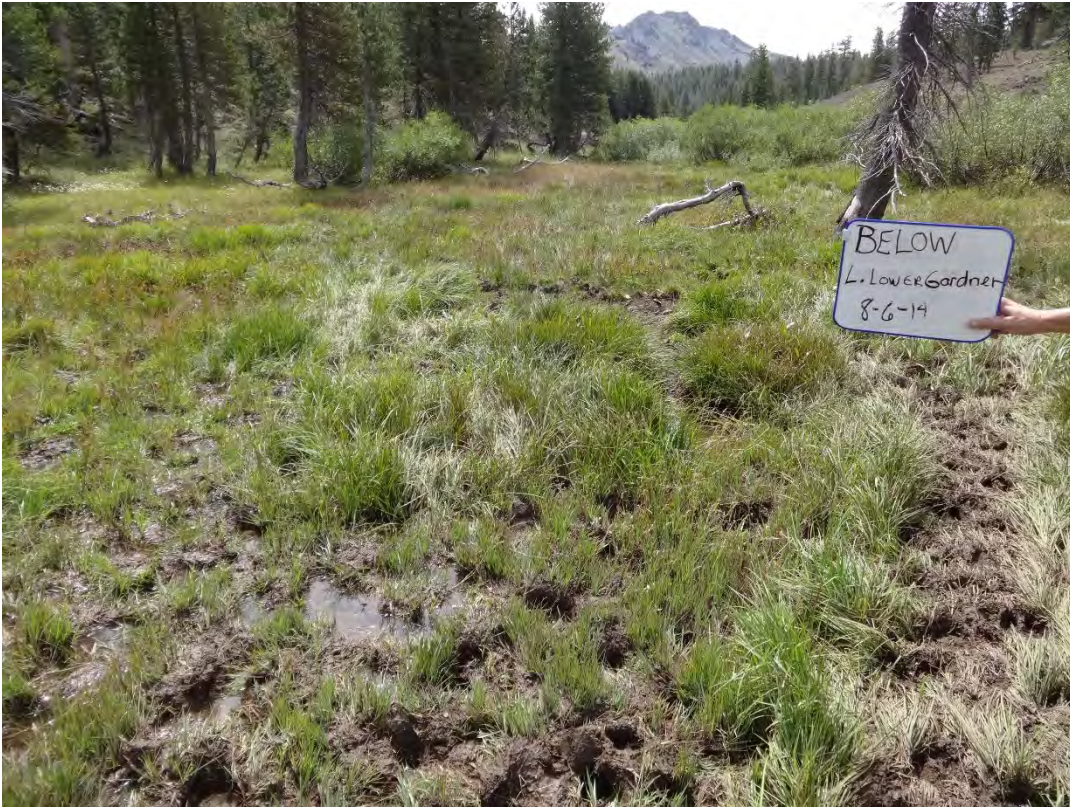
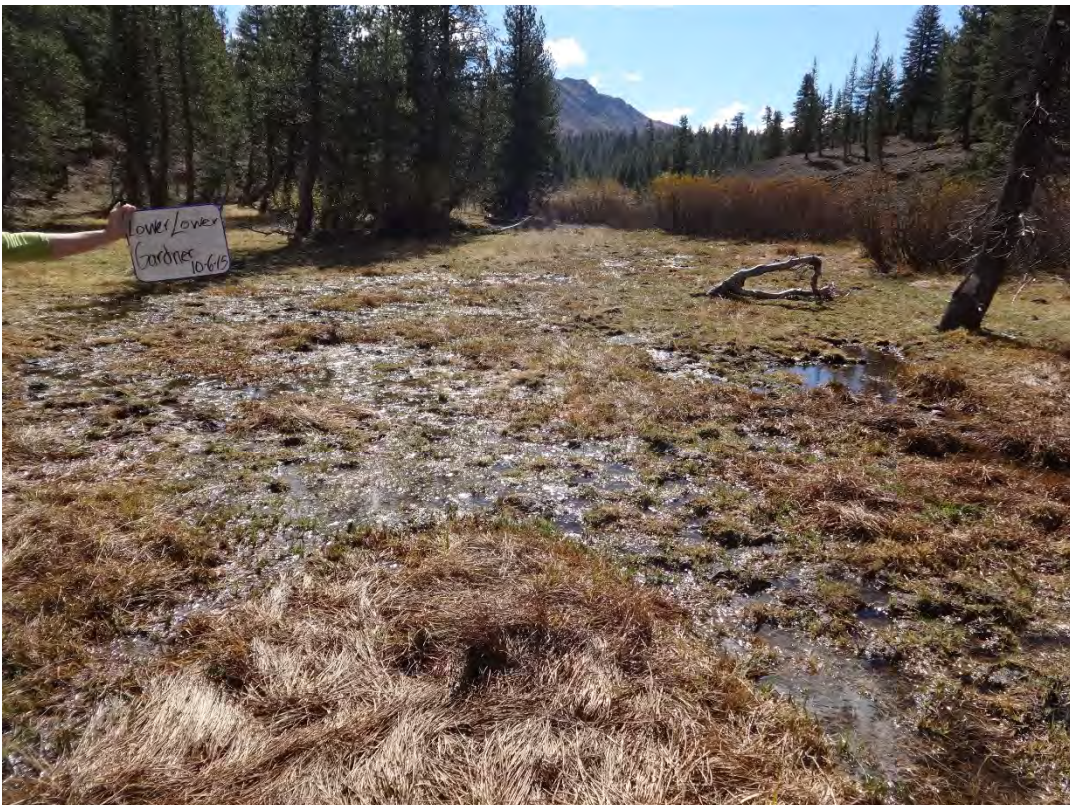
Lower Lower Gardner: wetland area below meadow (part of tributary to North Fork Mokeulmne) before and after grazing, 2015. Heavy utilization of forage, and pocking and defecation in wetland habitat.
