Central Sierra Environmental Resource Center
2015 Stanislaus National Forest
Meadow Condition and Grazing Utilization Report

2015 Meadow Condition and Grazing Utilization Report

Stanislaus National Forest

Central Sierra Environmental Resource Center

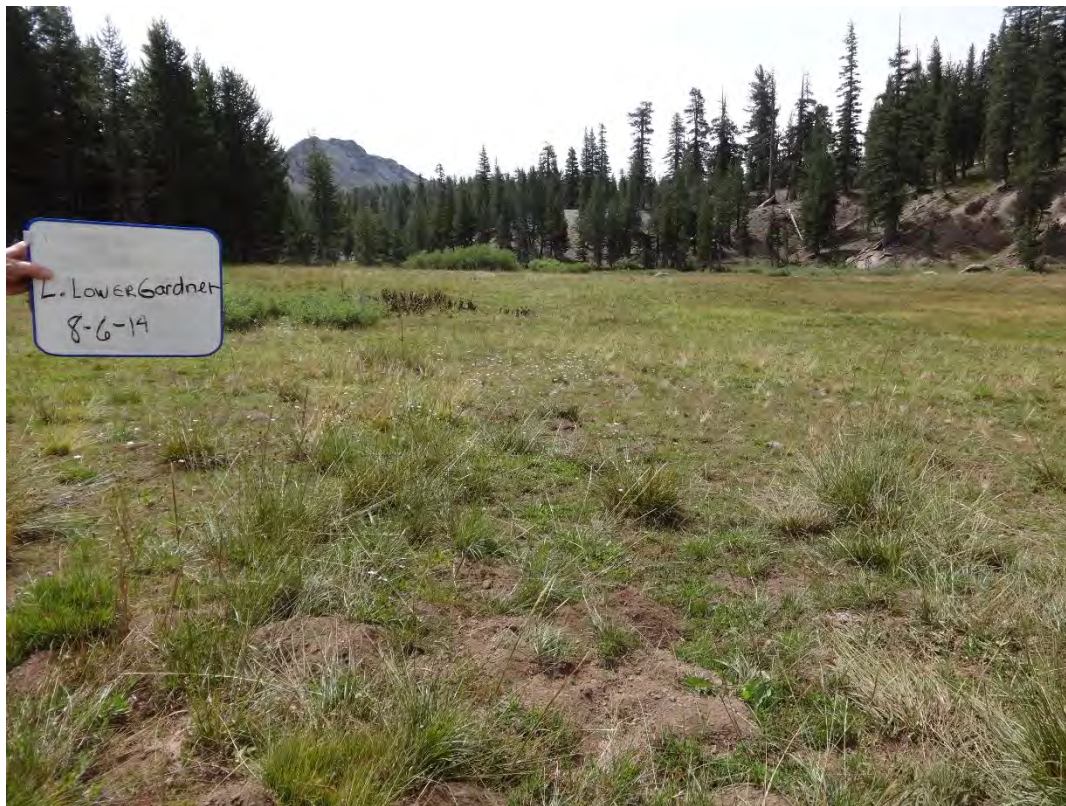
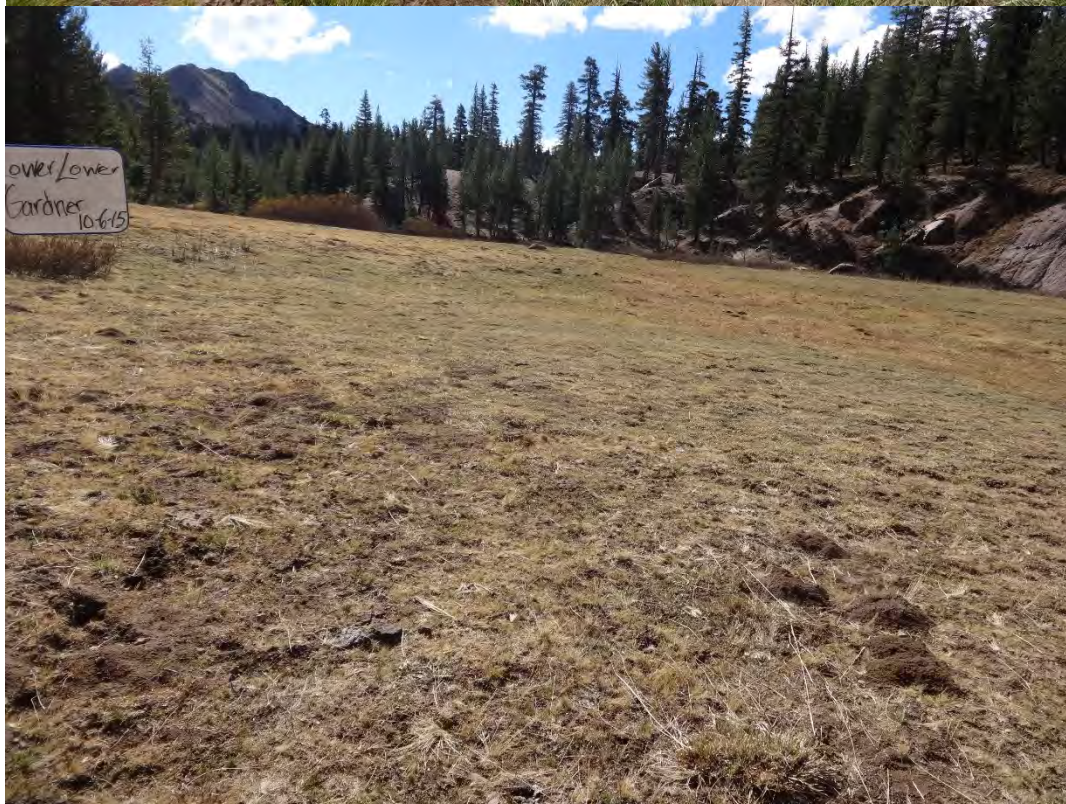
Lower Lower Gardner Meadow: Before and after photos show overgrazing past utilization standards throughout much of meadow. Areas that are moving to early seral conditions are becoming increasingly unstable through hoof action and overgrazing that disturbs and kills the roots of existing vegetation.

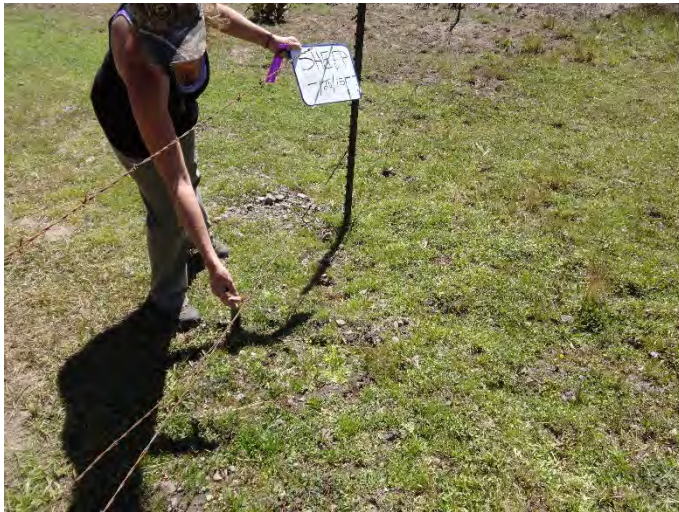
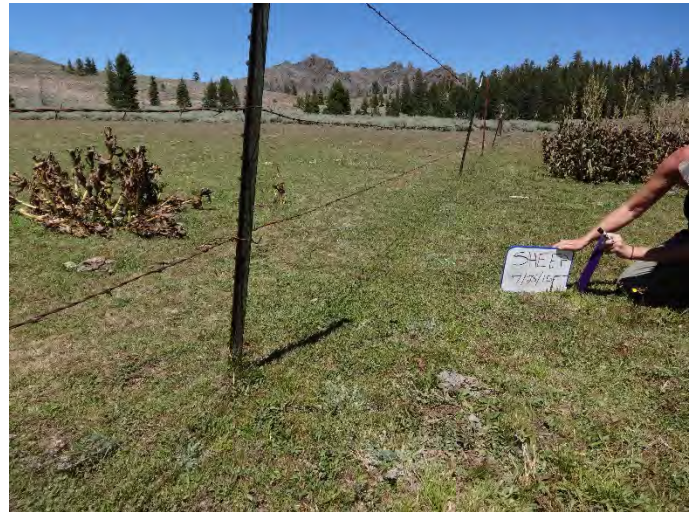
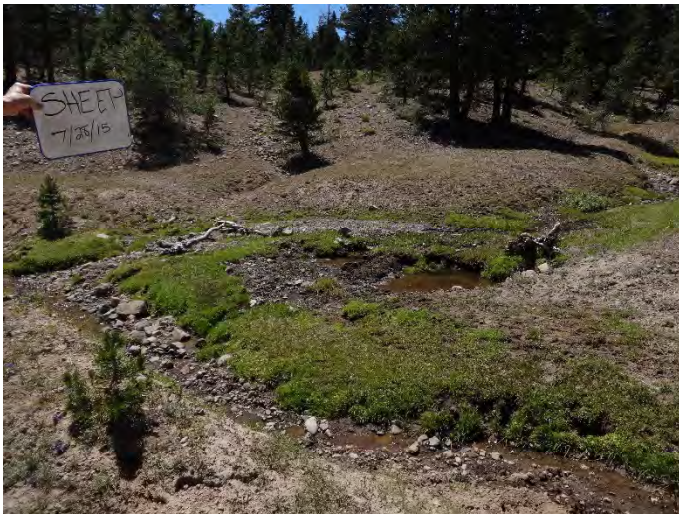
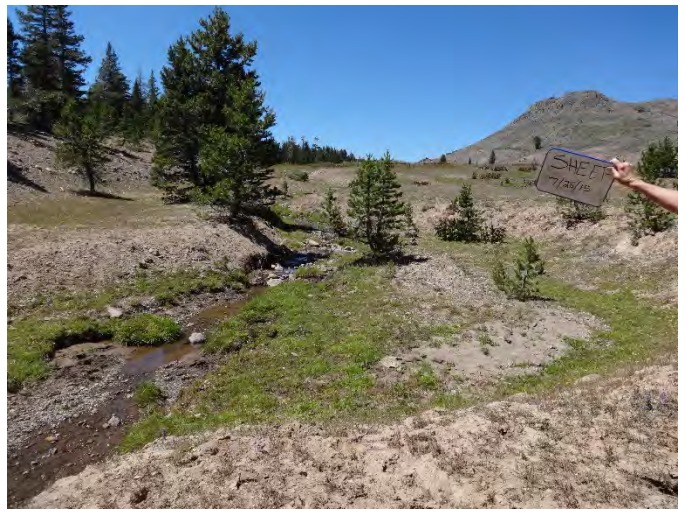
Sheep Meadow 2015: Top left and right photo how heavily grazed meadow inside and outside of the exclusion, as well as the poor fence conditions that are allowing livestock to trespass. Bottom left and right photo show the stream below the livestock exclusion area and the extreme trampling and trailing that are constricting and channelizing the stream.

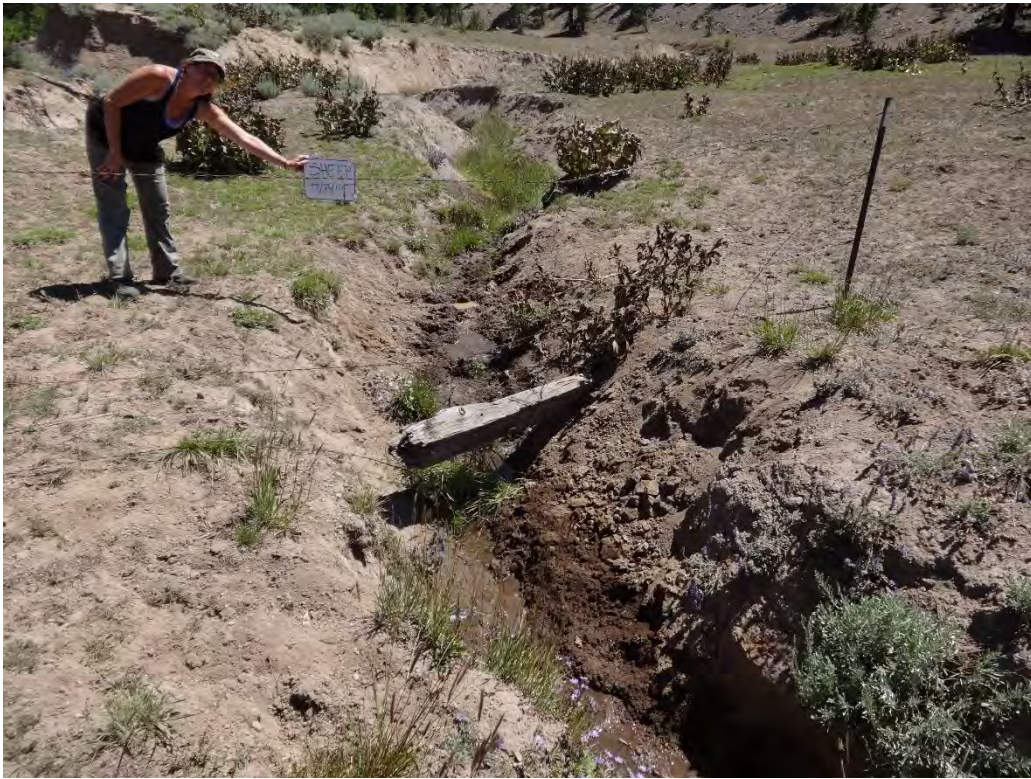
Sheep Meadow: At left, CSERC staff member is standing by a large hole in the fenceline where recent cow trails show that this is one location that livestock has been accessing the exclusion area.

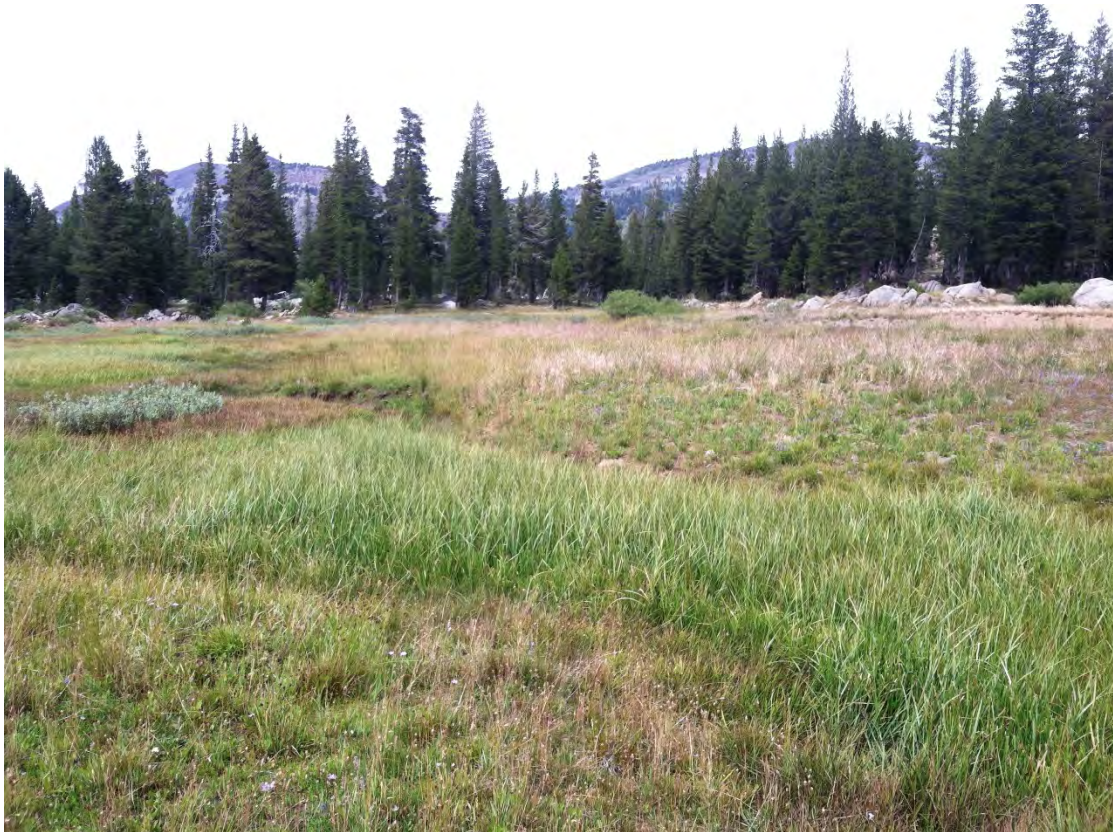
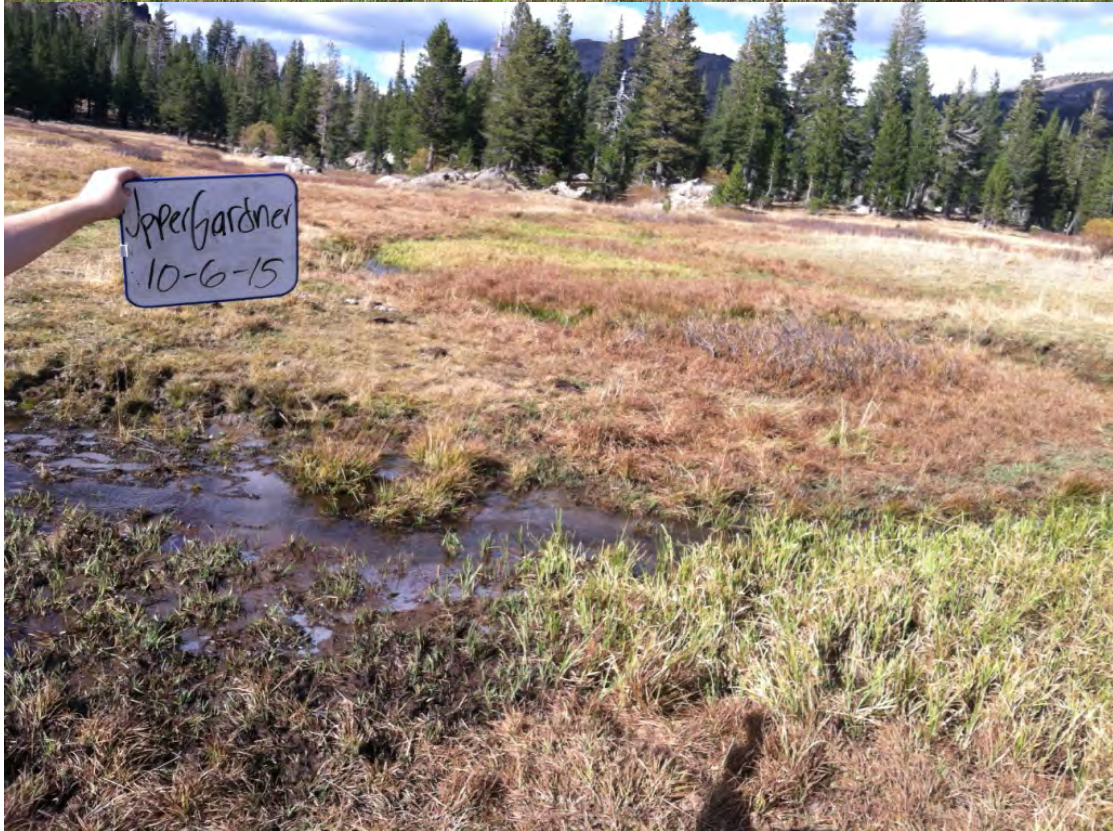
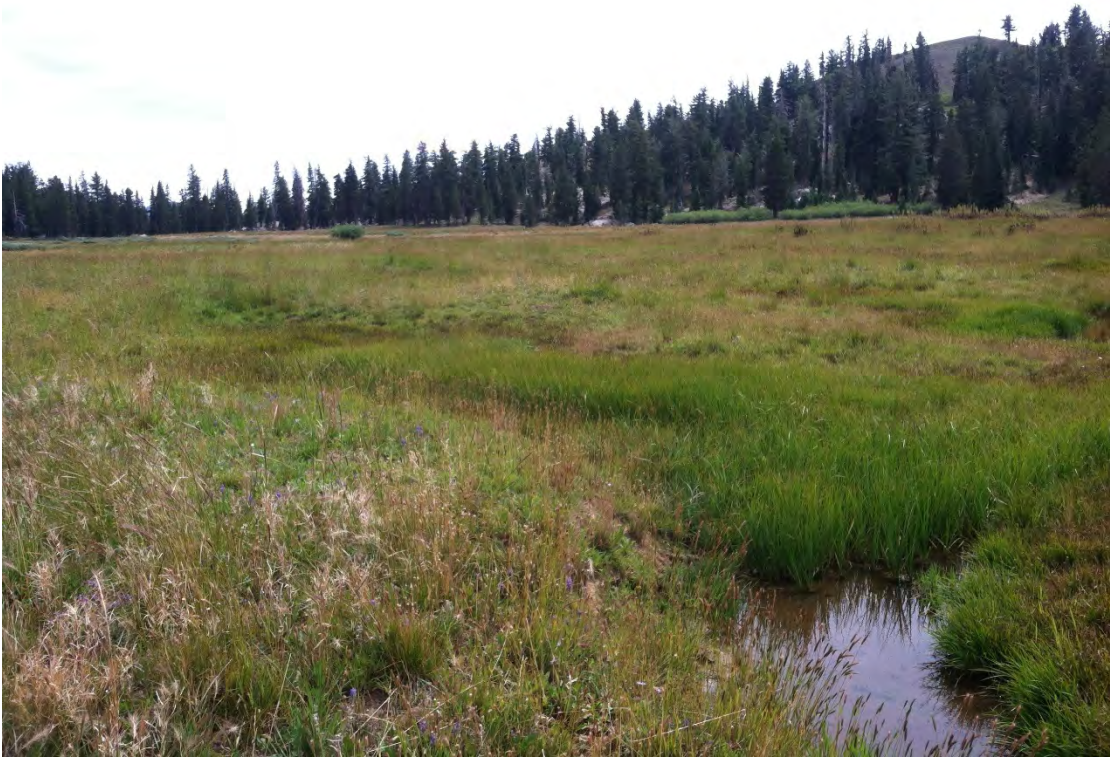
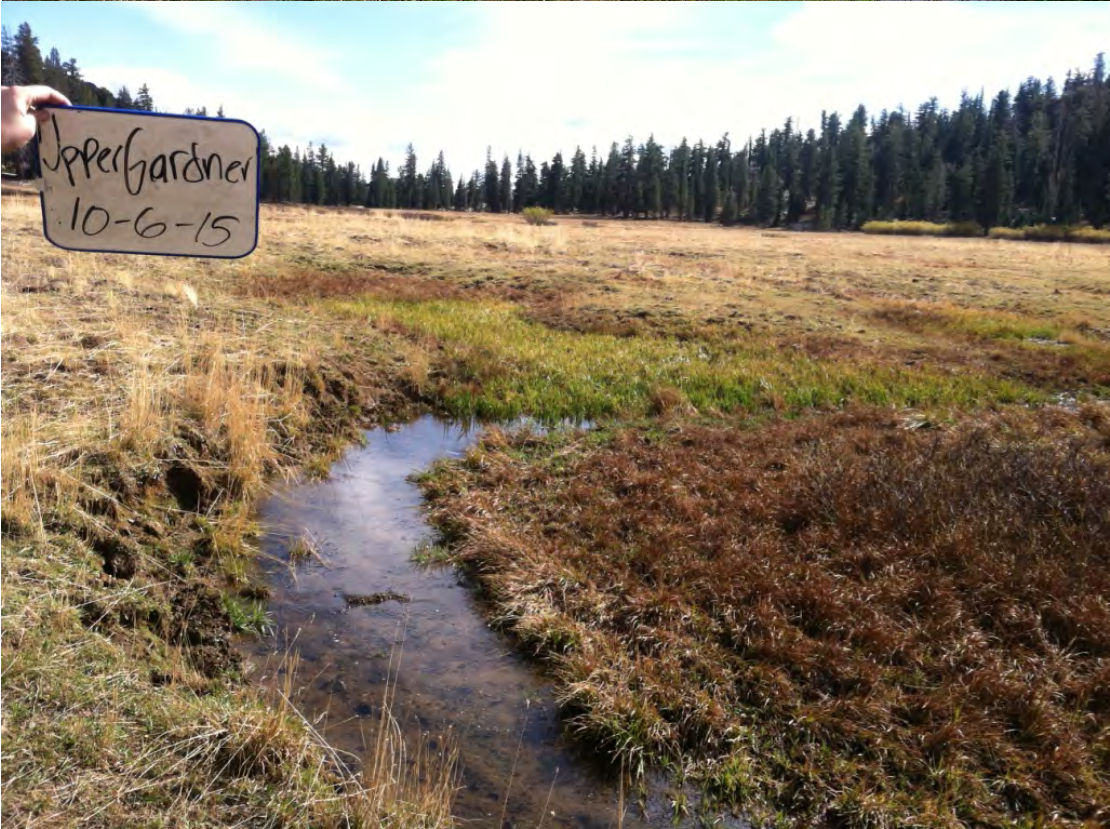
Upper Gardner: pond with possible fen is extensively pocked in around around shoreline, grazed heavily, and defecated in. this grazing management is not meeting the 20% shoreline disturbance outlined in the Forest Standard and Guideline.

As the past several pages of before and after photos show, the wetland areas of Upper Gardner Meadow are heavily hit especially in a drought year. Streambank damage and stream channelization, lowering of water table a concern. Active management and movement of livestock needed.

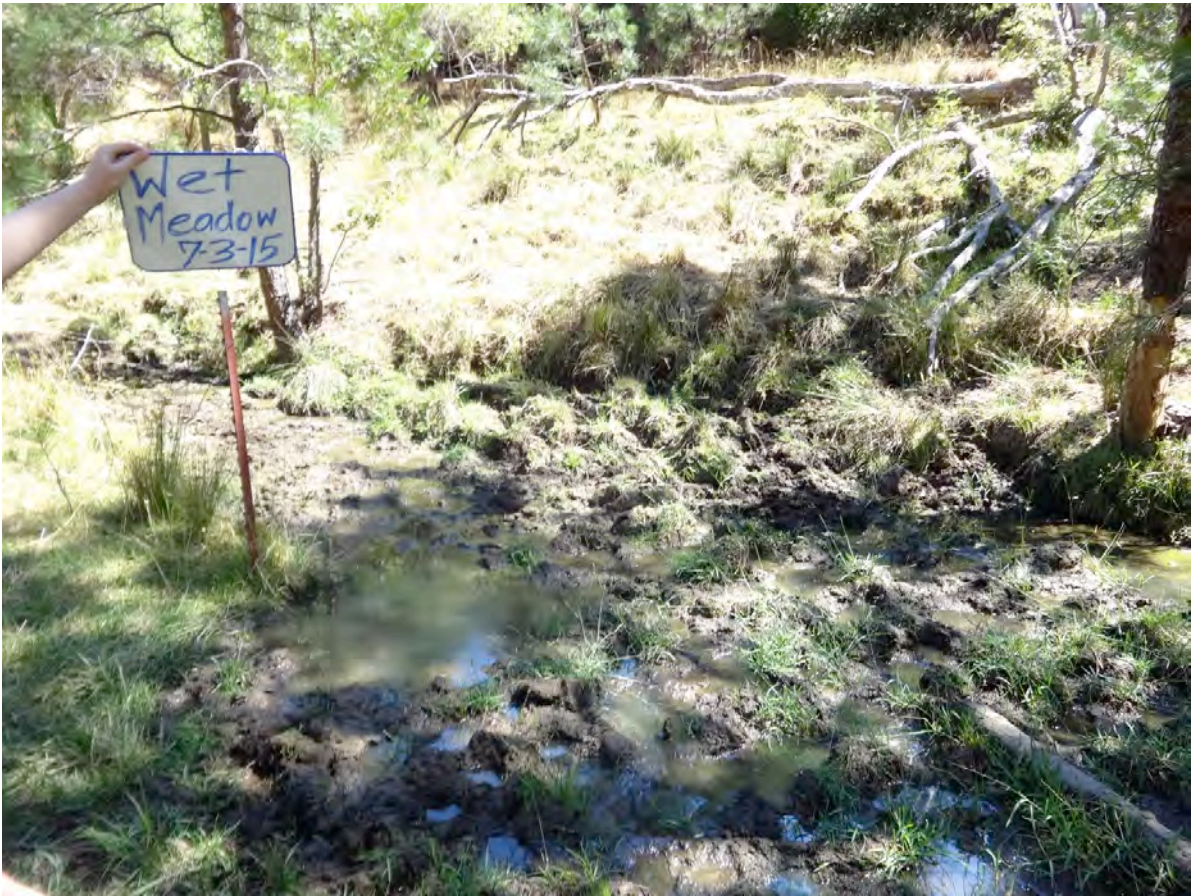
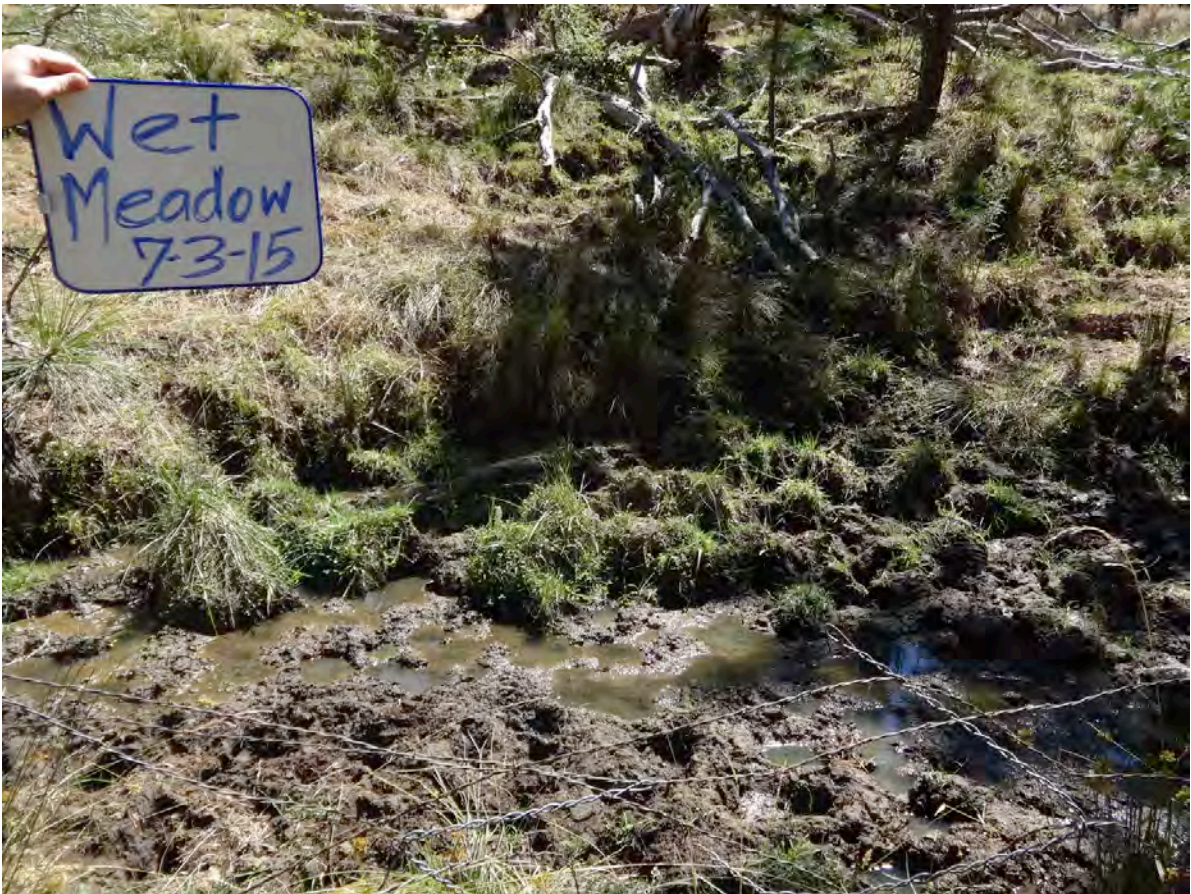
7-3-15: Severe pocking in wet meadow area muddy and contaminated seeps. Not functional condition. Sloughing and chiseling down the length of the hillslope. What is the status of the fence there? CSERC staff was under the impression that it is supposed to be maintained.

- Maintain fence that is around meadow
- Reduce number of cows in meadow and time allowed in meadow

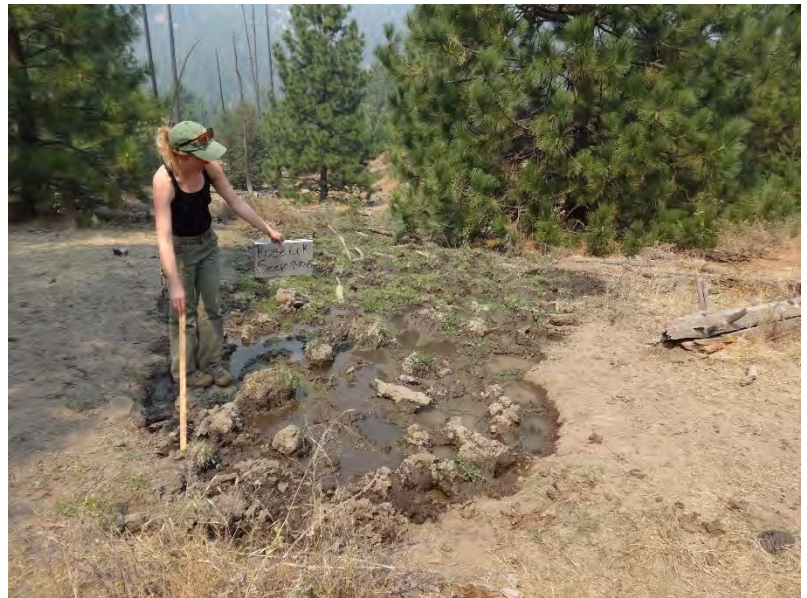
Rose Creek Seeps, 2015: these photos help show the extreme grazing that happens in all the seeps and springs in the Rose Creek area. **It seems as though there is no monitoring done in this area by Forest Service or permittees**, and every year cows are allowed to graze for however long the permit season is, with no regard to resource protection. **There is a strong need to re-evaluate the grazing plan for the Rushing Allotment.**

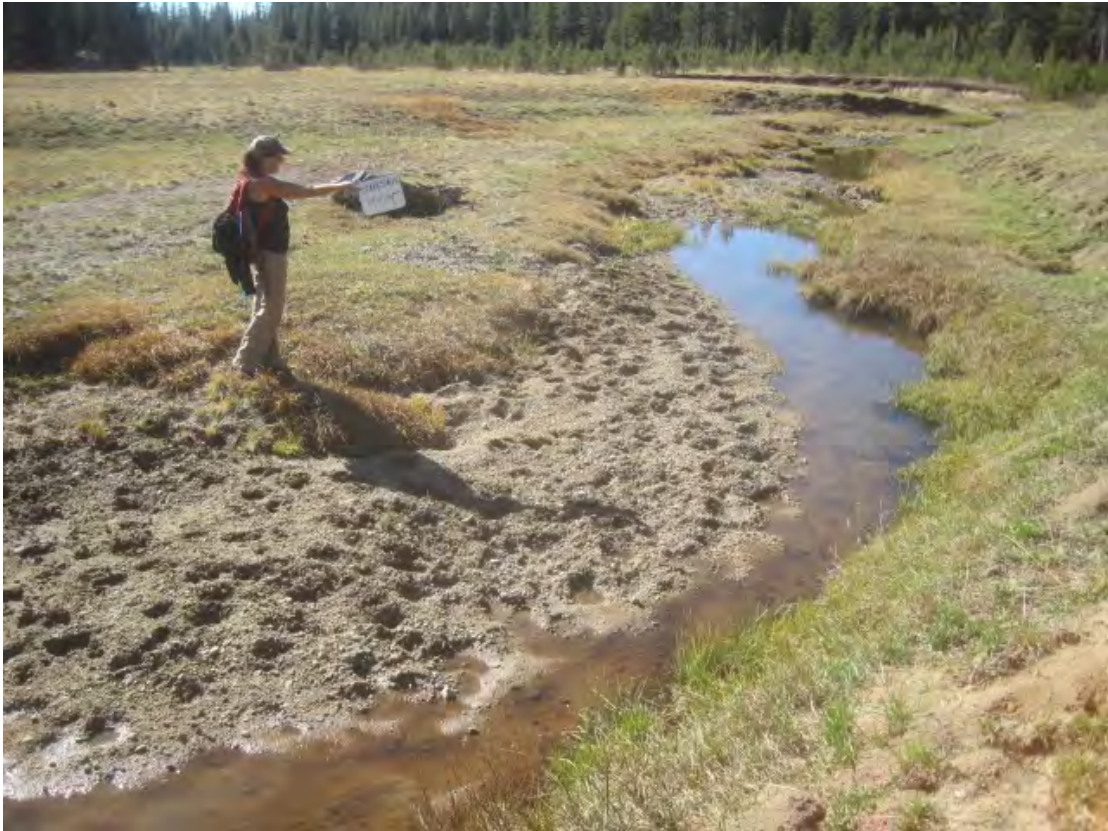
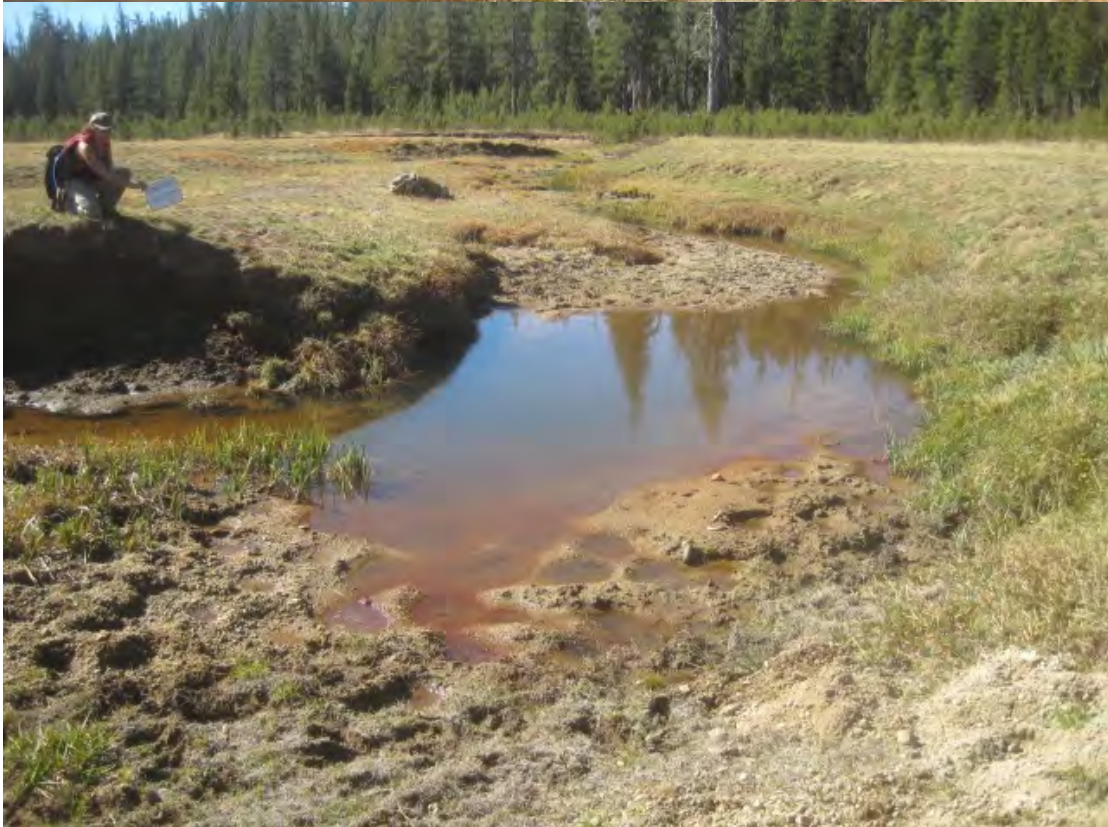
SNYLF Pools in N. Fork Stanislaus headwaters: Although some areas were less utilized by livestock this year, areas that were easy for cows to access were still heavily pocked, streambanks sloughed and forage heavily utilized. Clearly the SNYLF occupying these pools are being affected negatively by livestock presence: manure and sediment contaminating water, loss of vegetative shelter, and degradation of stream stability.

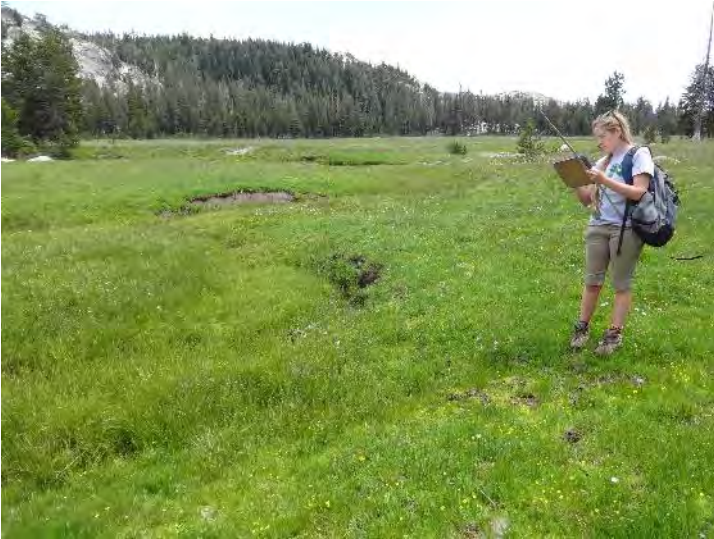
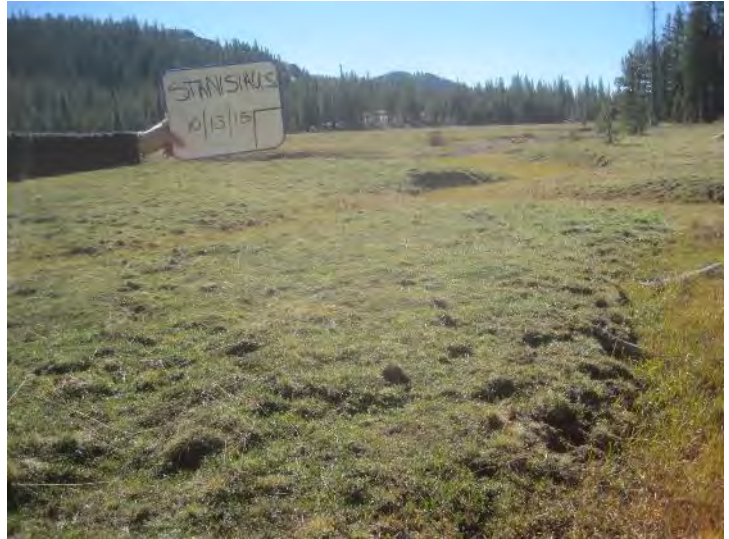
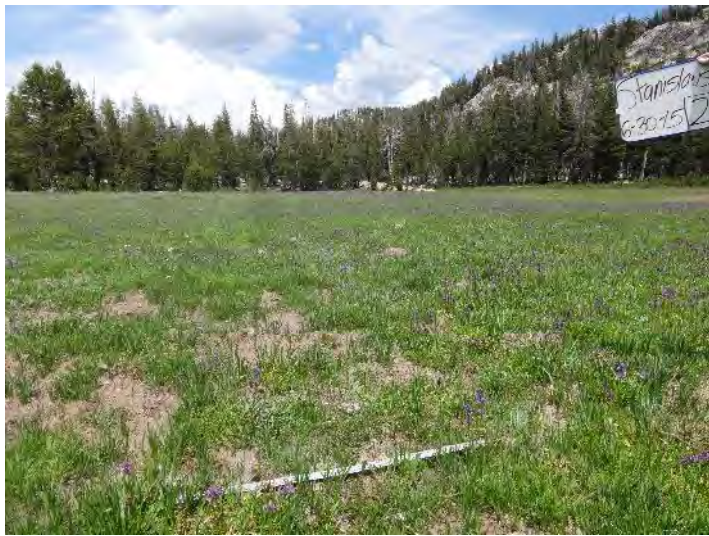
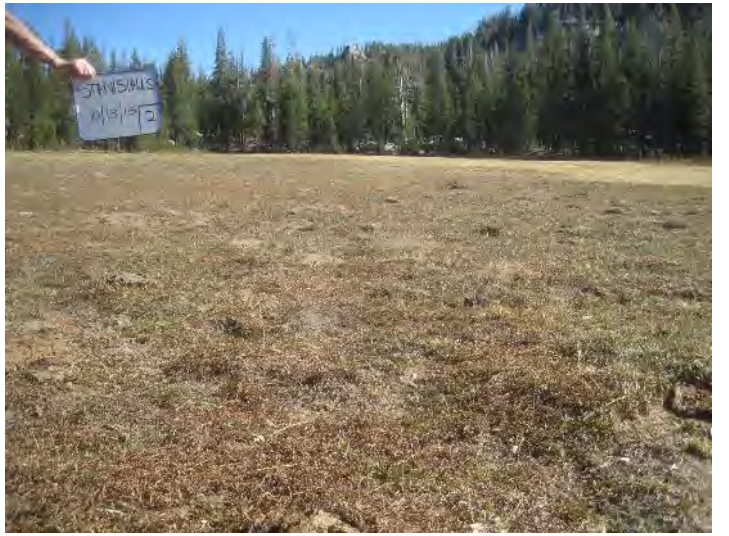
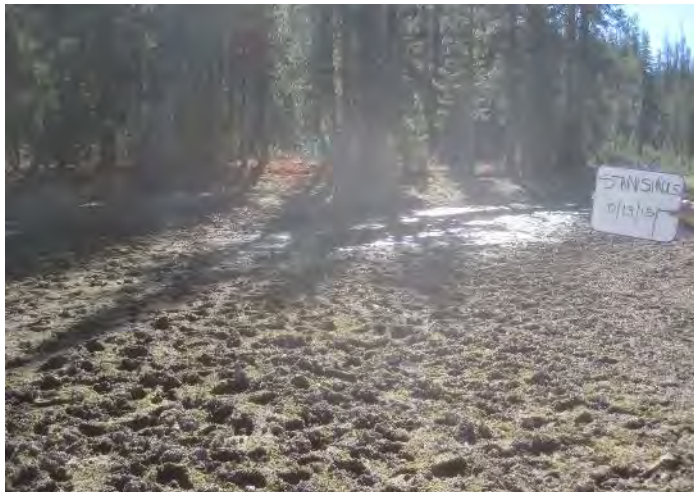
Stanislaus Meadow. Top left and right: before and after grazing in upper part of gathering meadow; shows overutilization and chiseling around wetland area is constricting the channel. Middle left and right; Photo point 2 before and after, in drier meadow habitat. Vegetation grazed past utilization standards. Bottom left; seasonal pond area is heavily pocked. Bottom right; another area of heavy sloughing and streambank degradation along SNYLF occupied pools.

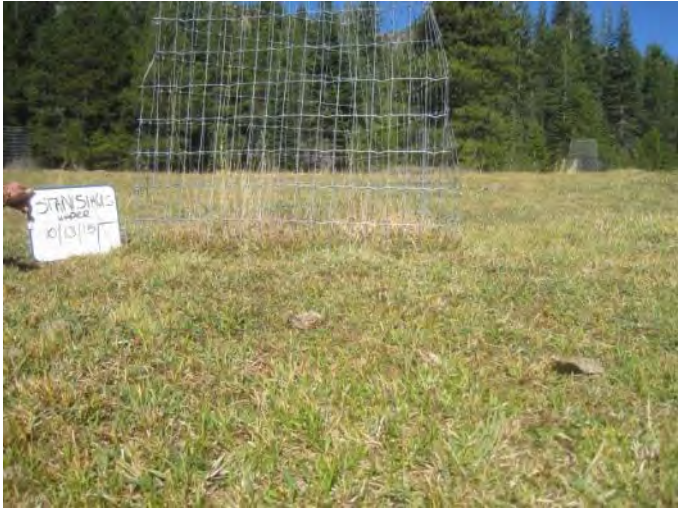
Upper Stanislaus Meadow (at Hwy 4 entrance): As these photos show, this meadow is one cows are allowed to linger in far past utilization standards being met. Wet areas are heavily pocked and chiseled causing dewatering of wetland areas, and channelization along streams. The restoration work that was done in this meadow is losing (and in some places, has lost) its function to stabilize the downcutting and headcutting in the stream channel. CSERC has reported the poor livestock movement and post-grazing conditions at this meadow for many years but the forest is yet to make any positive change to management.
