Central Sierra Environmental Resource Center
2015 Stanislaus National Forest
Meadow Condition and Grazing Utilization Report

2015 Meadow Condition and Grazing Utilization Report

Stanislaus National Forest

Central Sierra Environmental Resource Center

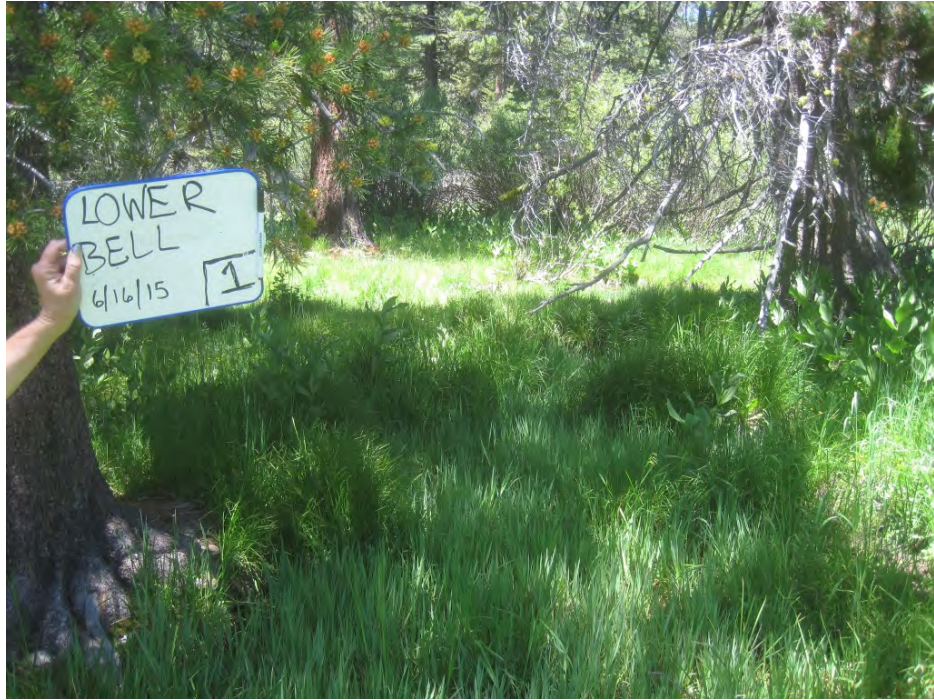
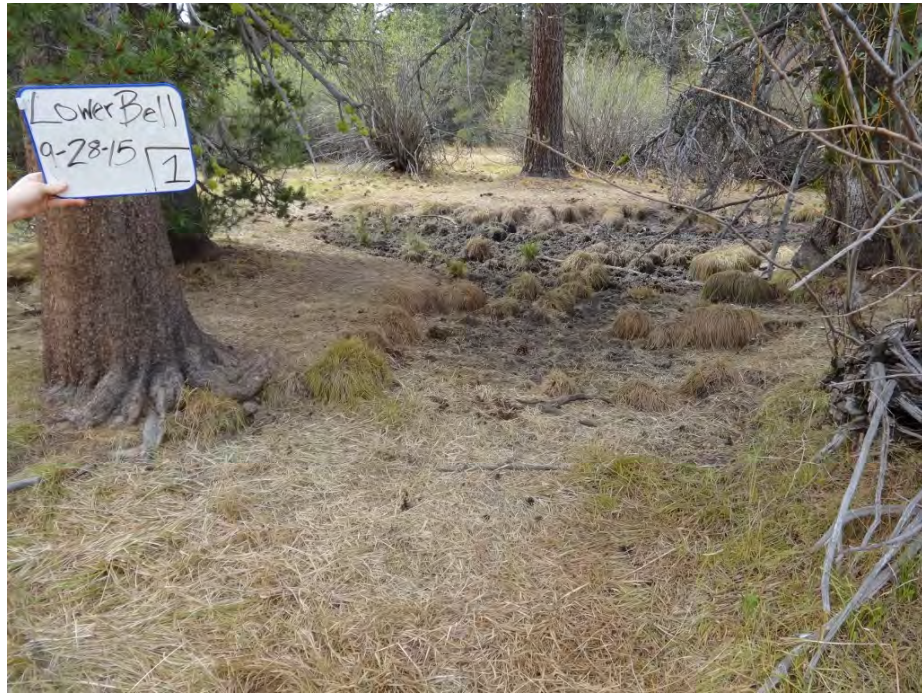
- 6/16/15: Meadow is mature, grasses flowering. Took pre-season photos and measured *C. integra* along transect. No cows yet.
- 9/28/15: Took transect measurements and photos at photo points. Areas of heavy grazing in mesic habitat. Spring area at photo point #1 has been pocked extensively. Overall moderately to lightly grazed in wetter *Carex* species areas.

Lower Bell Meadow (Bell I): Before grazing (*top*) and after grazing (*bottom*). Pocking and heavy grazing in spring that is in upper part of meadow.

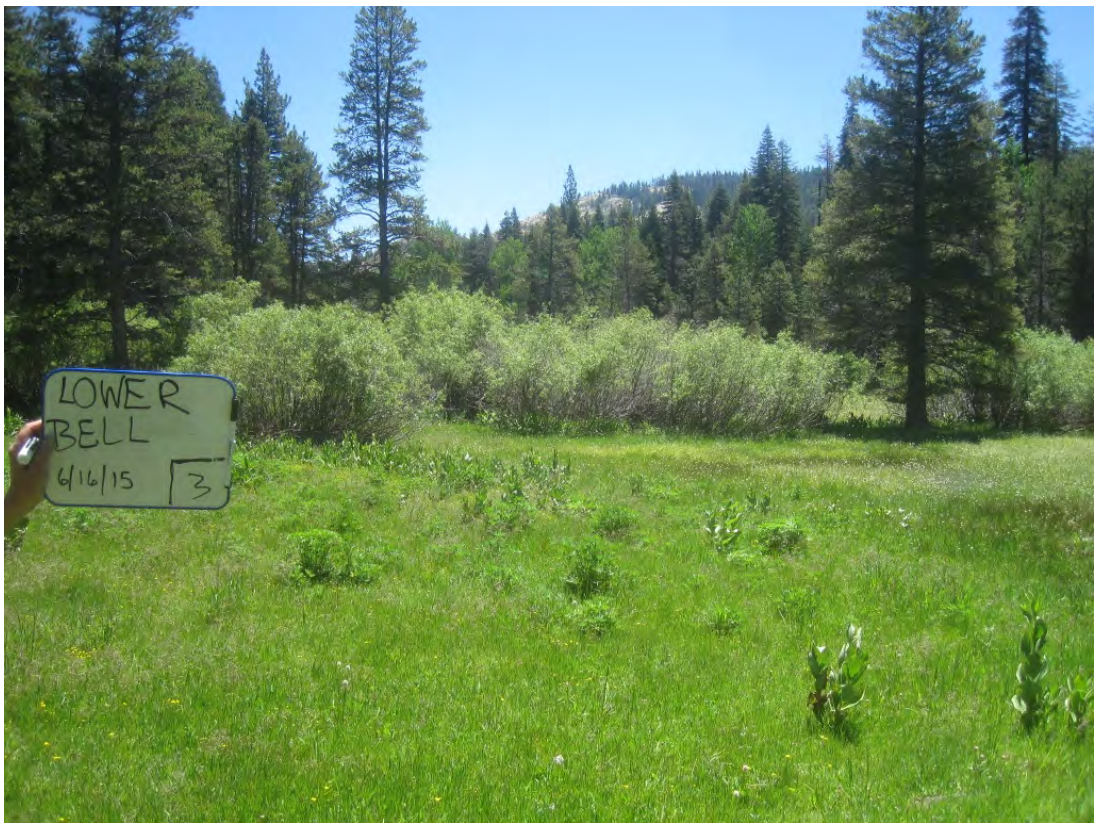
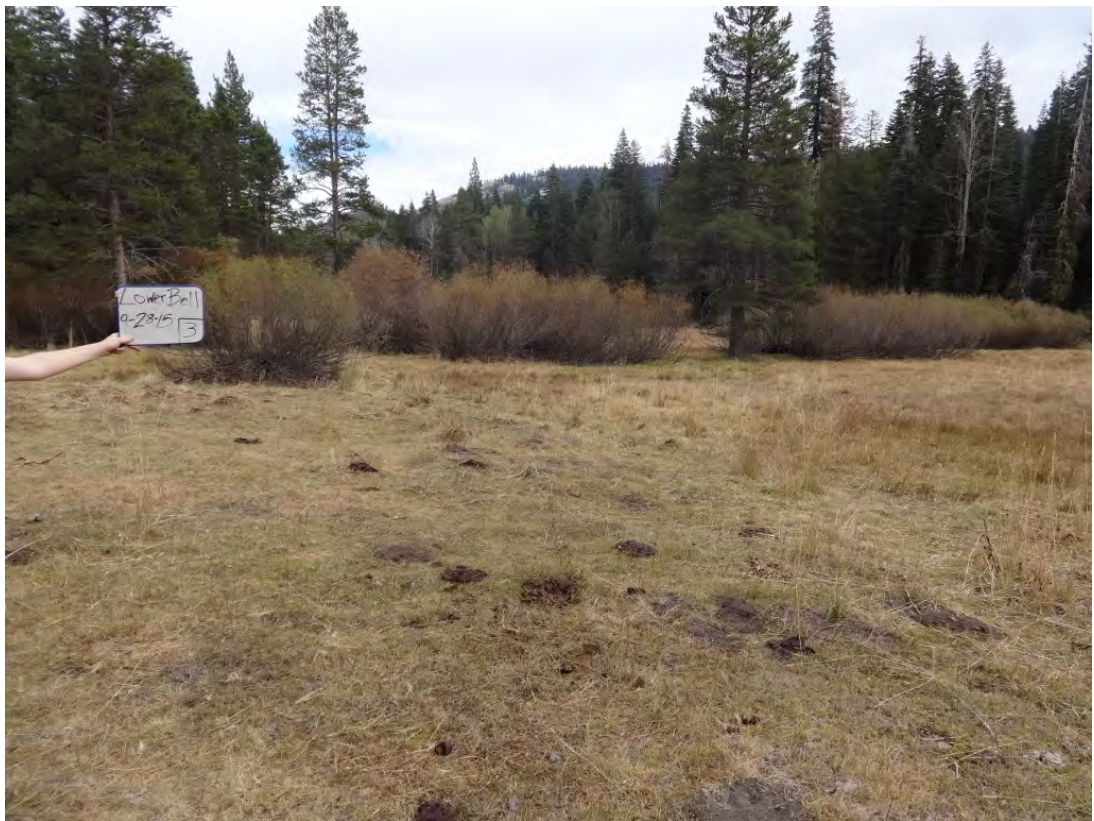
Lower Bell Meadow: photo point #3 before (top) and after (bottom) grazing shows heavy utilization of mesic meadow habitat in 2015.

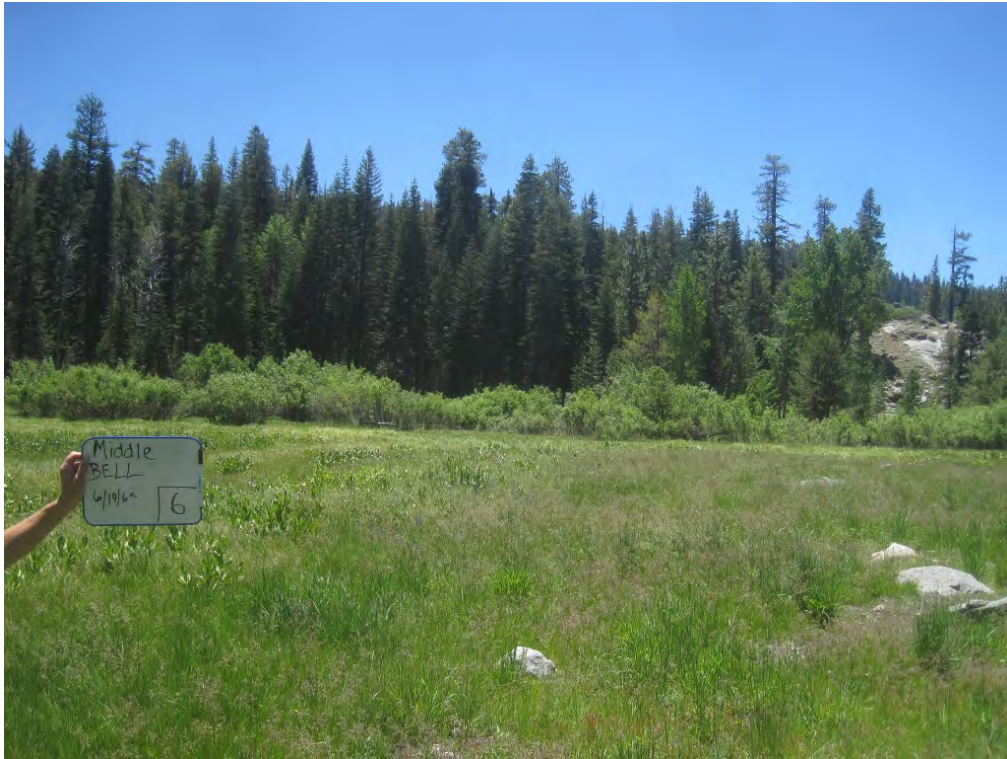
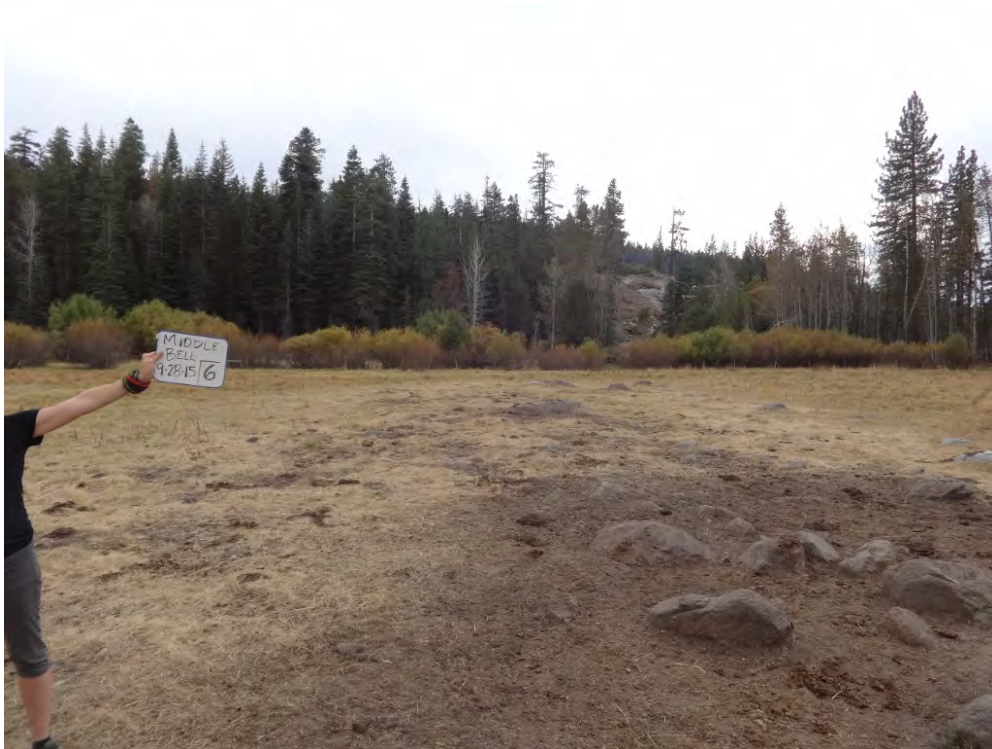
Middle Bell Meadow: pre and post season photos show heavy grazing in mesic and drier parts of the meadow.

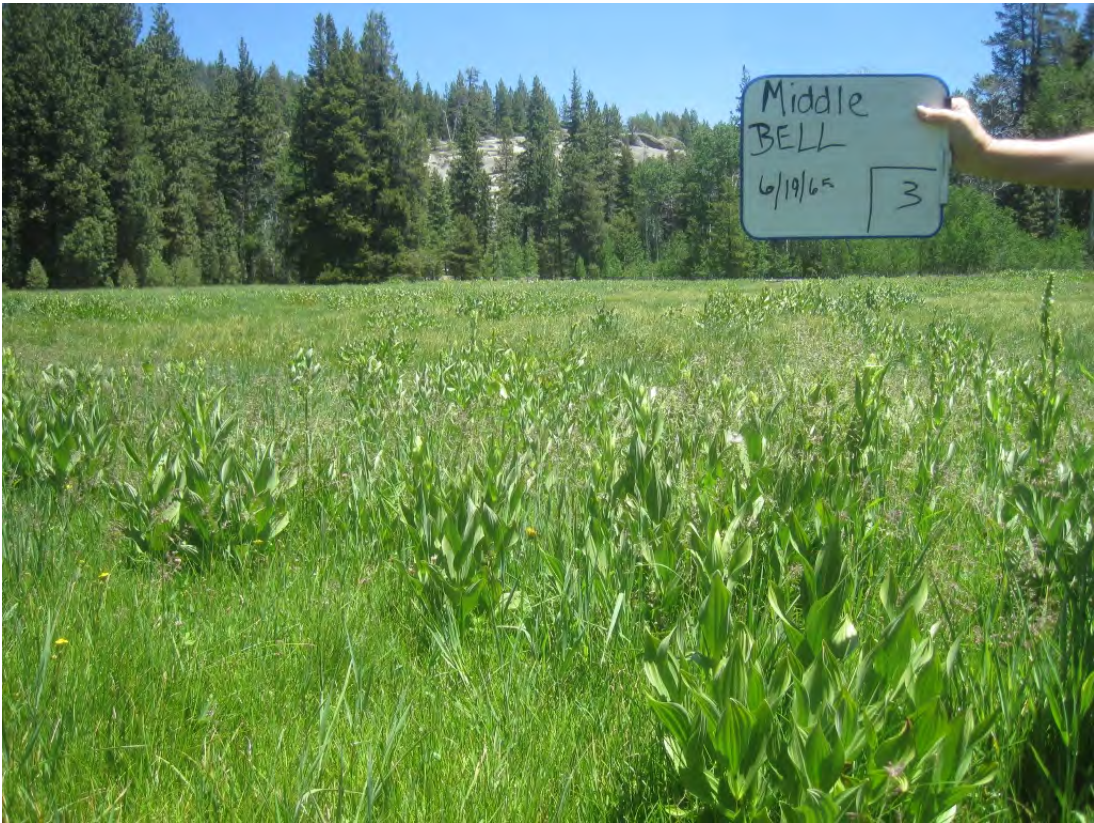
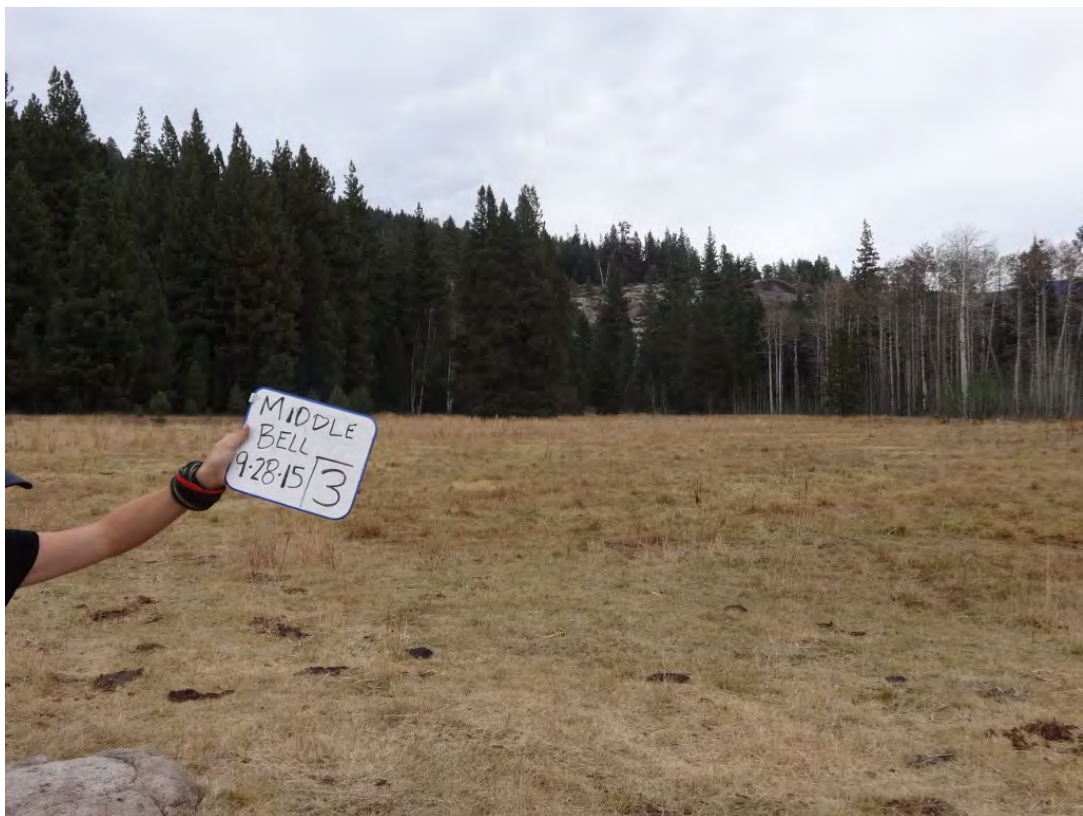
Middle Bell Meadow: pre and post season photos show heavy grazing in mesic and drier parts of the meadow.

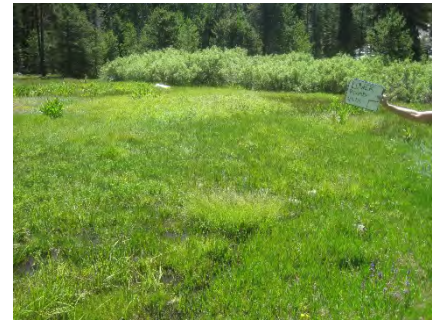
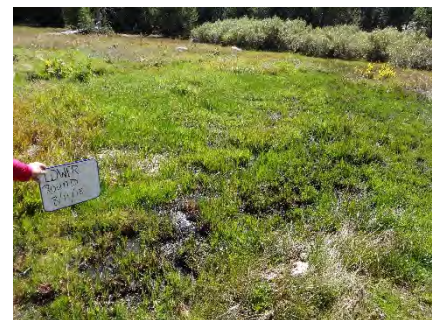
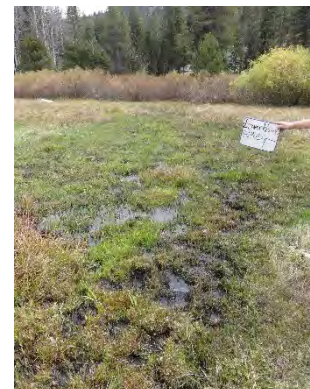
Above: Spring/possible fen in Lower Round – heavy pocking continues to degrade this special aquatic feature. Pictures show pre, mid and after grazing conditions.

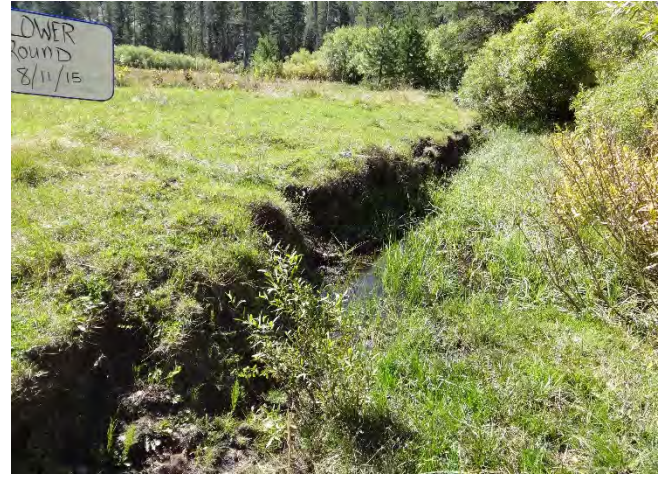
A season of degradation: Three photos of the same streambank throughout the season (June, August, September) show the high levels of grazing and livestock sloughing and pocking that continue to contribute to the deeply entrenched stream channel in Lower Round Meadow.

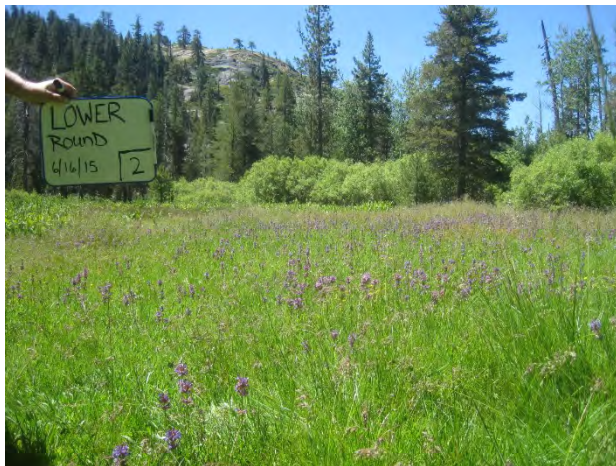
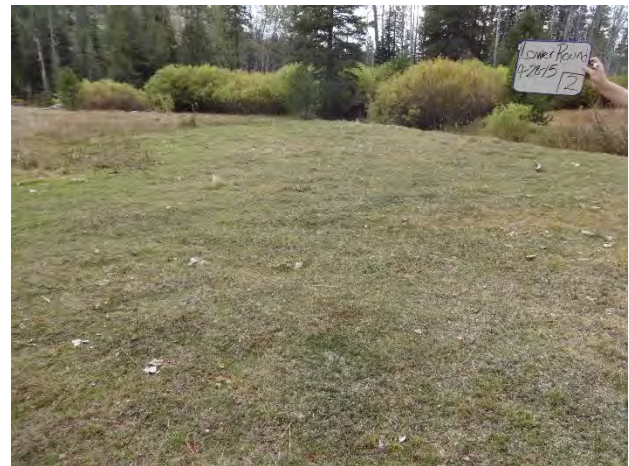
Lower Round Meadow: Before and after grazing 2015, photo point #2. Photo demonstrates overgrazed conditions in mesic areas of meadow.

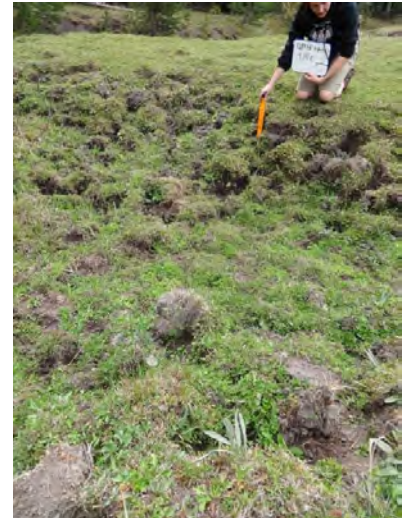
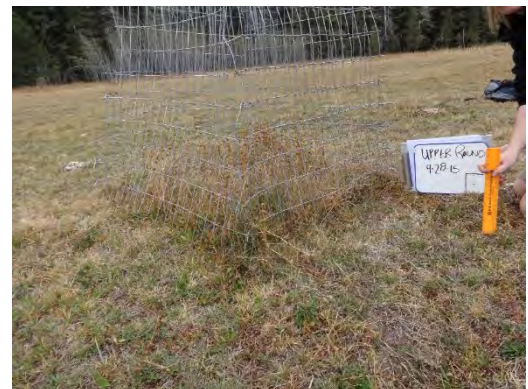
Bottom: Area of *Carex integra* (the key plant species for Upper Round) is **uniformly overgrazed** to about a 1" stubble height.

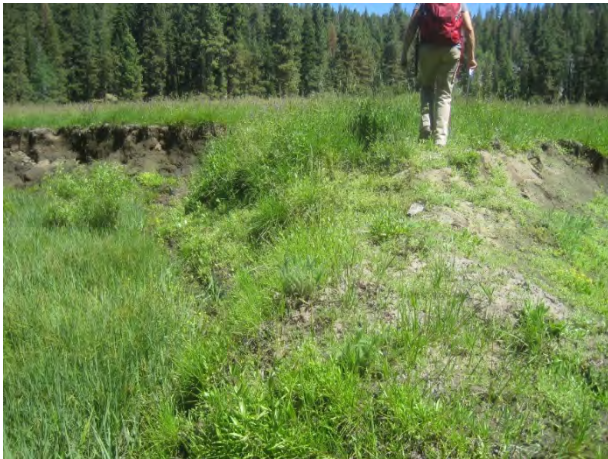
Pre and post season at one of many major headcuts in Upper Round shows a season worth of hoof damage and overgrazing making stream continually vulnerable to erosion and down-cutting. **AREA NEEDS TO BE FENCED TO BLOCK LIVESTOCK ACCESS.**

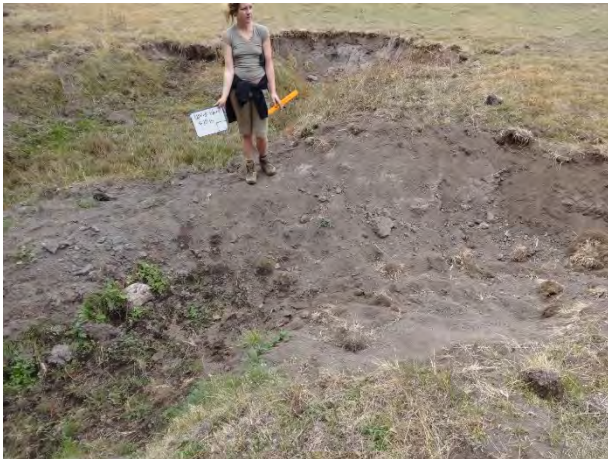
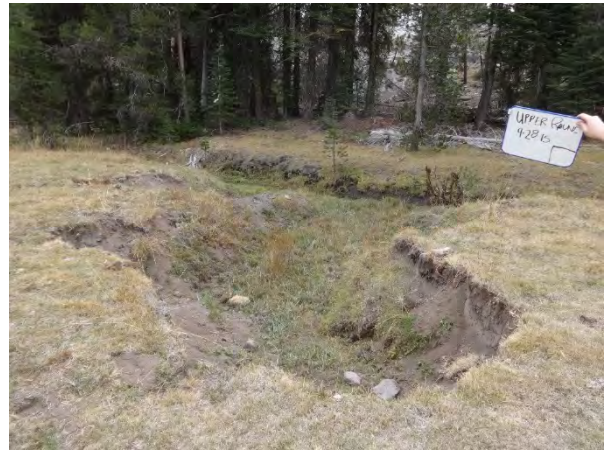
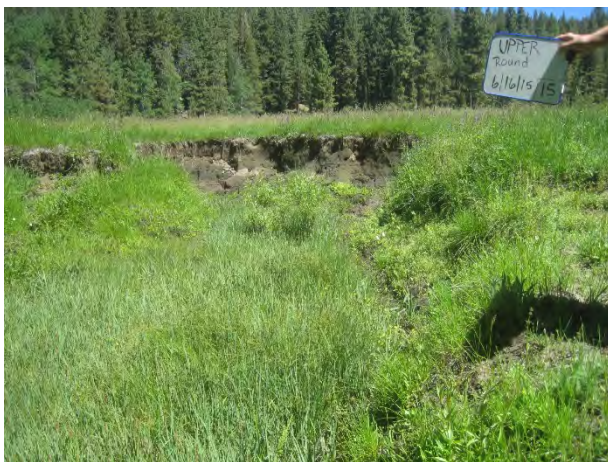
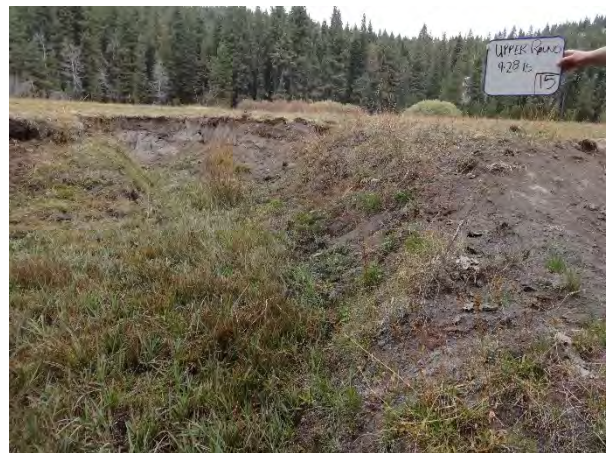
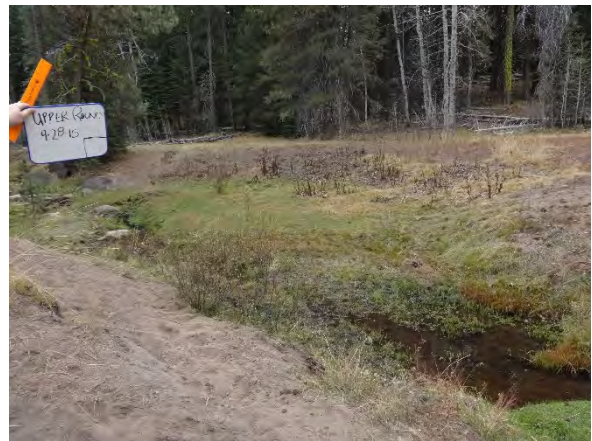
Headcut at base of Upper Round has visibly reduced greenline from the beginning to end of season. Major crossing point for livestock as they head downstream is right at this headcut, needs to be fenced and livestock re-directed to avoid further sloughing and downcutting on headcut.

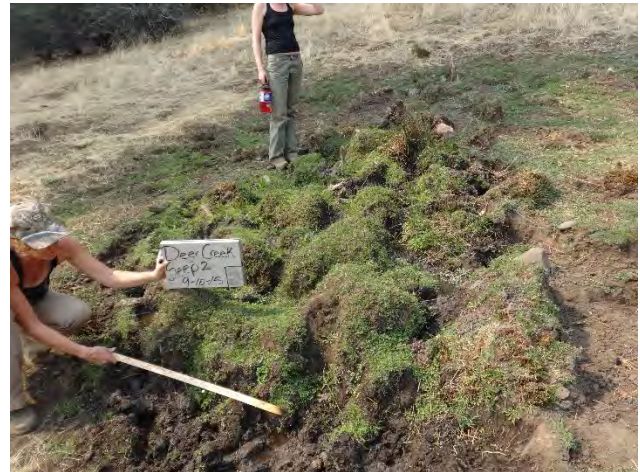
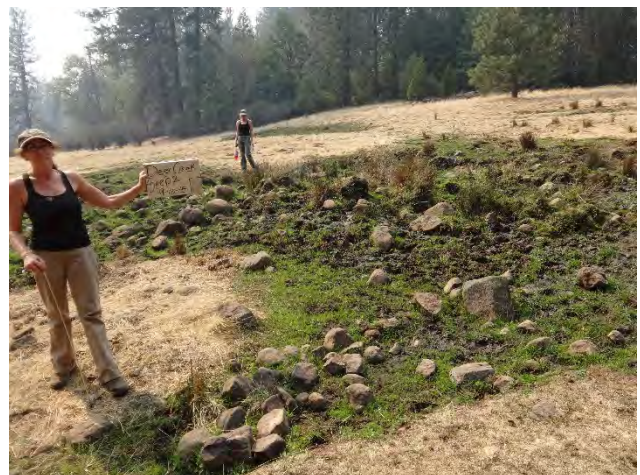
Seeps at Deer Creek 2015: Pocking and chiseling of these limited wetland habitats is further disabling their ability to retain water and are at a minimum in Functional-At-Risk condition, due to intense livestock utilization. This has been magnified during the drought. The wildlife and watershed value is significantly diminished and degraded, and need immediate protection and restoration.

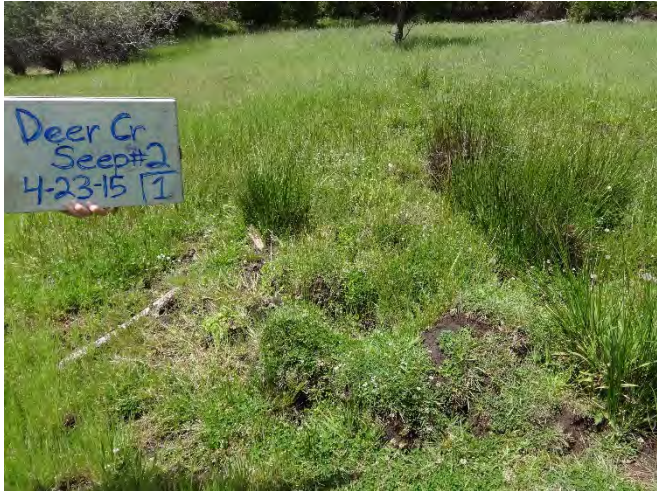
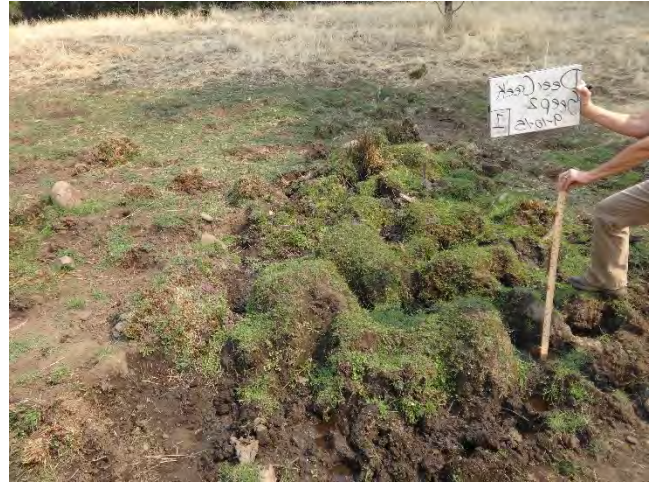
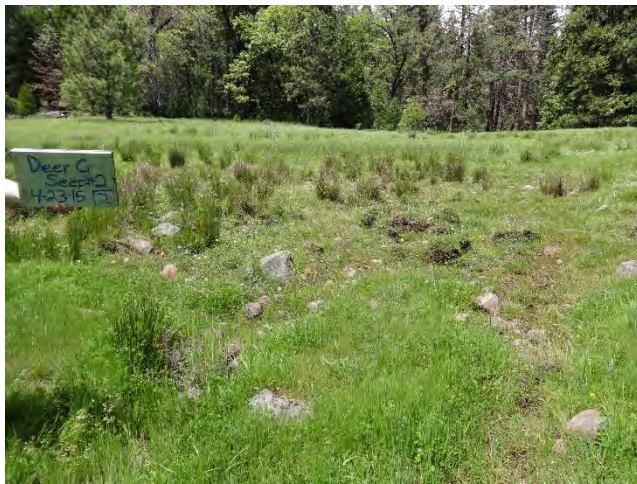
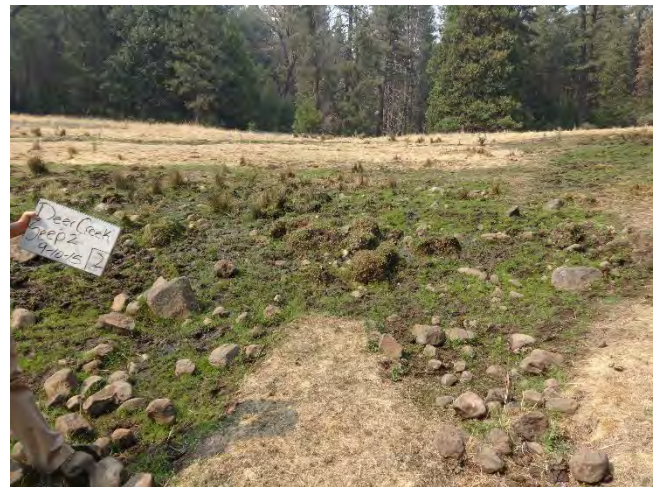
Deer Creek, Seep #2: **Before (left) and after (right) photos show another important wetland feature for an otherwise dry area of the forest, with high levels of forage utilization and soil disturbance.** These seeps have shrunk in their perimeter since staff has started monitoring them and have a dire need for rest from livestock impacts, and restoration is needed.

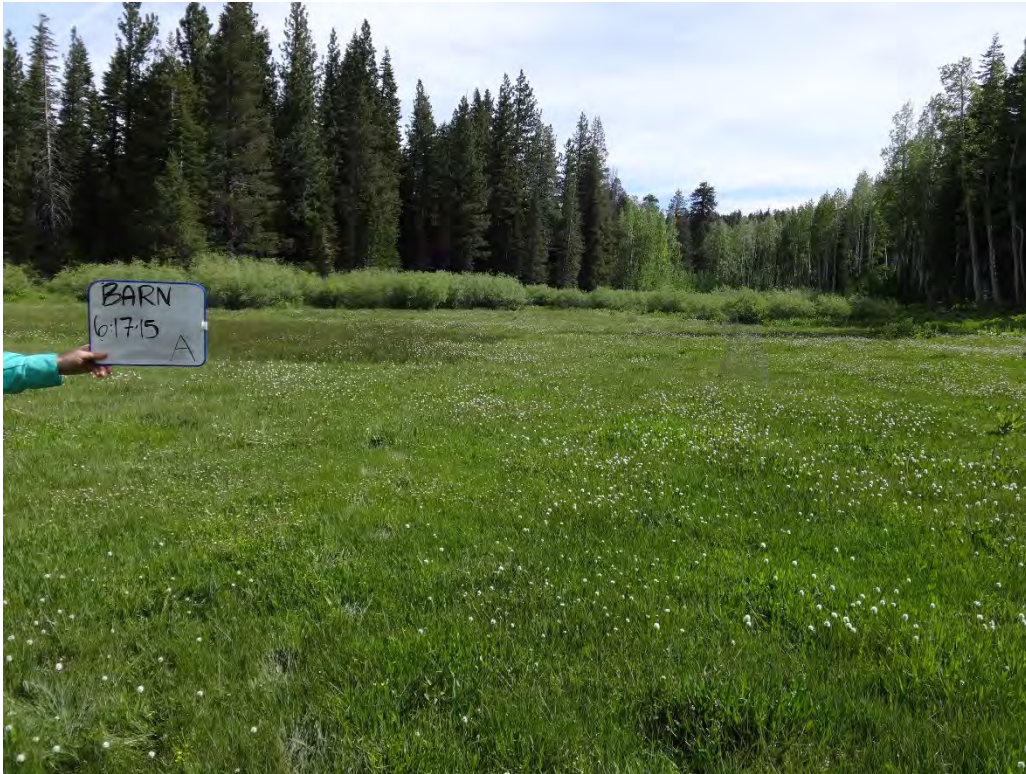
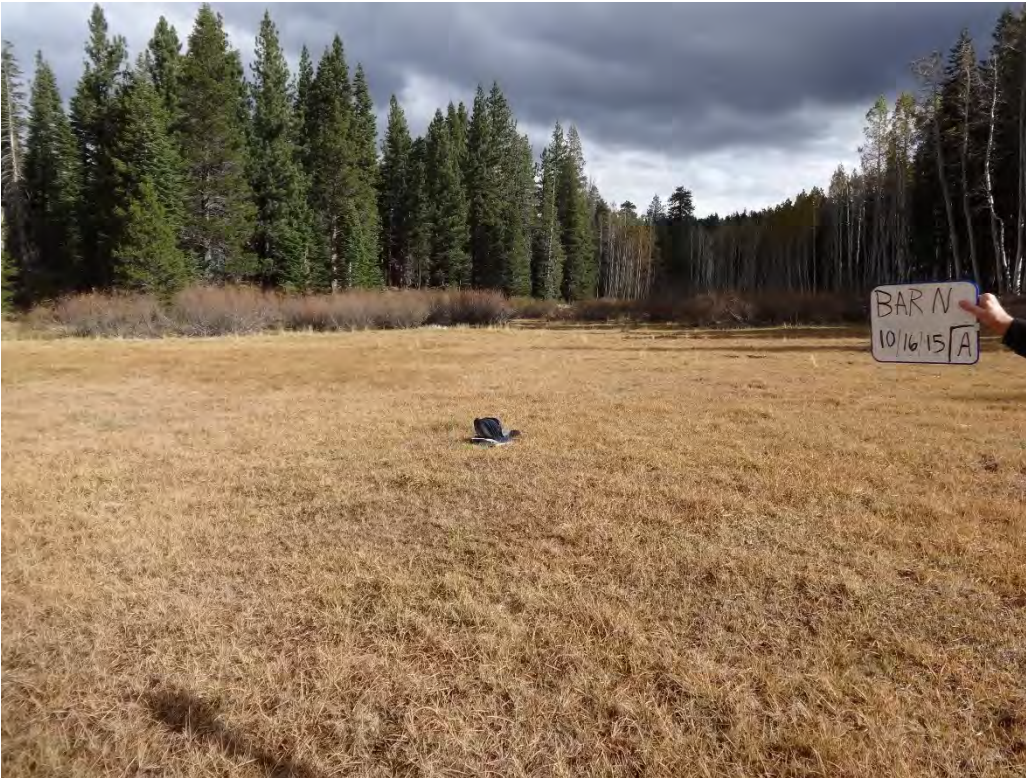
Barn Meadow 2015 – photo point A shows meadow has been grazed within standards this season.

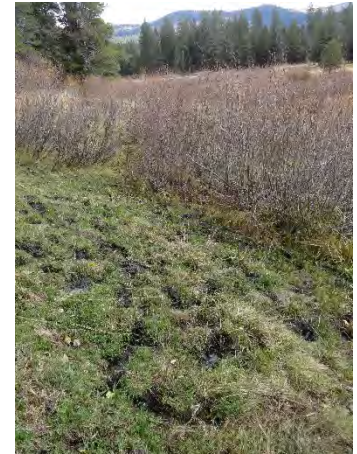
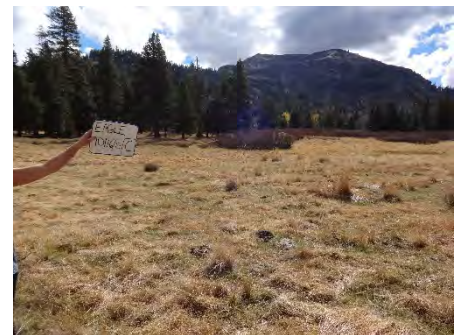
Spring and fen areas (top) were heavily pocked and grazed in Eagle Meadow in 2015. Gathering at the end of the season draws cows to the wetter green areas in a meadow that browned early in a drought year (bottom).

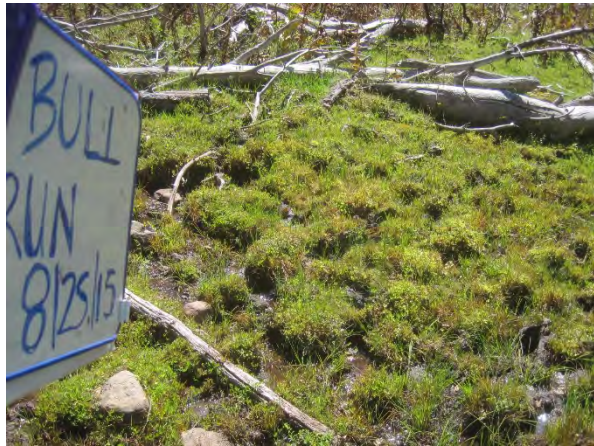
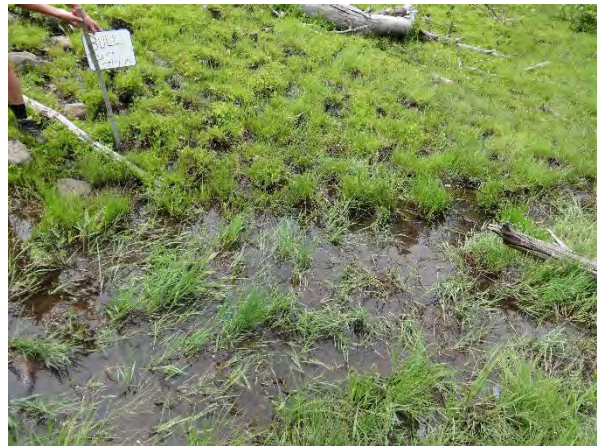
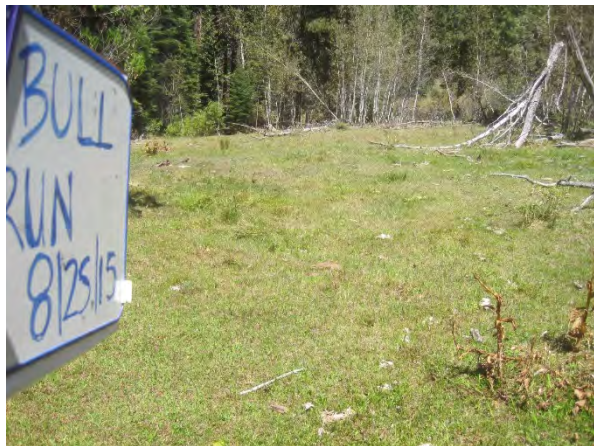
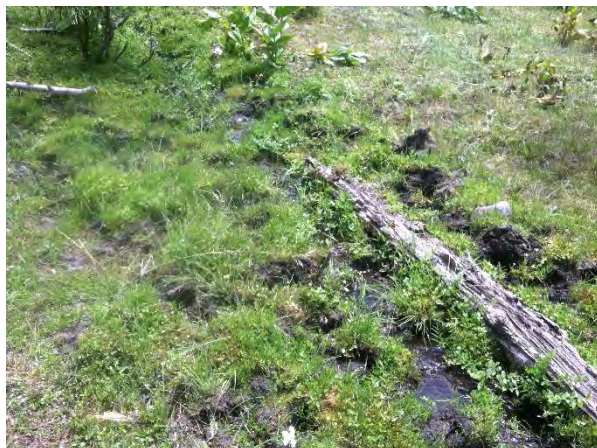
- **Bull Run:** Moderate to heavy grazing evident, grasses have grown back since beginning of season. Cows weren't allowed to hang out in this area all summer as they have in previous years. Sloughing and pocking continues to worsen along wet spring area and stream banks. Deep pocking documented. The upper wet area of Bull Run is also moderately grazed. Took photos throughout.

Bull Run 2015: Grazing damage was less than documented in the past several seasons due to reduced numbers and cows not being left in Bull Run all summer. However the level of grazing still exceeded utilization standards, and wetland areas continue to also not meet established regulations for protection of Special Aquatic Features.

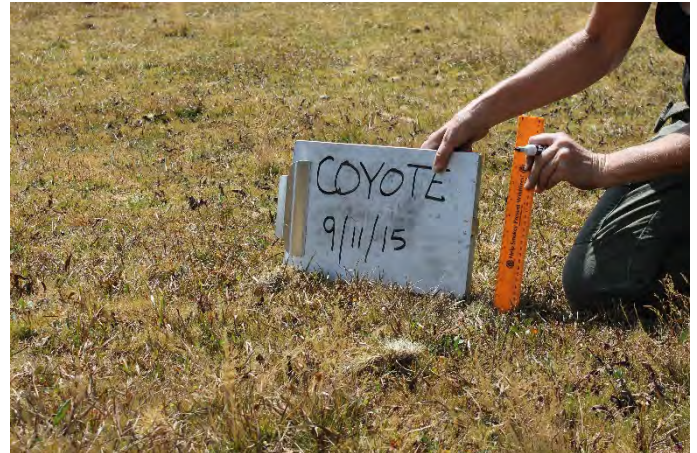
Coyote Meadow 2015: Heavy uniform grazing in some areas within the meadow, especially where *Carex integra* dominates.

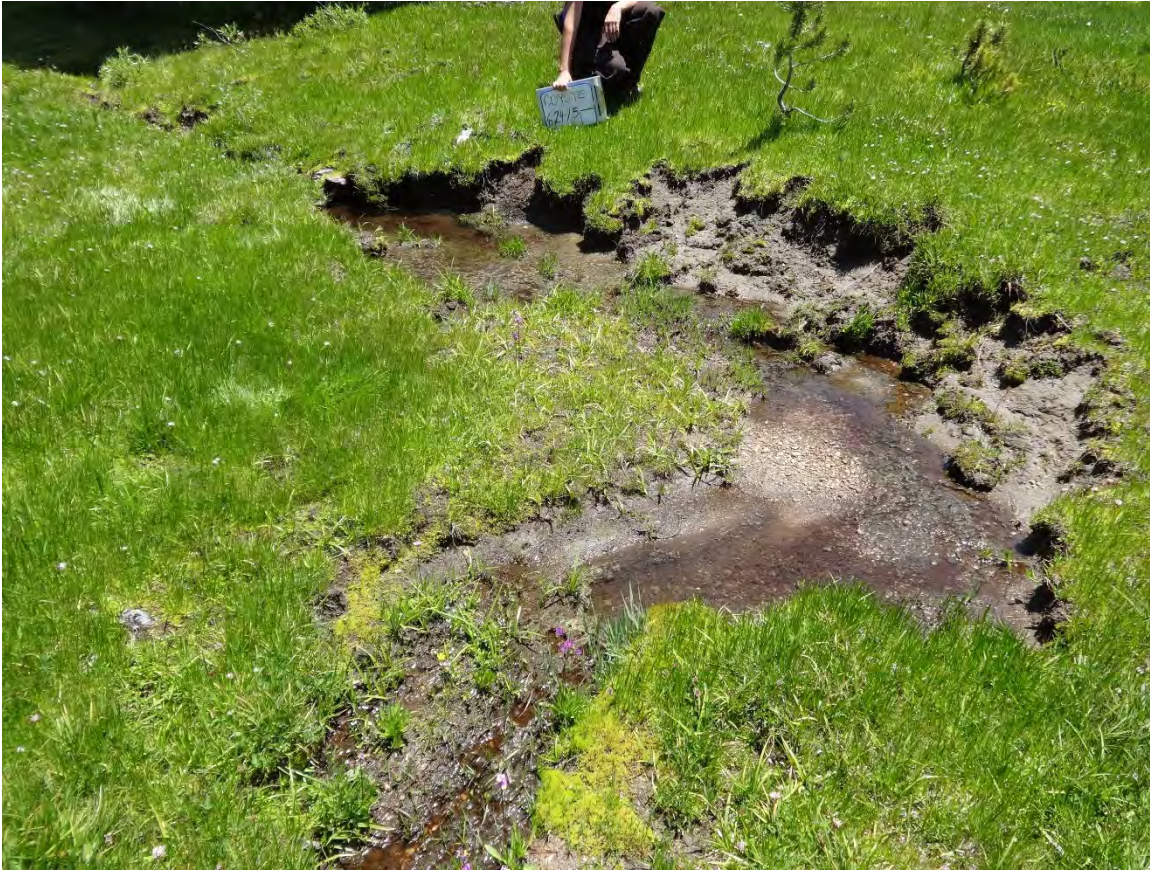
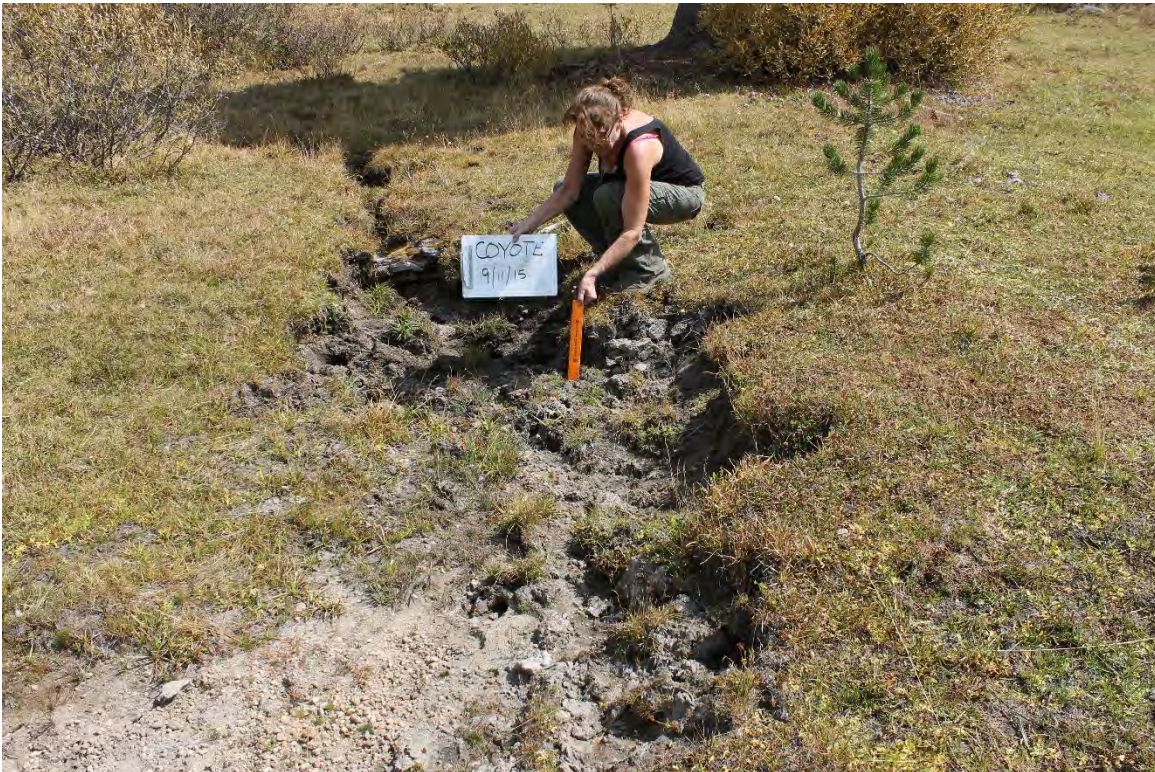
- Streambank damage and down-cutting

Coyote Meadow 2015: Channelized and downcut stream in lower part of meadow continues to worsen from hoof chiseling and sloughing.

- Protect Yosemite toad habitat
- Restoration of stream entrenchment
- Repair diverted stream channel

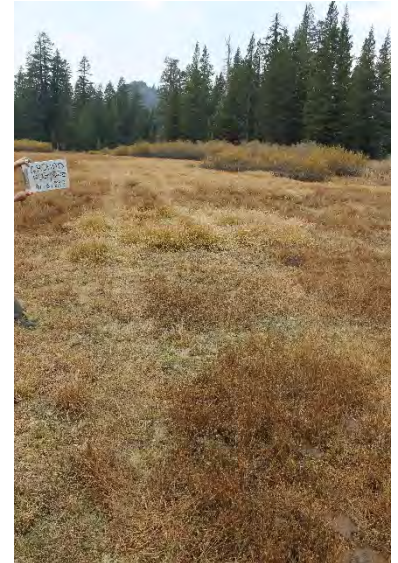
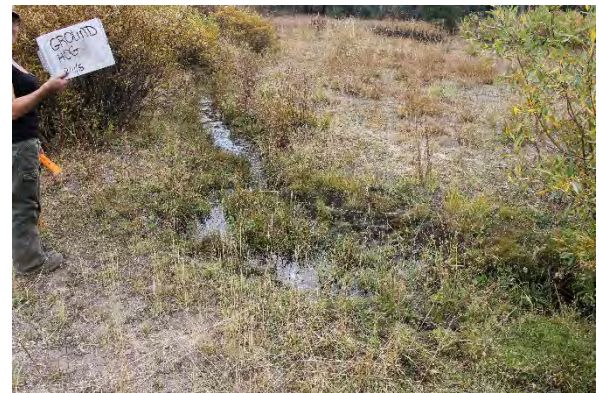
- **6/24/15:** Took photographs. USFS amphibian crew overlapped with our staff again at this meadow, and found 1 Yosemite toad tadpole in creek mid-meadow. Breeding pools almost dry, those with water had *Pseudacris regilla*.
- **9/11/15:** Some grazing has occurred. Stream has trampling and sloughing where livestock accessed it (bottom photo). No cattle present at this time. Illegal off-road vehicle driving has occurred in the meadow, tracks throughout breeding pools of YOTO (top photo). Staff attempted to block vehicle access with rocks and sticks, but many possible access points from dispersed camping remain. Blocking access to meadow from campsite with boulders or a berm should be considered.

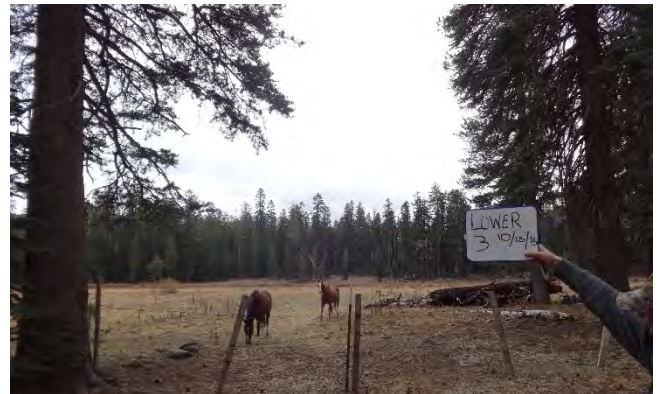
Lower Three Meadow: Horses grazing in a Yosemite toad-occupied meadow all summer causes moderate to heavy utilization. Forest Service documents share that this meadow is supposed to be off-limits to grazing.

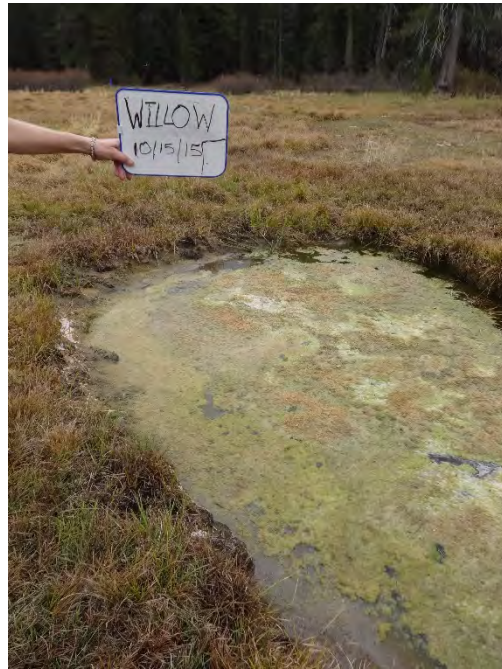
Willow Meadow 2015: Pond where *Pseudacris regilla* breeds, was clogged with algae this year.

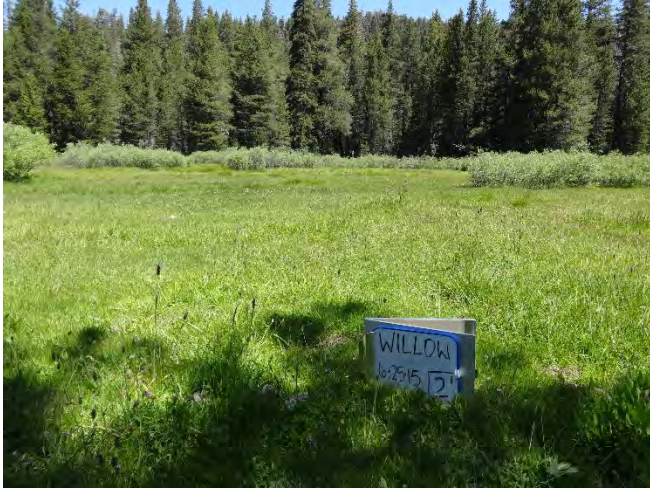
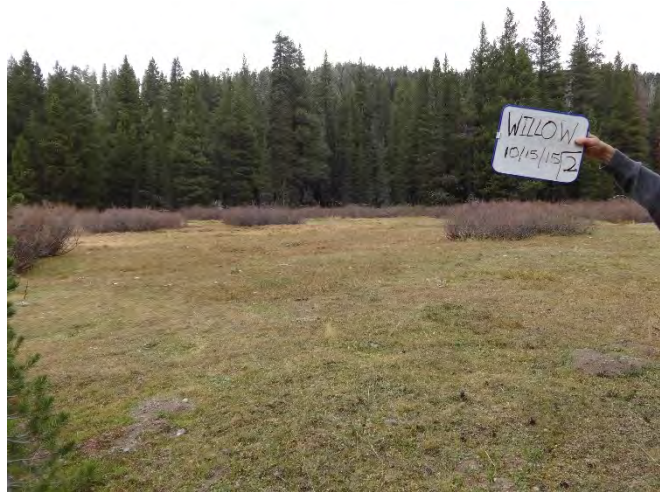
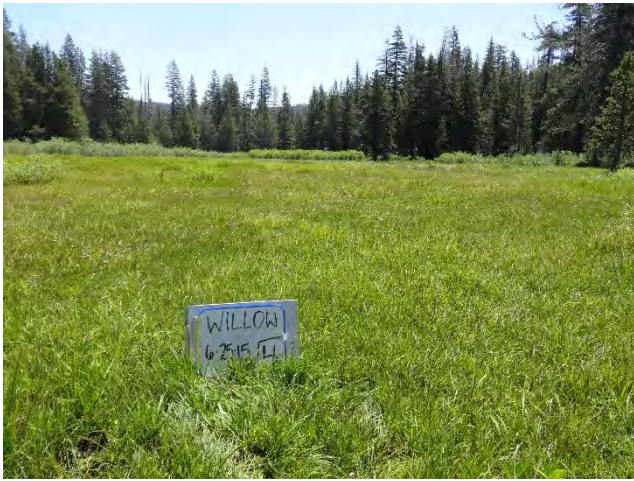
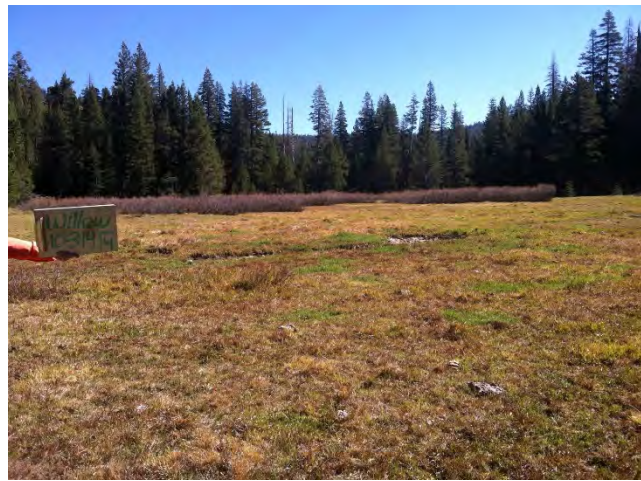
Measured utilization: *C.integra.*: 86% (+/-1 %),
C.scopularum.: 61.03% (+/-3.45%)

Willow Meadow 2015: heavily grazed conditions were observed both at transect measurement locations, and at photo point locations, as pre- and post-grazing photographs reveal.

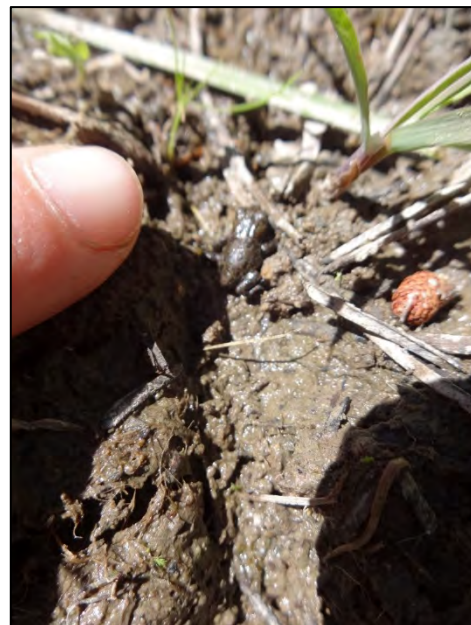
Wire Corral Meadow, 2015: A recently metamorphosed Yosemite toad in the heavily grazed and pocked wetland area in lower Wire Corral. **Especially considering the size and slow movement of recently metamorphosed toads, CSERC staff raises the concern whether this at-risk amphibian is truly being protected.** Habitat and shelter is drastically affected by livestock, and they are in danger of trampling and other potentially fatal hazards that have been widely acknowledged by Forest Service scientists.

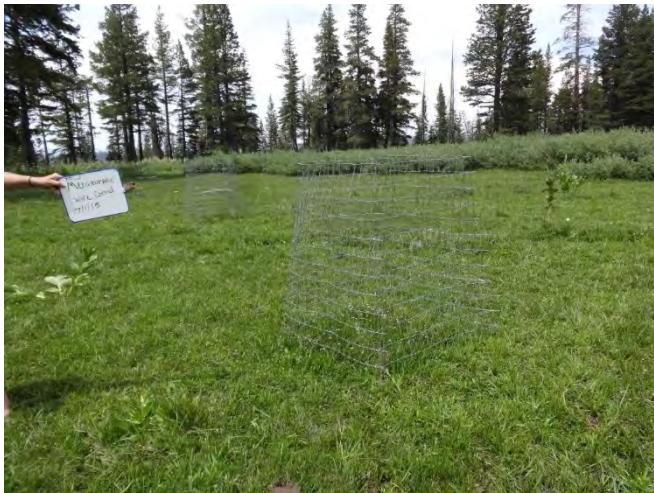
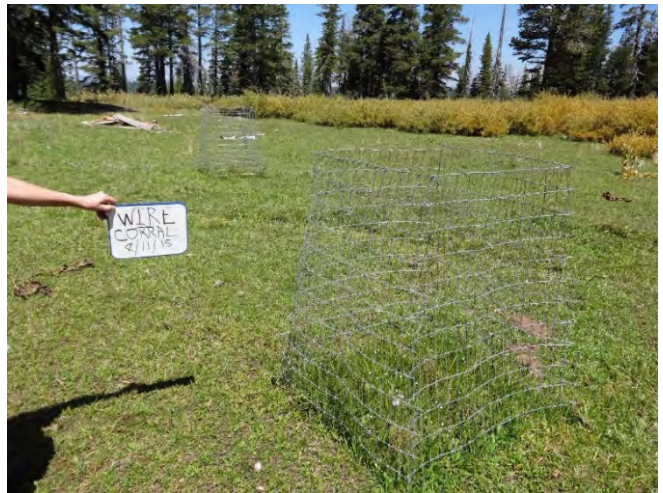
Wire Corral Meadow, 2015: The Forest installed several utilization cages in the bottom are of the meadow where YOTO are commonly found and near to the breeding pools. **Photos taken by CSERC staff throughout the season demonstrate the high level of grazing in Wire Corral this season.** Removal of vegetation is acknowledged by the Forest Service to be detrimental to YOTO as it makes them vulnerable to predation as well as to overheating from lack of shade. This is demonstrative of the poor management of livestock in the Herring Allotment this season as many other meadows remained largely untouched by grazing, yet cows were allowed to linger in and degrade one of the most highly populated locations for the Yosemite toad.
