Central Sierra Environmental Resource Center
2015 Stanislaus National Forest
Meadow Condition and Grazing Utilization Report

2015 Meadow Condition and Grazing Utilization Report

Stanislaus National Forest

Central Sierra Environmental Resource Center

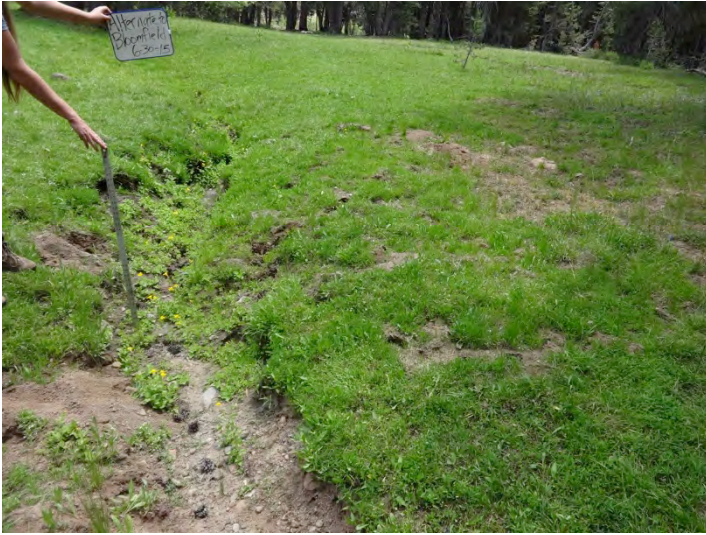
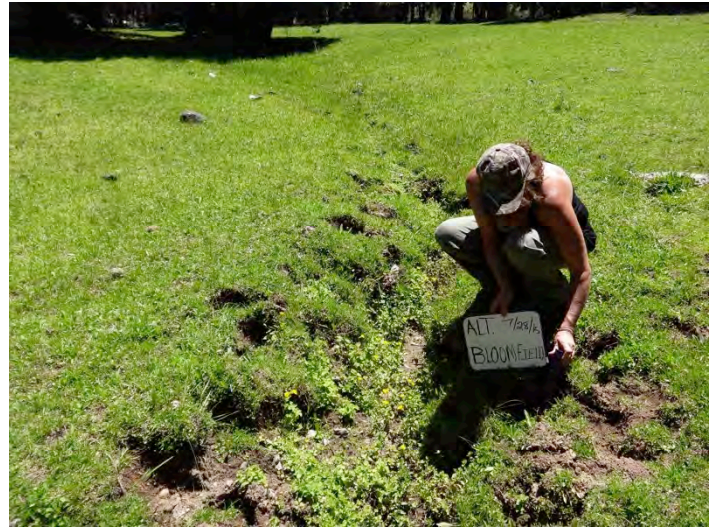
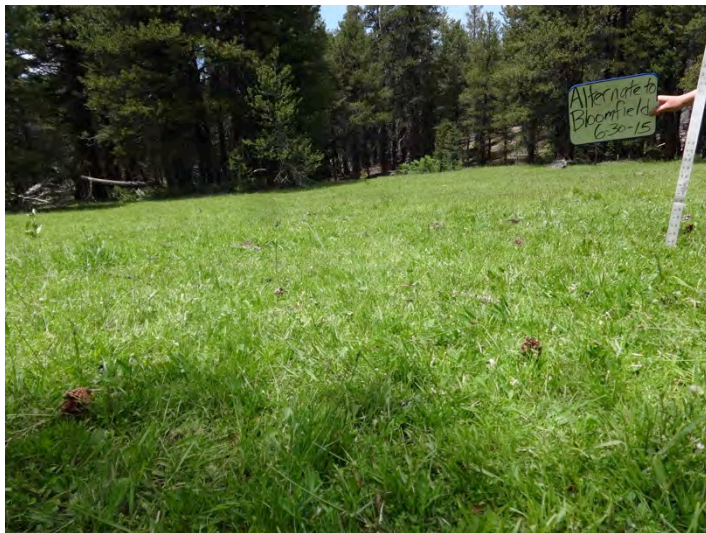
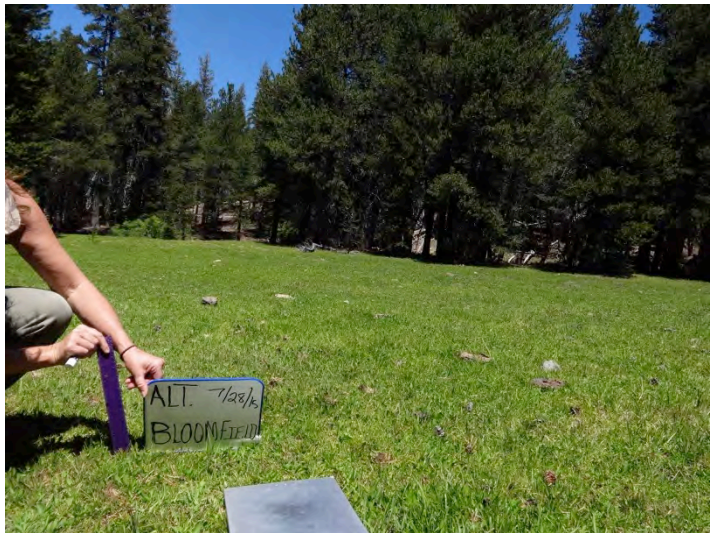
Alt. to Bloomfield: Top left (pre-season) and right (post-season) show that the ephemeral channel in the meadow has been notably pocked and chiseled from a season of use. This is causing instability of the channel. Bottom left (pre) and right (post) shows heavy level of grazing in a month of use.

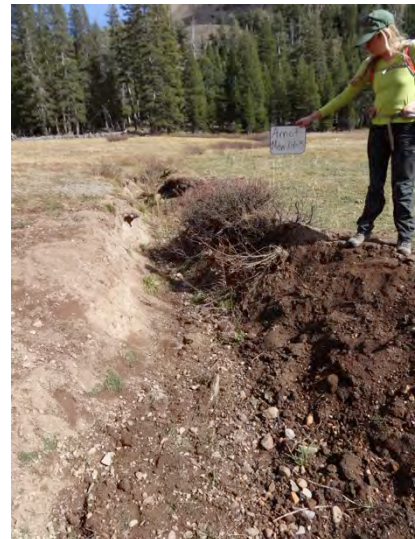
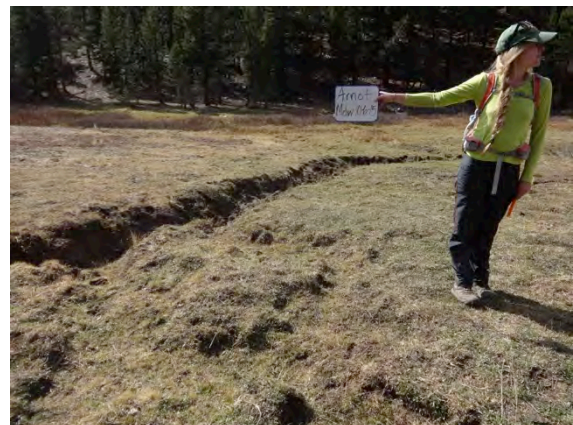
- 8-6: Meadow mature, cows present. Took measurements along the transect line.
- 10-6: Heavily to moderately grazed (uniform) throughout. Lots of manure. Heavily incised channels are dewatering the meadow. Downcutting and chiseling are severe along feeder channels.

Arnot Meadow: Severely entrenched stream in Arnot continues to degrade. Before and after grazing photos document heavy willow browse, overgrazing of soil stabilizing vegetation, and more sloughing and chiseling of stream banks.

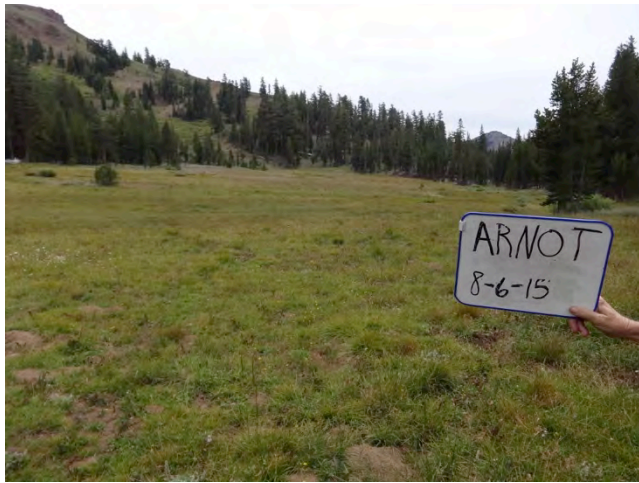
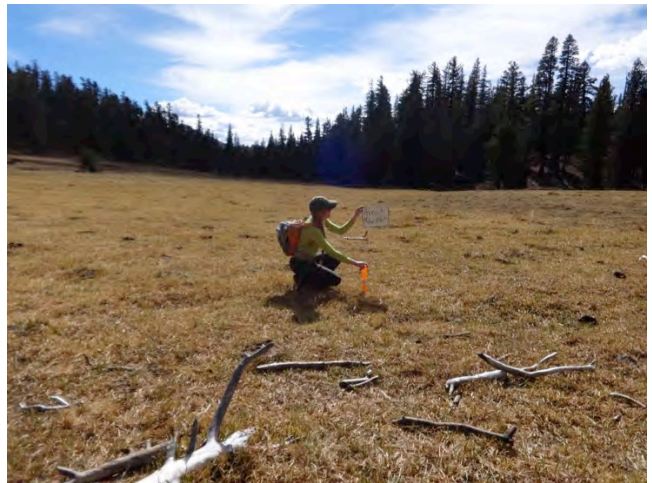
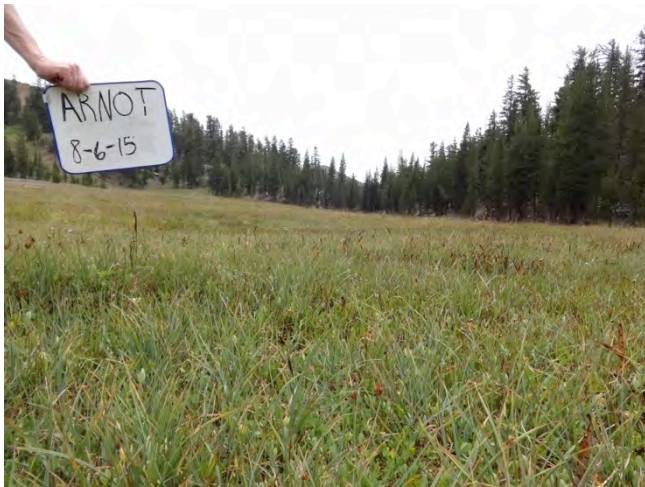
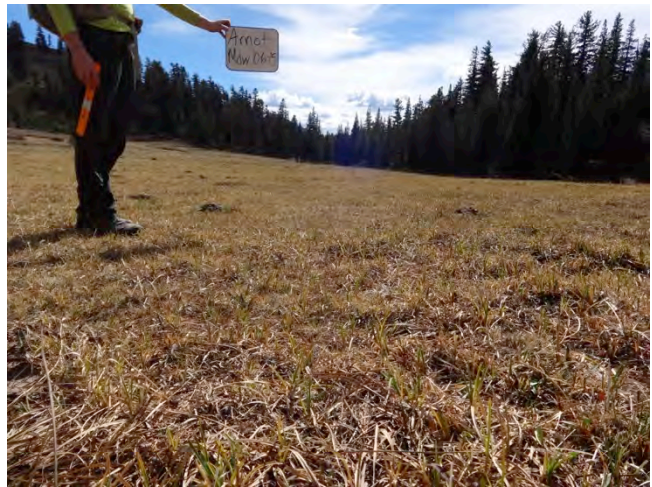
Arnot Meadow 2015: Before and after photos correlate with transect measurements, showing that livestock have overgrazed beyond utilization standards in the transect area.

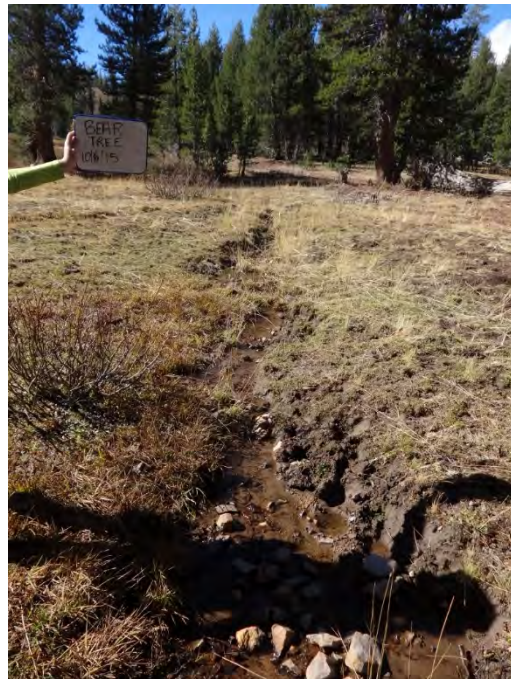
Tributary creek (source is the fen and upland areas of the meadow) to main creek in Bear Tree Meadow is heavily chiseled, overgrazed, and channelizing.

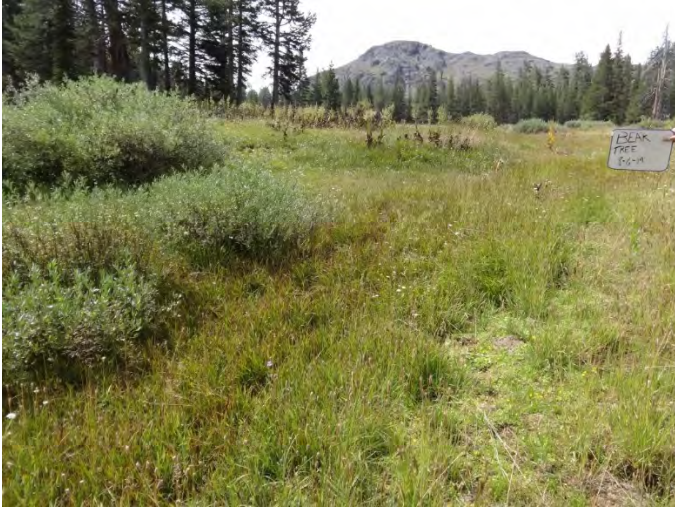
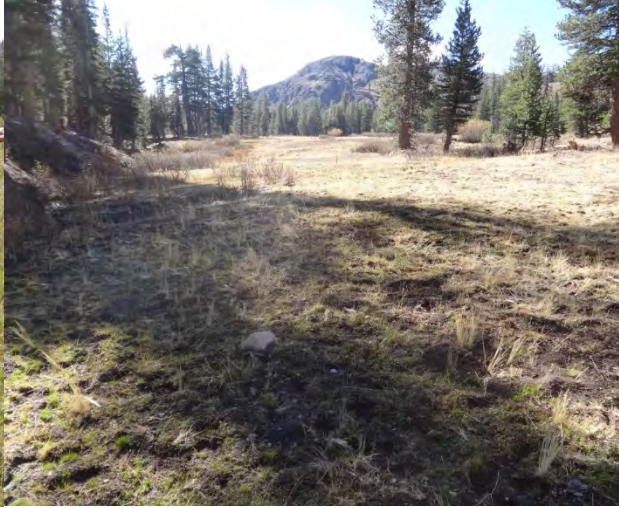
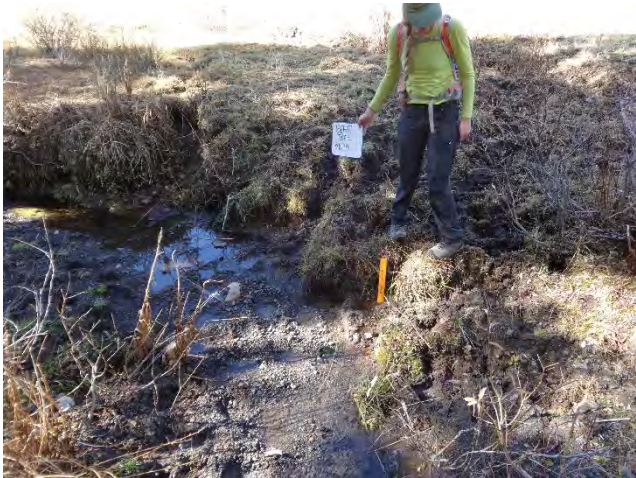
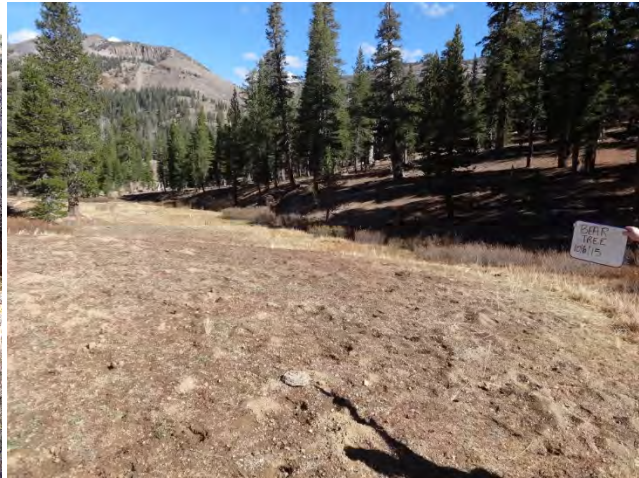
SMZ's in Bear Tree Meadow: Streams throughout Bear Tree are supposed to be maintained to a 4" stubble height along banks. Chiseling, sloughing, and overgrazing documented all along this meadow's streams in 2015.

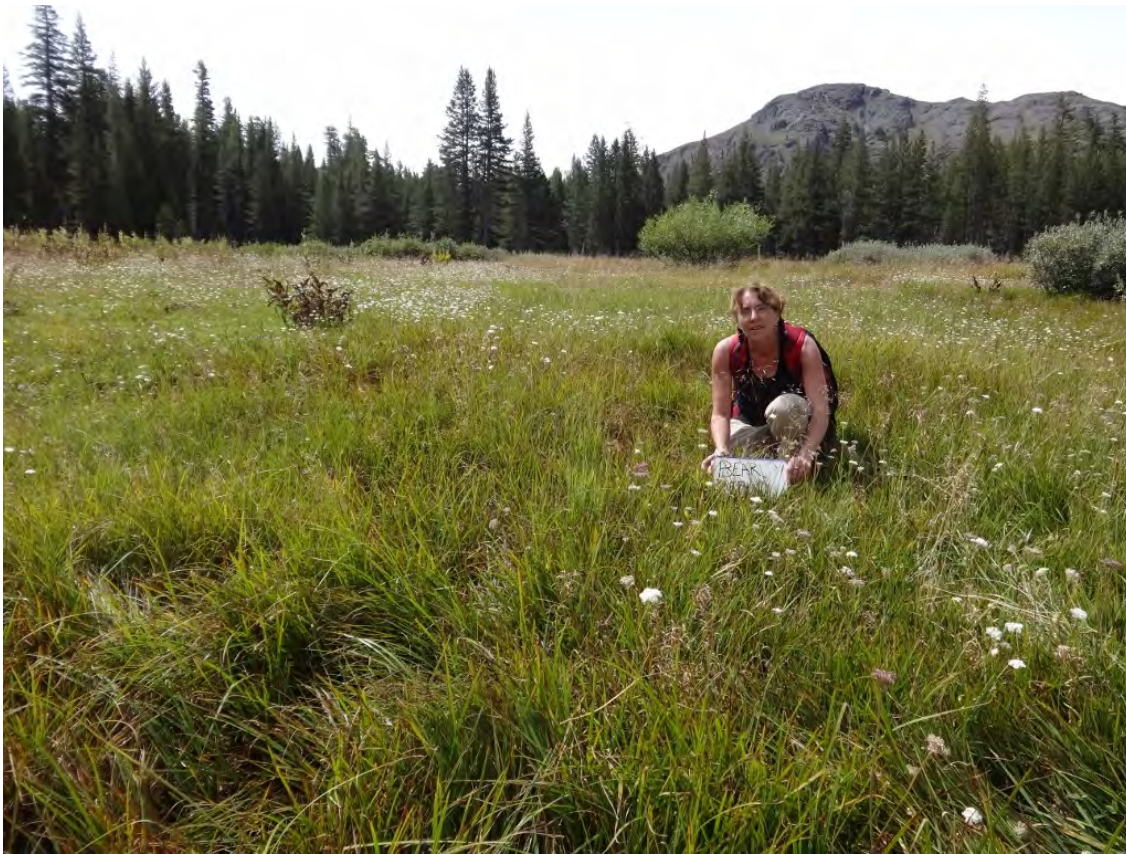
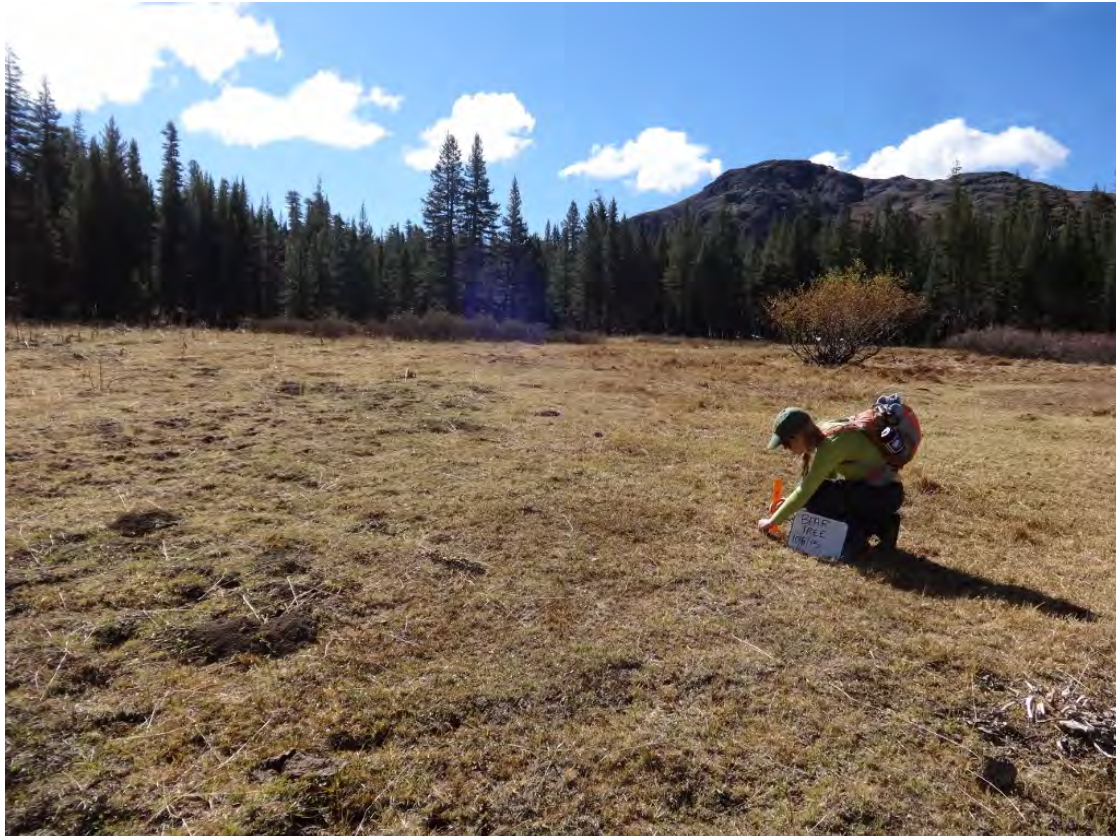
Before and after photos, Bear Tree Meadow, 2015. Visual assesment indicates that meadow has been grazed past utilization.

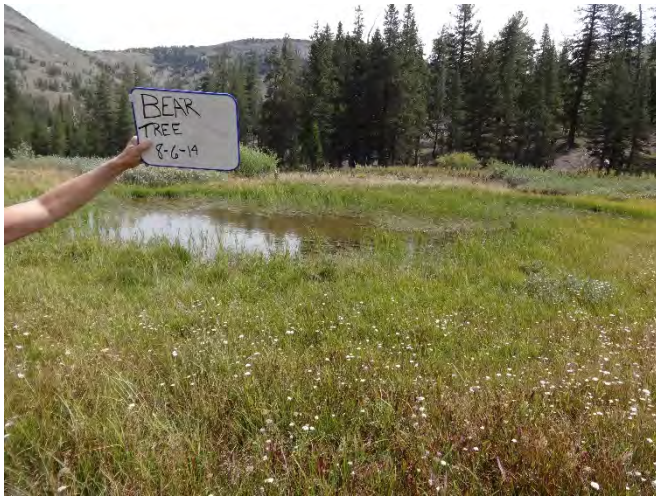
Bear Tree Meadow: Spring shown here is in upper meadow and is a confirmed Yosemite toad breeding pool, which undergoes extreme pocking, overgrazing, and contamination from feces every season, resulting in long-term cumulative damage to this essential habitat for a federally threatened species. Top left is pre-season (wrong year written on the board), and top right is post-season, 2015.

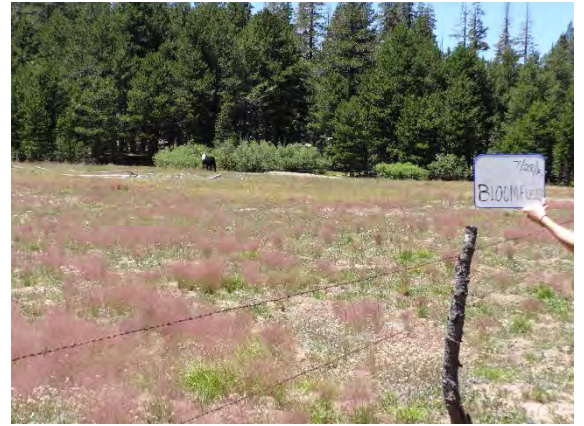
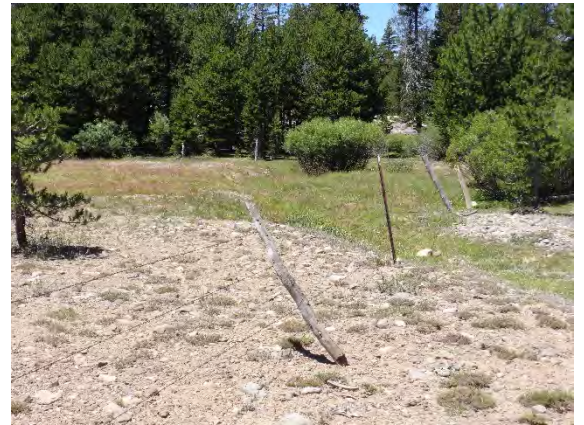
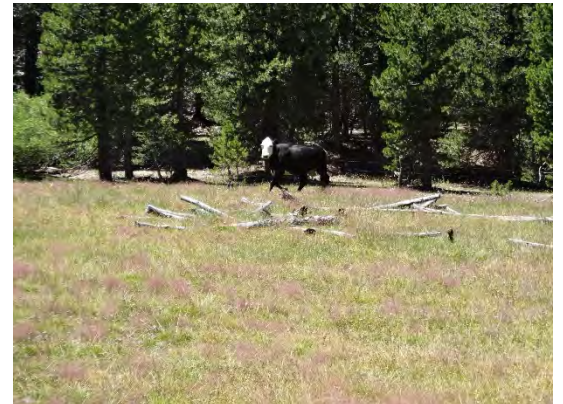
- Some patches of bare soil
- Streambank outside of meadow fence (trib. to N. Fork Mokelumne) is highly degraded from sloughing, grazing, and chiseling. (see picture at right)
- Removal of vegetative cover

Cows inside Bloomfield (top right and middle), and poor fence conditions shown (bottom right).

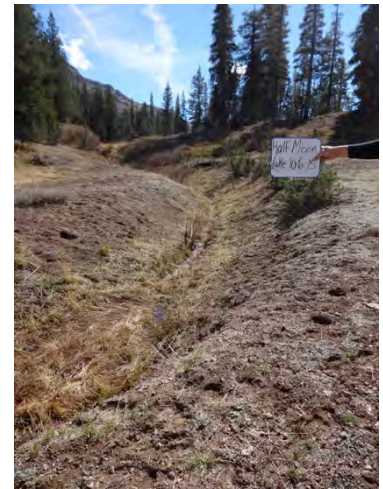
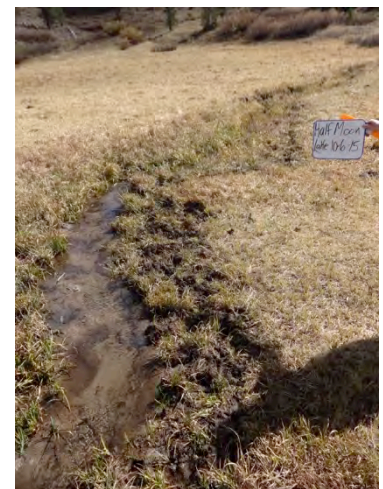
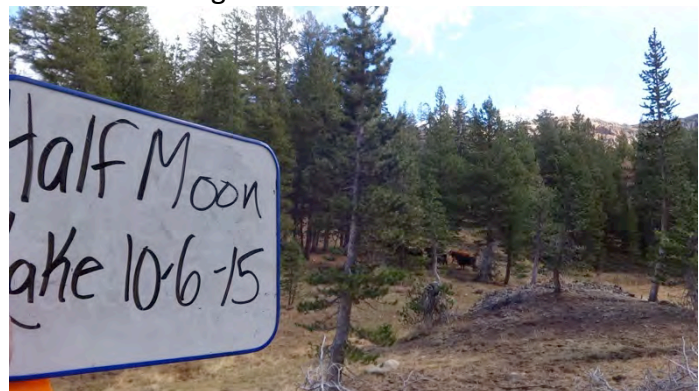
management plan to mitigate for the species is to not allow cows into this part of the unit until after September 1st. A field observation of the YOTO occupied meadow and conditions of Half Moon Lake indicate cows have been in this area for longer than a month. In addition the permittee is supposed to “move cattle that congregate excessively in occupied toad habitat to areas not occupied by toads”. At YOTO occupied sites cattle are supposed to be managed “so as to prevent disturbance to stream banks and natural lake and pond shorelines from exceeding 20% of stream reach or natural lake and pond shorelines”. Clearly grazing management direction is not being followed and protections that are supposed to mitigate for livestock damage in YOTO habitat are being violated.

Half Moon Lake: Top two photos show the extreme pocking and soil disturbance along stream tributaries to the lake. Hydrological connectivity is at risk. Bottom photo shows 7 cows still at Half Moon a week after they were supposed to be off the allotment.

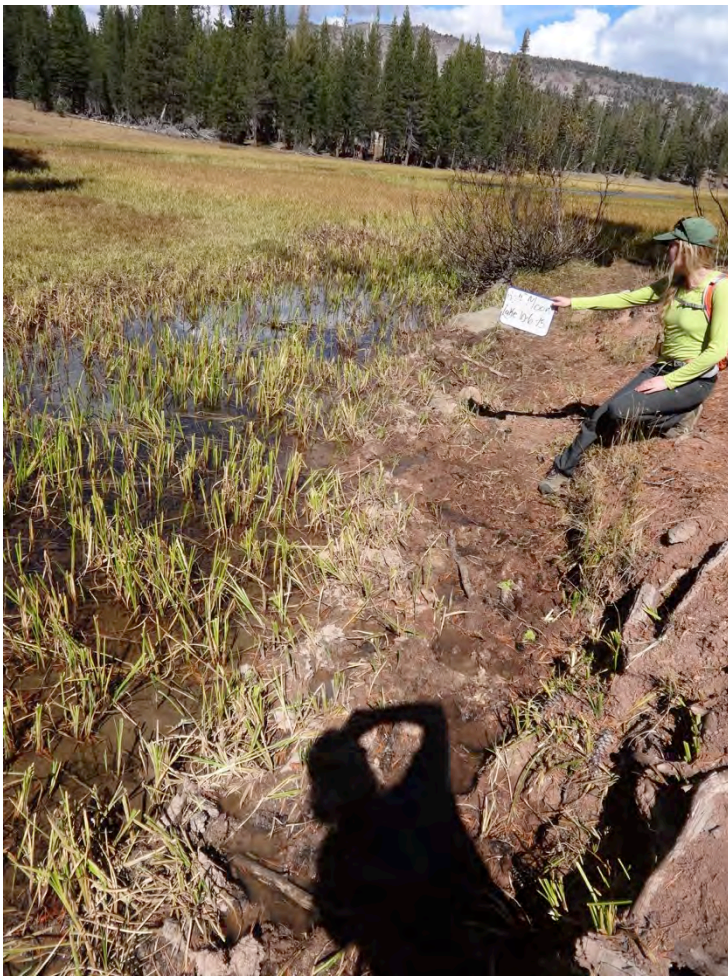
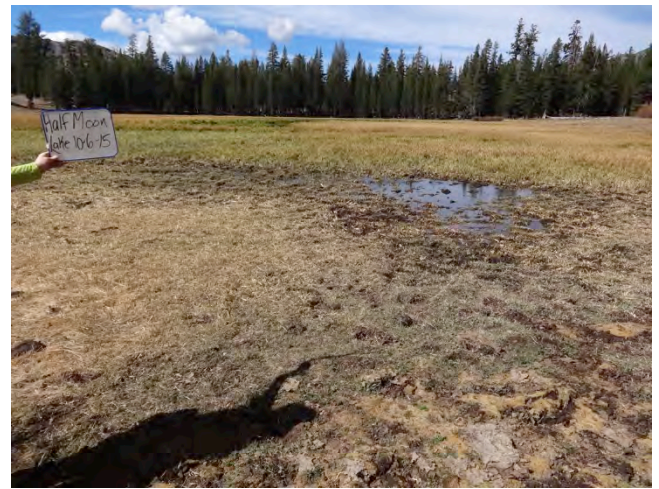
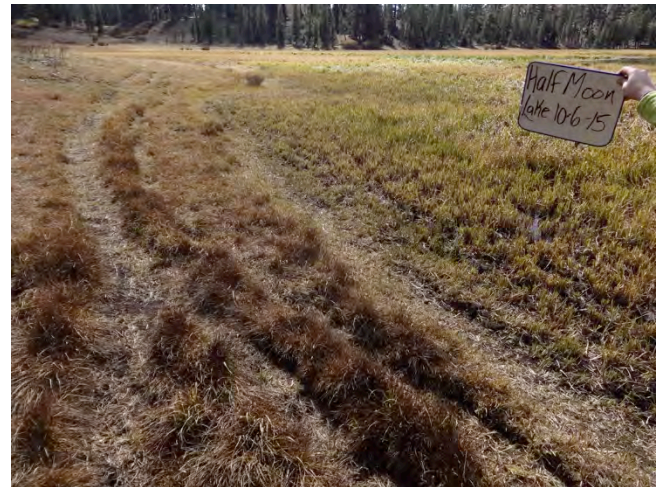
Half Moon Lake:
Shoreline is *heavily* trailed, compacted and pocked. Cows have been allowed to concentrate in this area for an extended period of time (and still are here despite an allotment off-date of 10/1/15). **The maximum of 20% shoreline disturbance mandated by Forest Plan Amendment as well as the AOI is clearly not being followed.**

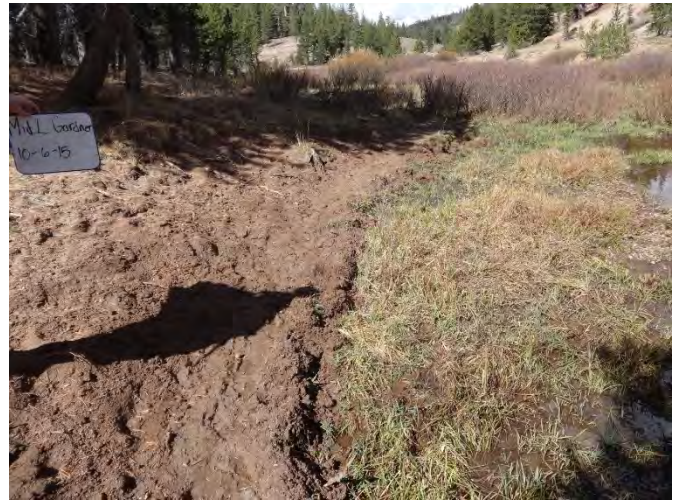
- 8-6: At least 10 cows present. Grasses are mature. Did key species measurement along transect lines. *C. scopularum* heads are drying. Stream below meadow has severely pocked and chiseled cow trail.
- 10-6: *C. scopularum* habitat is the only area in large meadow that is not uniformly heavily grazed. It browned early in season. *Scopularum* that still has green is much more heavily grazed. Lots of manure. Area in stream below meadow very heavily trailed along and sloughed.

- Reduce number of cows and time allowed on meadow

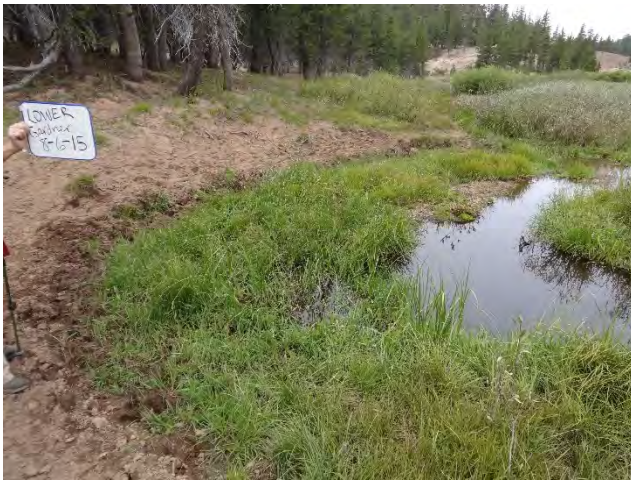
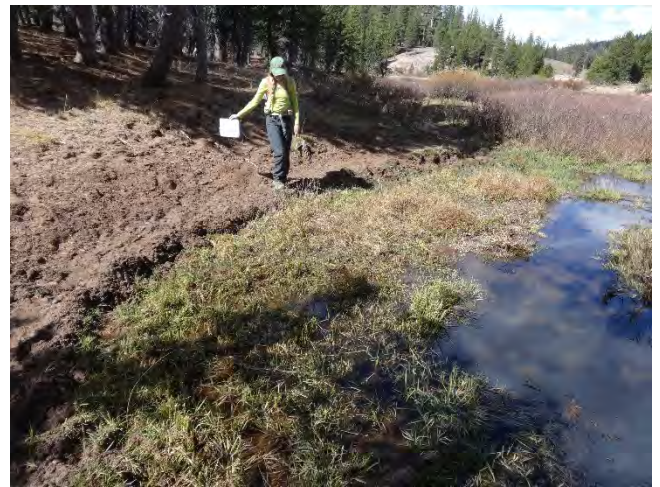
Tributary to North Fork Mokeulmne below Lower Lower Gardner: Before (left) and after (right) photos from 2015 show the high level of degradation to the stream bank that one season of livestock grazing, trampling, pocking, and sloughing has caused. Cumulative effects are also visible as the cattle trail and sloughing on the streambank causes channelization and soil compaction that are affecting the hydrological health of the meadow and creek.

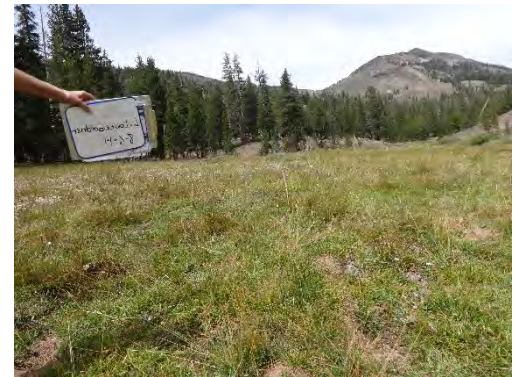
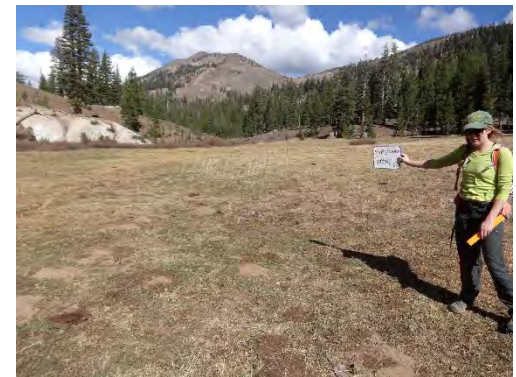
Lower Lower Gardner: wetland area below meadow (part of tributary to North Fork Mokeulmne) before and after grazing, 2015. Heavy utilization of forage, and pocking and defecation in wetland habitat.

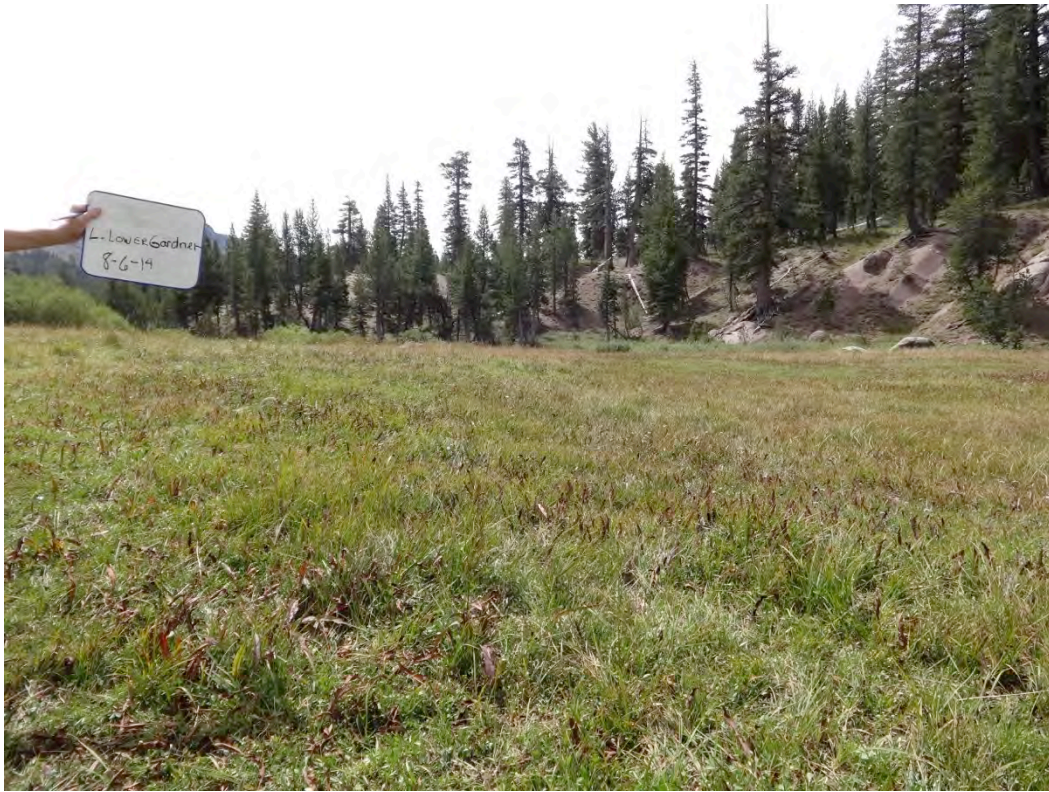
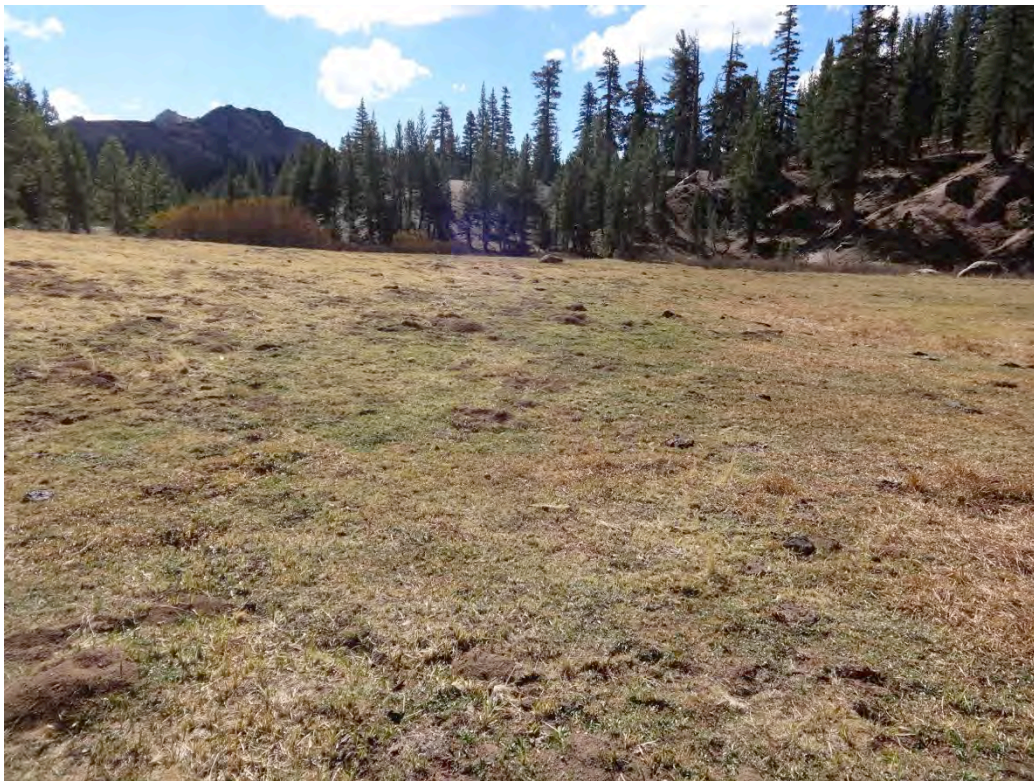
Lower Lower Gardner Meadow: Before and after photos show overgrazing past utilization standards throughout much of meadow.

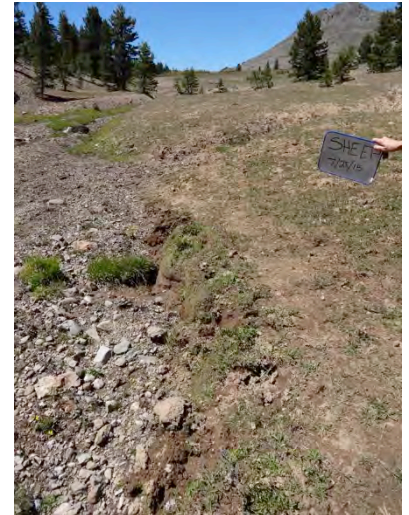
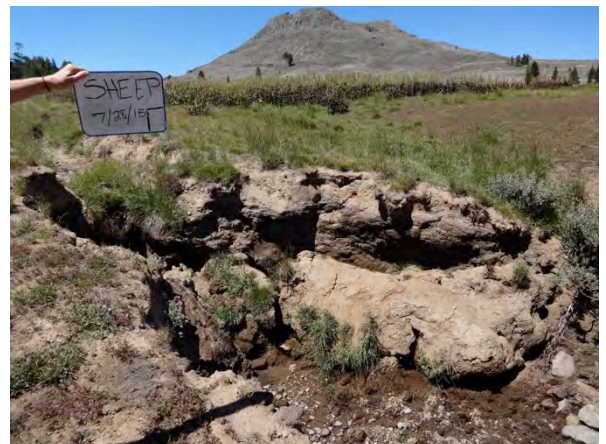
A note from CSERC about Sheep Meadow: This is the second year in a row that CSERC has documented evidence of cows grazing within the exclusion area of Sheep Meadow. The areas of the meadow that cows are allowed access to, are grazed to dust in most areas and constricting the greenline around the highly entrenched stream through hoof damage and overgrazing. This meadow's hydrological condition is clearly non-functional and yet grazing is continued to be allowed in this severely damaged meadow. The Forest Plan clearly spells out that meadows in Non-Functional condition should be on rest until their condition is in an upward trend from Functional-At-Risk. All of these points are compelling reasons that Sheep Meadow should be rested from grazing by the Forest immediately, and also have a project planned to restore the watertable and meadow.

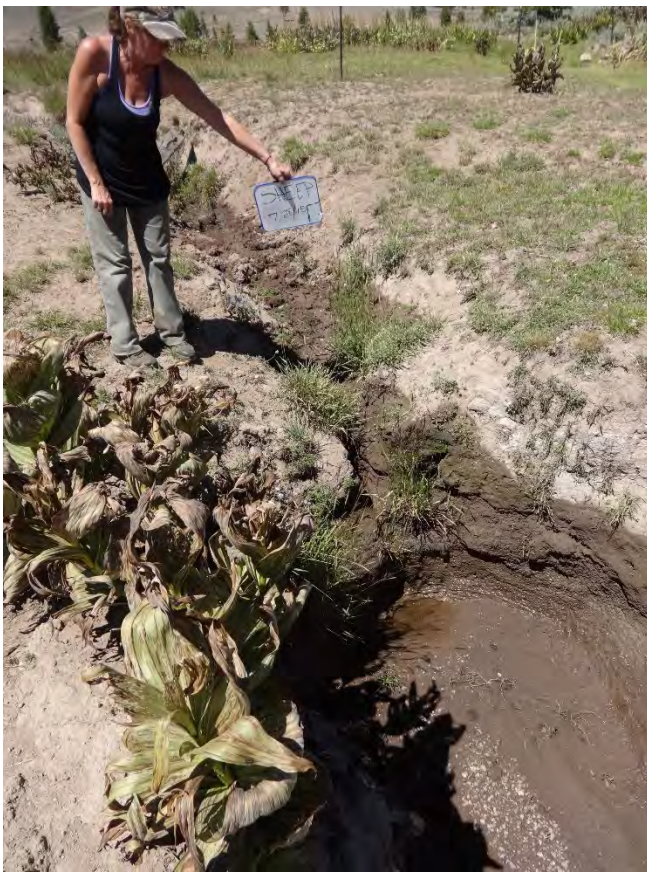
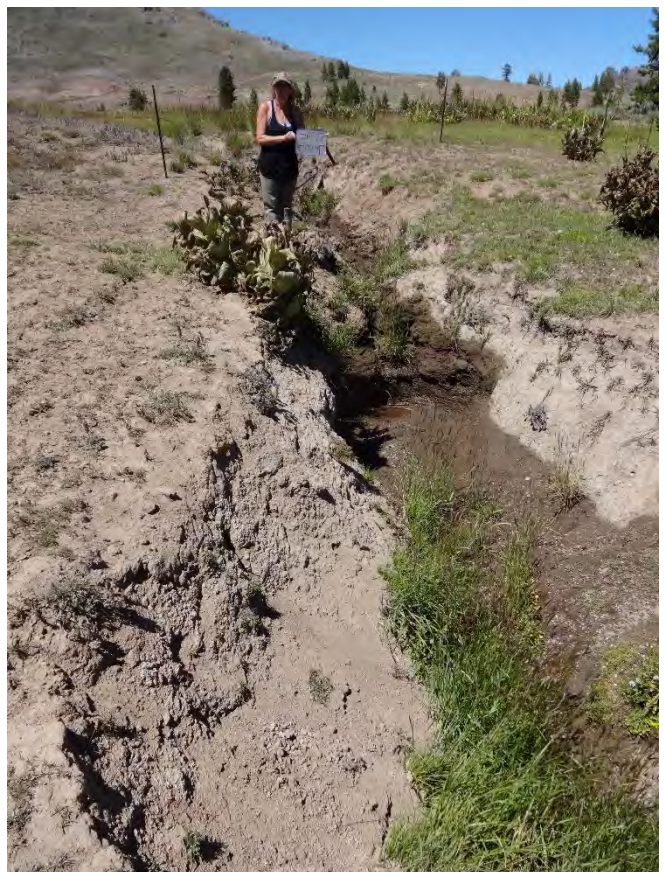
Active down-cutting and head-cutting of Sheep Meadow. Cattle activity (trampling, sloughing, chiseling, overgrazing) is contributing to the drying out of the meadow and the destabilization of streambanks.

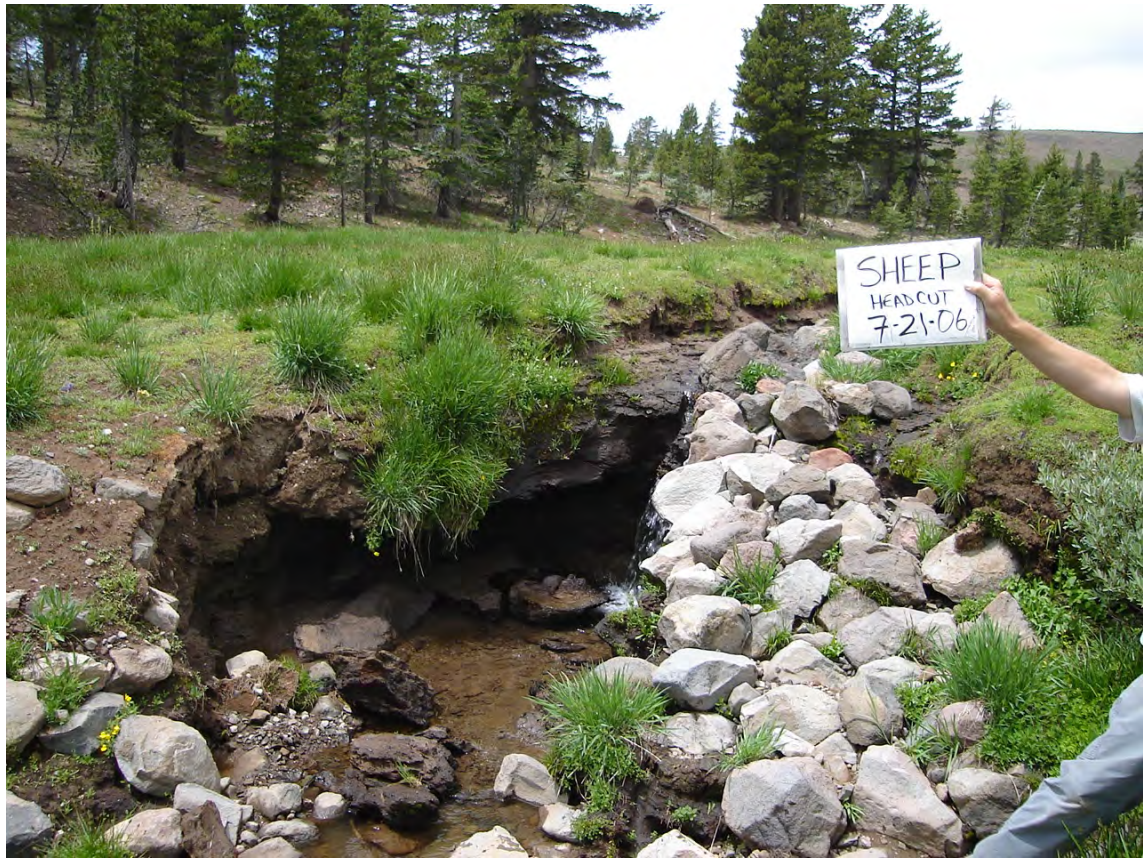
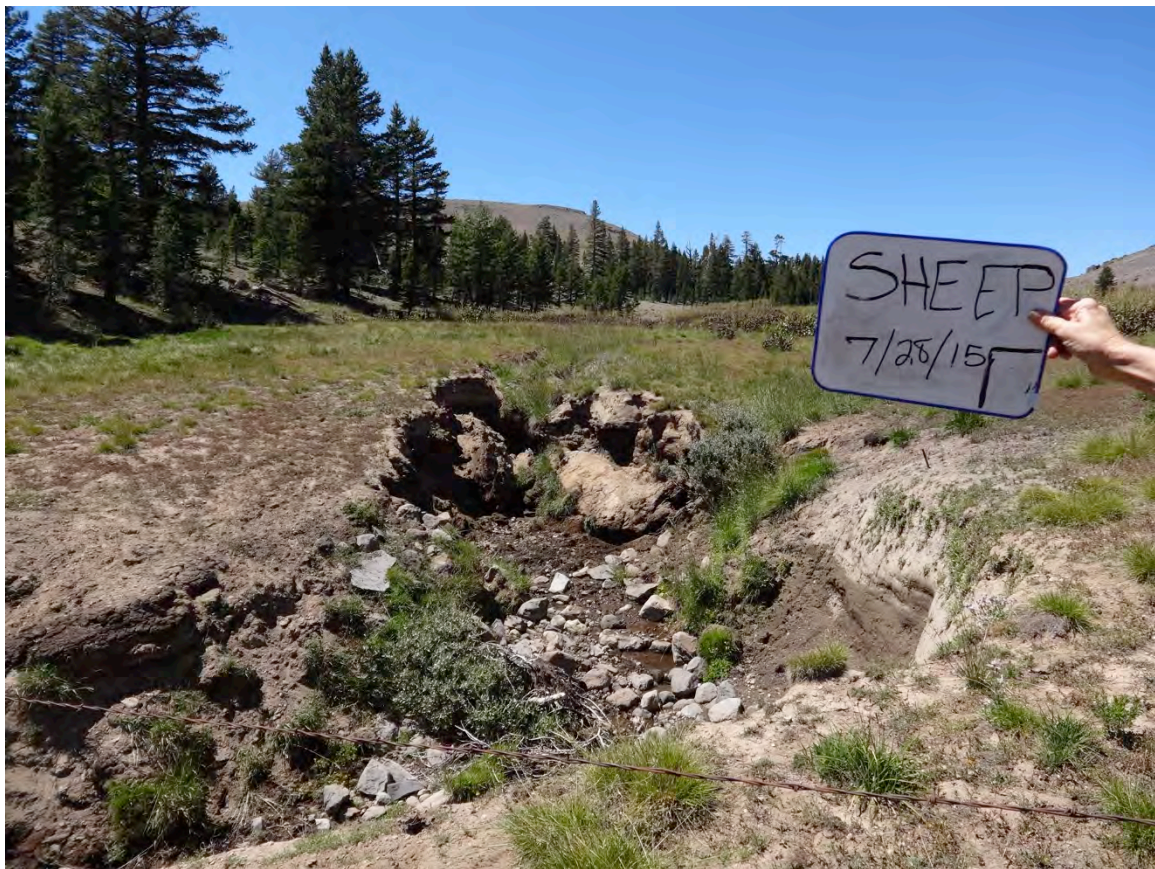
Sheep Meadow: top photo is from 2006, bottom is from 2015. Site of restoration has clearly blown out and continues to headcut back into the meadow.

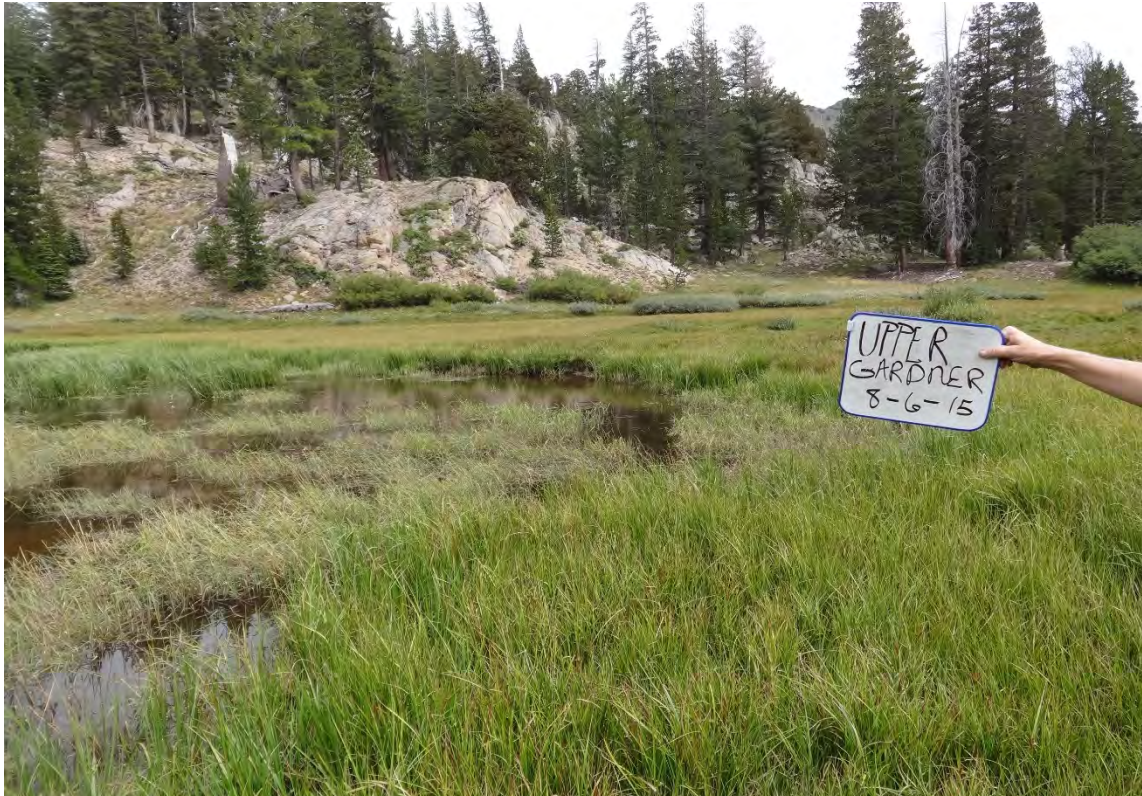
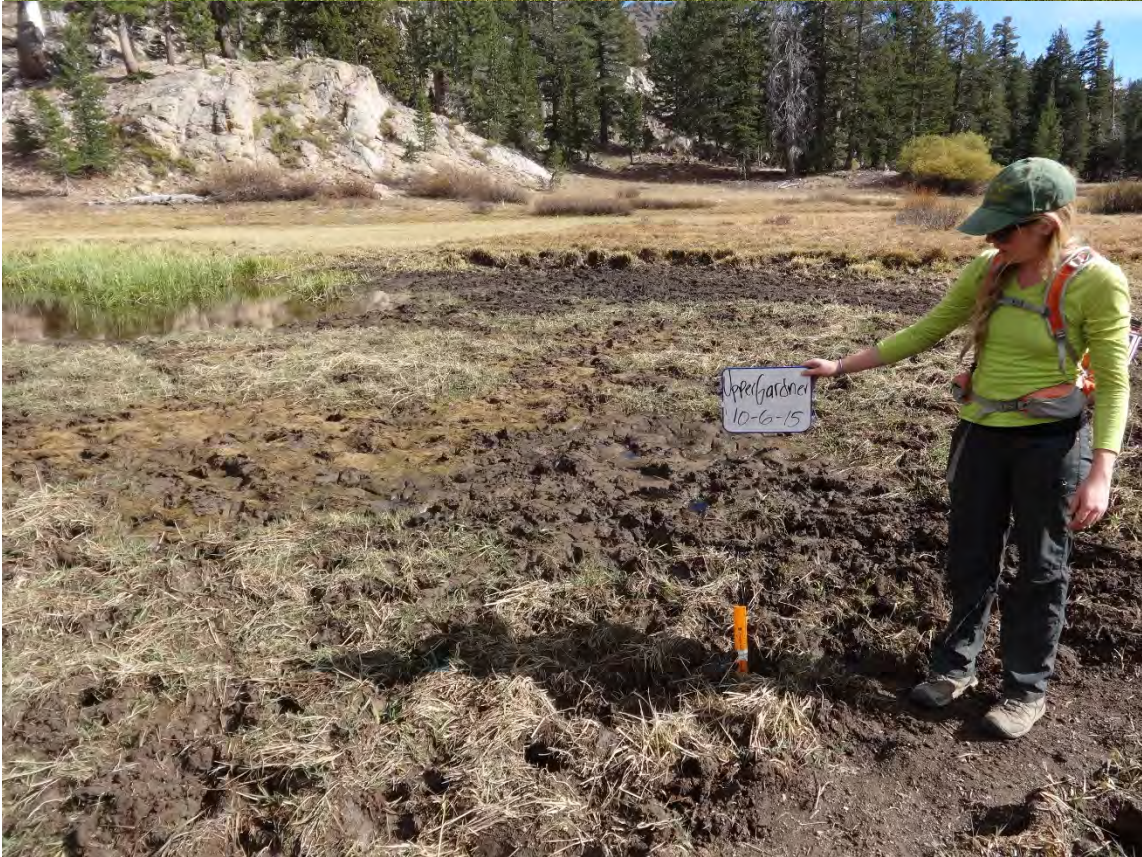
Upper Gardner: pond with possible fen is extensively pocked in around around shoreline, grazed heavily, and defecated in. this grazing management is not meeting the 20% shoreline disturbance outlined in the Forest Standard and Guideline.

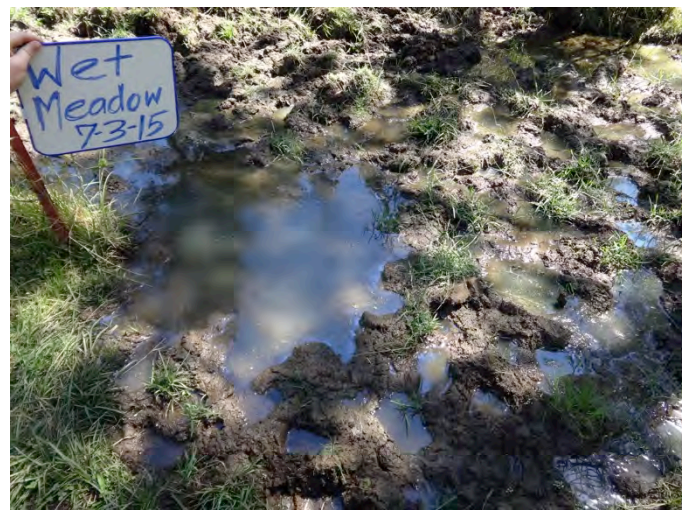
7-3-15: Severe pocking in wet meadow area muddy and contaminated seeps. Not functional condition. Sloughing and chiseling down the length of the hillslope. What is the status of the fence there? CSERC staff was under the impression that it is supposed to be maintained.

- Maintain fence that is around meadow
- Reduce number of cows in meadow and time allowed in meadow

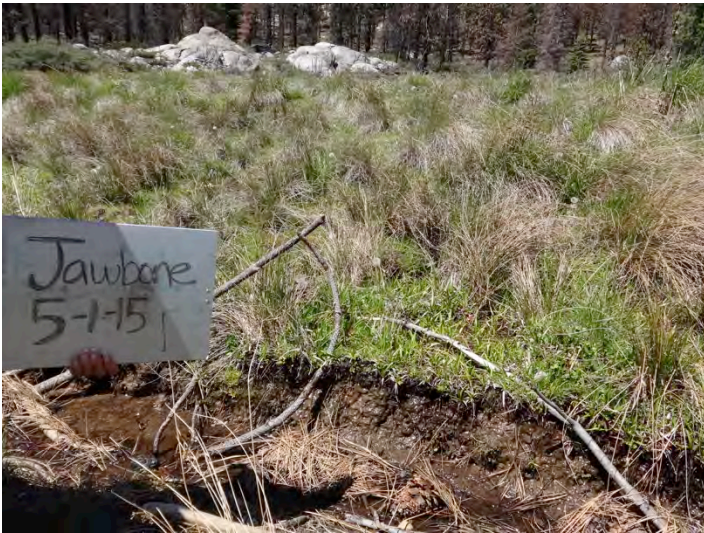
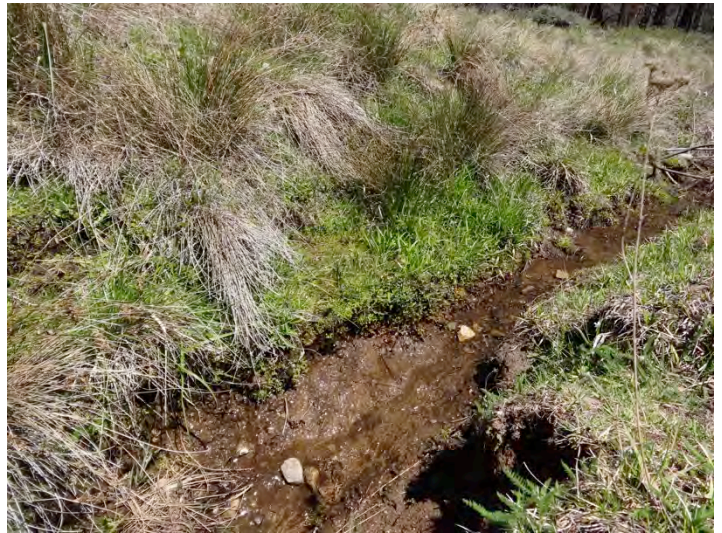
May 2015, Jawbone Meadow: A manmade ditch (*top left and right*) has been dug along base of the meadow and is dewatering it in addition to the headcut (*left*) that has already affected this meadow's hydrology.

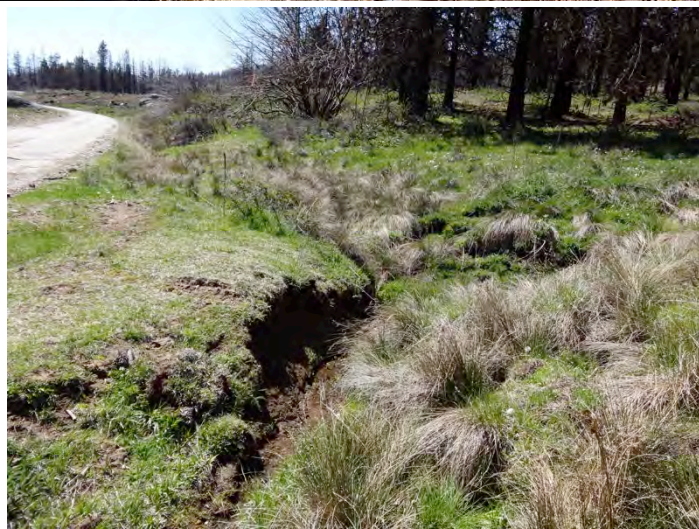
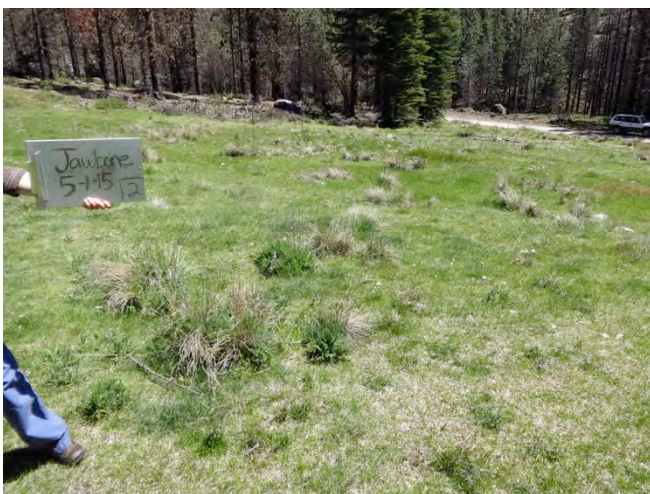
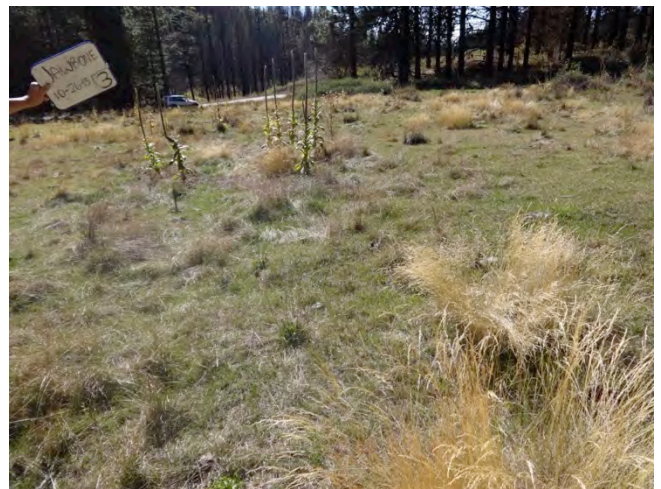
Grazing utilization this year was much less than in any other year since CSERC has started monitoring this allotment, as the pre-season (*bottom left*) and post-season (*bottom right*) photos show.

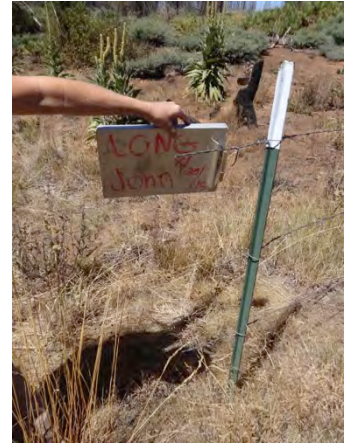
Fence line cut at Long John's Meadow

CSERC monitors several meadows within the Jawbone/Rosasco Allotments. In addition to our monitoring work, our staff also has maintained (repaired and restrung) the fence lines that are supposed to be kept up (as stated in the AOI) around specific meadows that have had restoration work done to them. Several days of CSERC staff member's time are spent every spring fixing these fences, which administration of the Groveland RD has approved in the past. However, in the summer of 2015 our staff found that all of the fence lines were being intentionally cut (after we had repaired them) to allow access for cows to enter rested meadows. Assuming it was vandalism our staff immediately repaired the fencelines again, only to find a week or two later that they had been cut once more. After reporting the situation to the Groveland RD, it came to light that some of the range staff had authorized the permittee to cut the fence line. Our Center sees that these meadows are not restored and still need protection from grazing impacts - especially in a post-fire habitat where livestock will concentrate in green areas. **CSERC urges that Crest, Meteor, Long John, Upper John, and Silver remain prohibited from livestock grazing (with the exception of the specified use of specific meadows for gathering purposes) until at a minimum a forest hydrologist assesses their condition as restored and functional. In addition, we also ask that Boggy Meadow's fence remain intact permanently to exclude cows, as this meadow is exceptionally diverse and has fen habitat with the rare sundew plant growing in it.**
