Central Sierra Environmental Resource Center
2015 Stanislaus National Forest
Meadow Condition and Grazing Utilization Report

2015 Meadow Condition and Grazing Utilization Report

Stanislaus National Forest

Central Sierra Environmental Resource Center

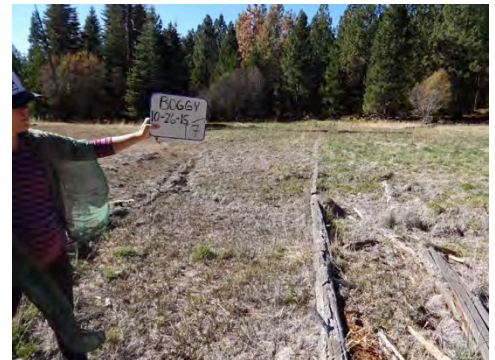
Boggy Meadow – An important field note about Boggy Meadow is that the spring that feeds this important wetland habitat dried up this year. The place where sundew grows and the fen/wetland habitat around it stayed mostly brown the entire season. This is highly concerning since the plant community found in this type of habitat depends on perennially wet soils to thrive. CSERC asks that the Forest continue to monitor and protect this area.

Fen habitat completely dry with little growth, even at the end of the season.

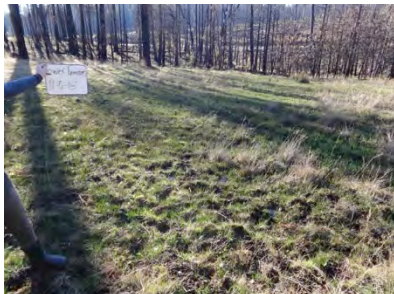
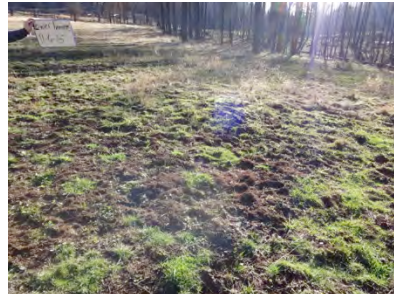
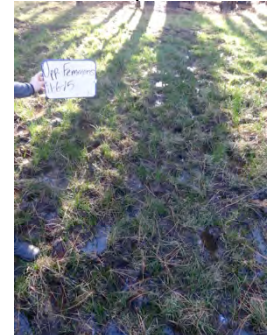
These meadows are supposed to be on permanent rest from grazing but the fences have not been maintained due to salvage logging activities in the proximity (from the Rim Fire). **CSERC documented grazing and deep pocking in wet areas of both meadows in November 2015.** Our Center urges that once logging activity is completed in the area, that the Forest commit to repairing the fences. If that can not happen in 2016, CSERC asks that the Forest communicates to the permittees a need for them to actively herd their livestock out of those areas.

Lower Femmons (left) and Upper Femmons (above) show cattle trespass – grazing and deep pocking in wet areas of meadows.

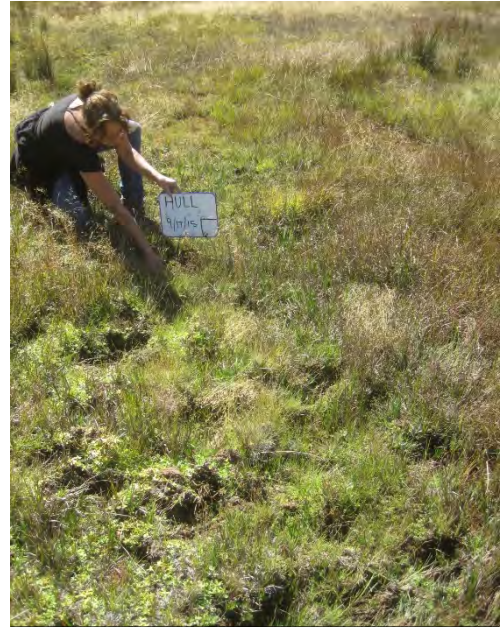
Cow hoof pocks documented by CSERC staff in lower meadow show that despite the permittee being on suspension in 2015, another meadow (since Funks also had grazing trespass) was grazed by his cows over the summer.

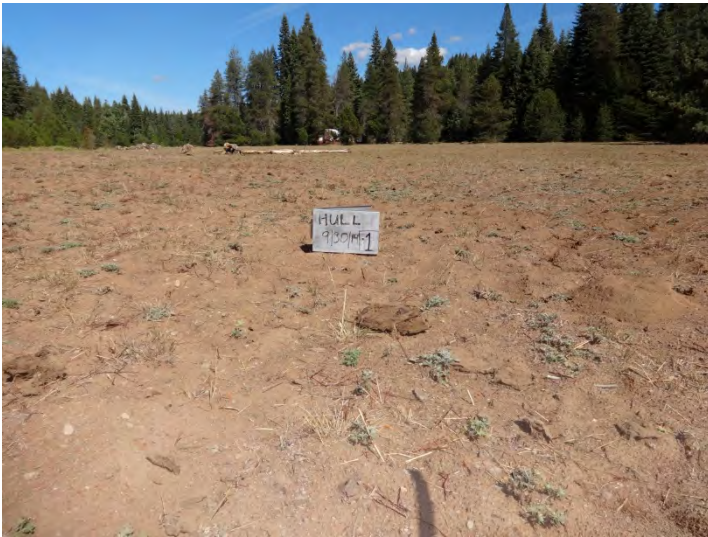
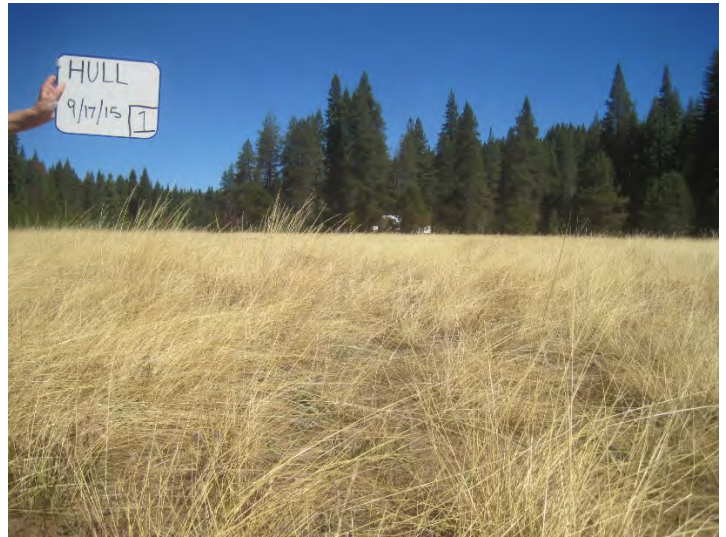
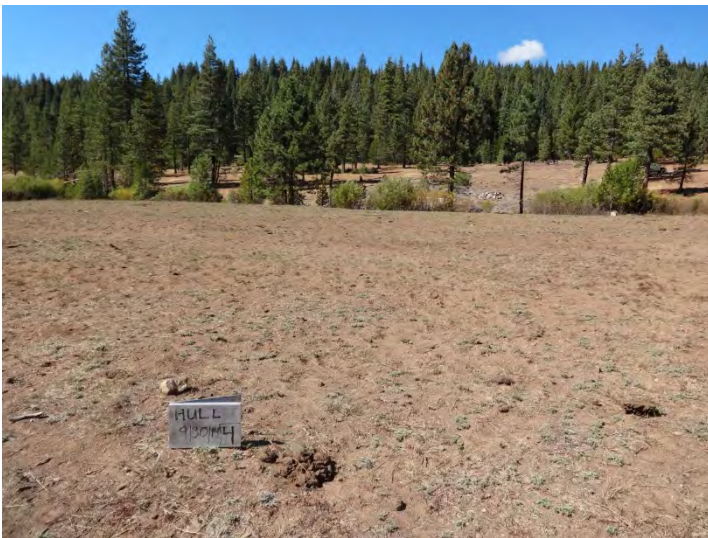
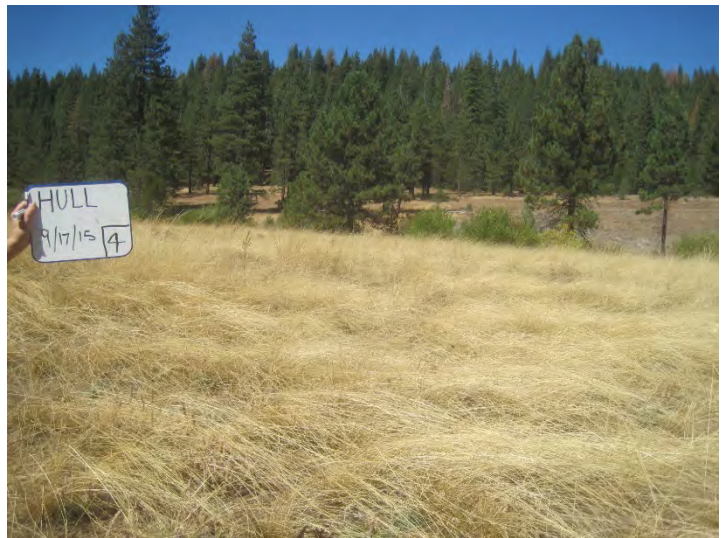
Hull Meadow post-grazing September 2014 (left) compared to Hull Meadow not grazed September 2015 (right). Last year's absolute devastation of all vegetation from overgrazing is easy to see when looking at what the meadow looks like at the same time of year when not grazed. CSERC urges that should the current permittee be allowed to continue grazing on this allotment, that a much higher level of monitoring and management is carried out by Forest staff, to prevent the blatant abuse of grazing privileges that have occurred historically.

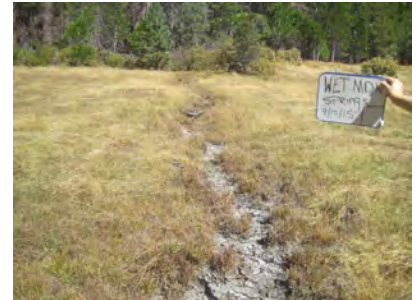
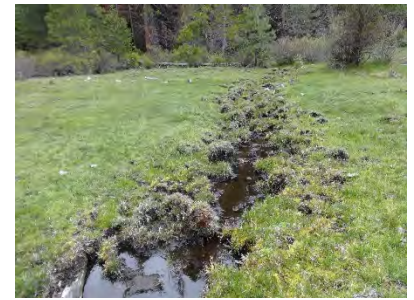
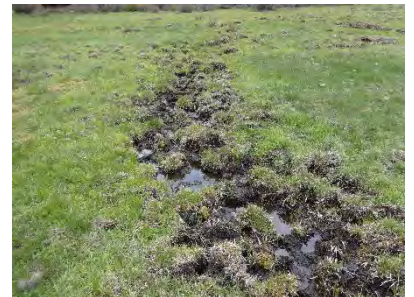
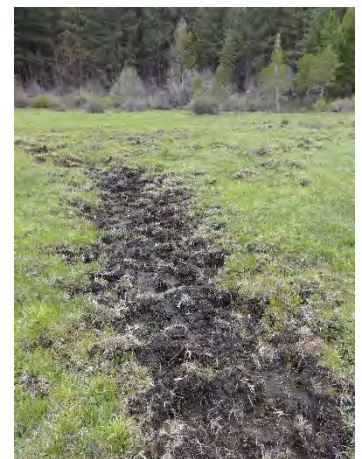
- 9-17: Meadow is dry. Took photo point photos of dry stream. No sundew found – completely dry where they normally grow (see photo top right). Fen areas dry (top right photo). Recommend that the Forest limit or exclude grazing here.

****CSERC was informed by Forest Service staff that cows were found that had “over-wintered” in Wet Meadow Springs by the permittee, a major violation of his permit.** Staff visit on 5/21/15 to the Meadow found that meadow was grazed and pocked due to the non-stop grazing activity there (see the 3 bottom photos to the right), and wetland/fen areas had not had any time to recover from the previous year’s onslaught. This was one of the contributing reasons that the permittee for this allotment had his permit suspended. This is especially problematic because the drought has already reduced the ability of this rare habitat to thrive, and bad livestock management has increased the chance that the fen habitat here may become non-functional. Our staff encourages the Forest to continue to consider revoking the grazing permit of the current permittee if there are any violations in the next grazing season.

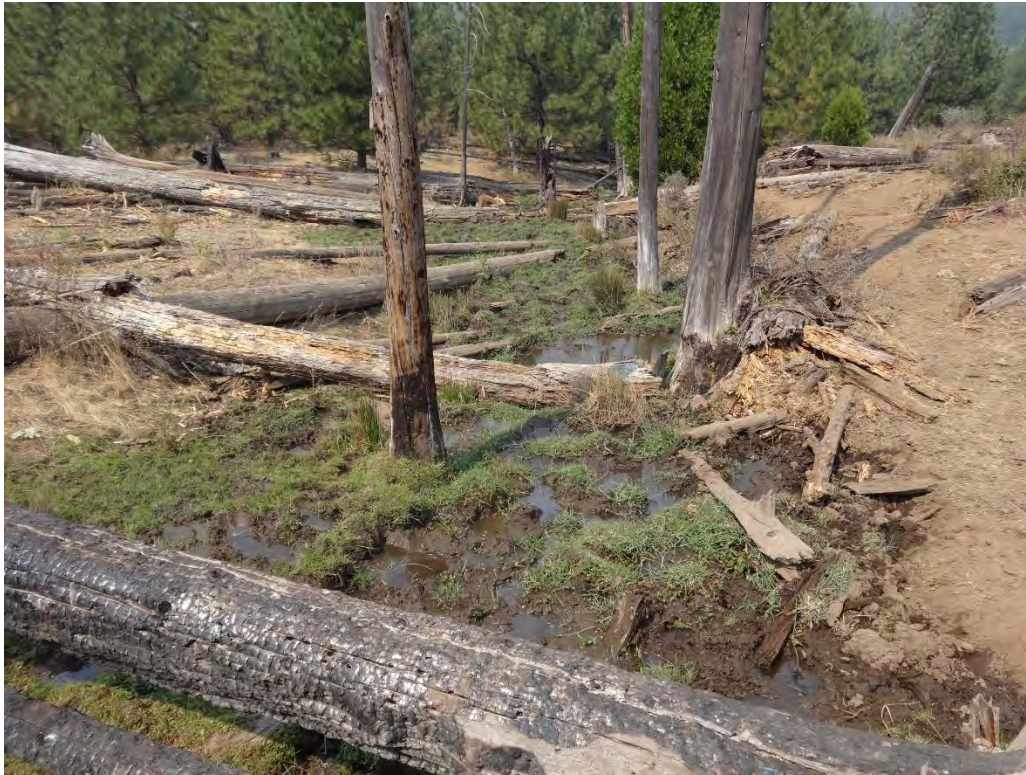
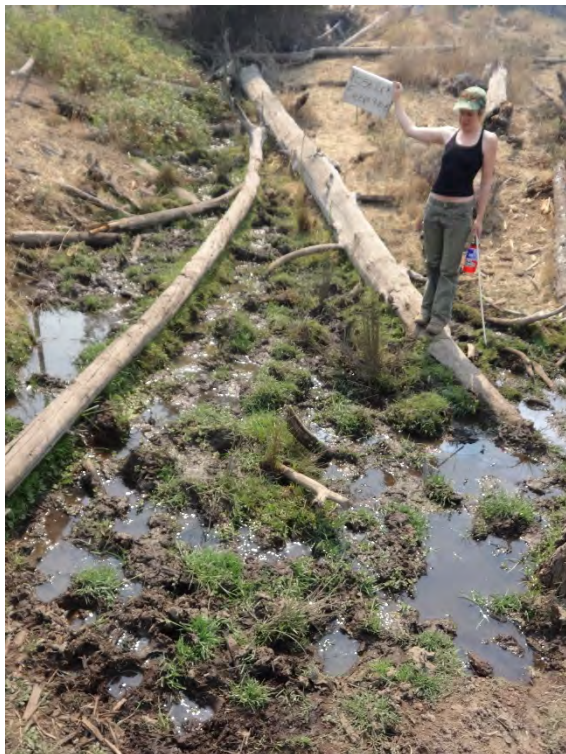
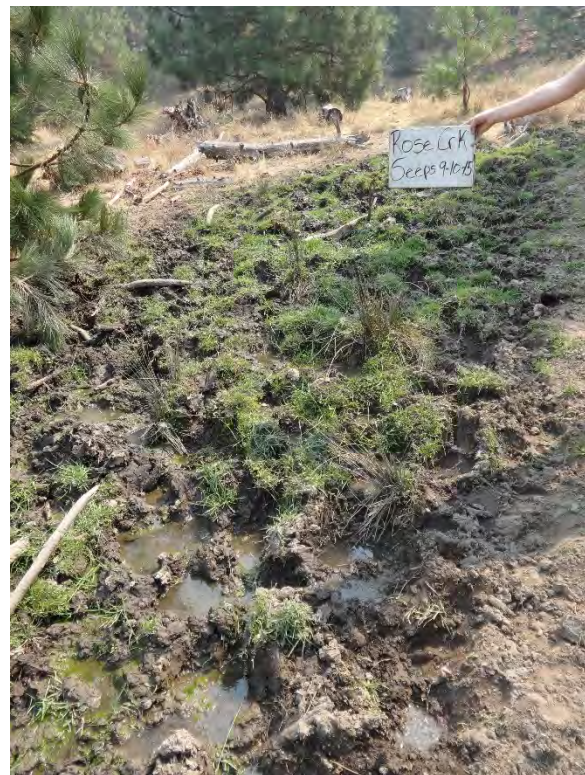
Rose Creek Seeps, 2015: these photos help show the extreme grazing that happens in all the seeps and springs in the Rose Creek area. **It seems as though there is no monitoring done in this area by Forest Service or permittees**, and every year cows are allowed to graze for however long the permit season is, with no regard to resource protection. **There is a strong need to re-evaluate the grazing plan for the Rushing Allotment.**

Top: Extremely hummocked soils all throughout the seep areas, and **vegetation is grazed to mud or ¼" stubble height.** Wetland flow is being visibly constricted, and channelized.

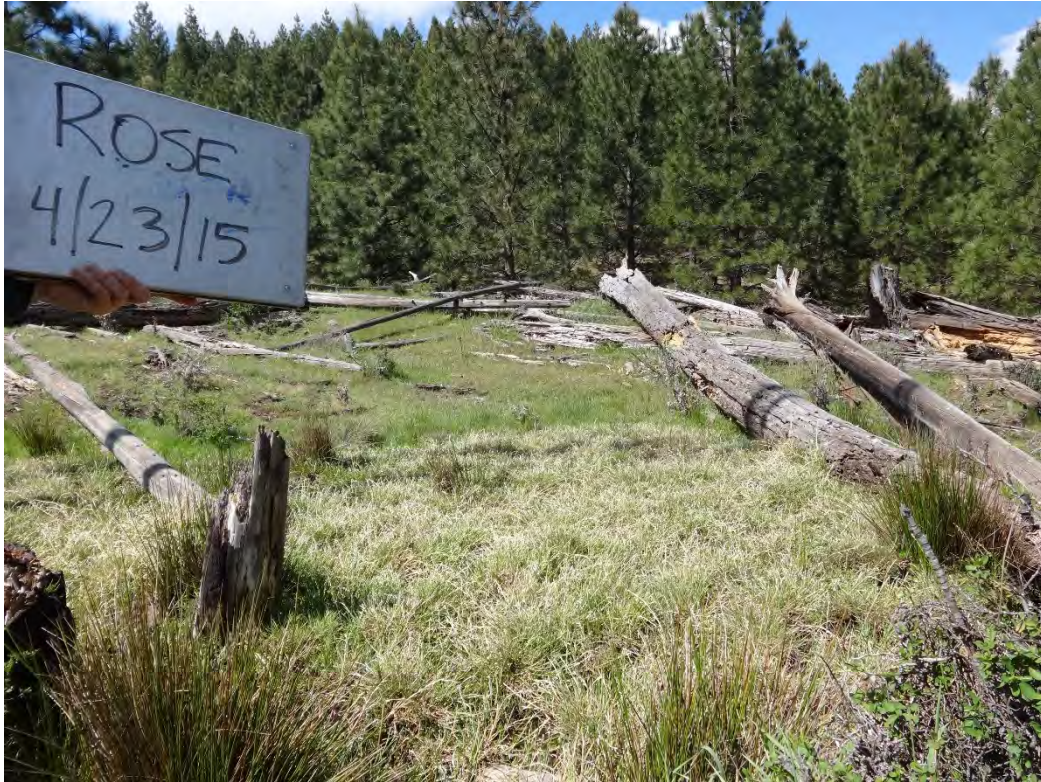
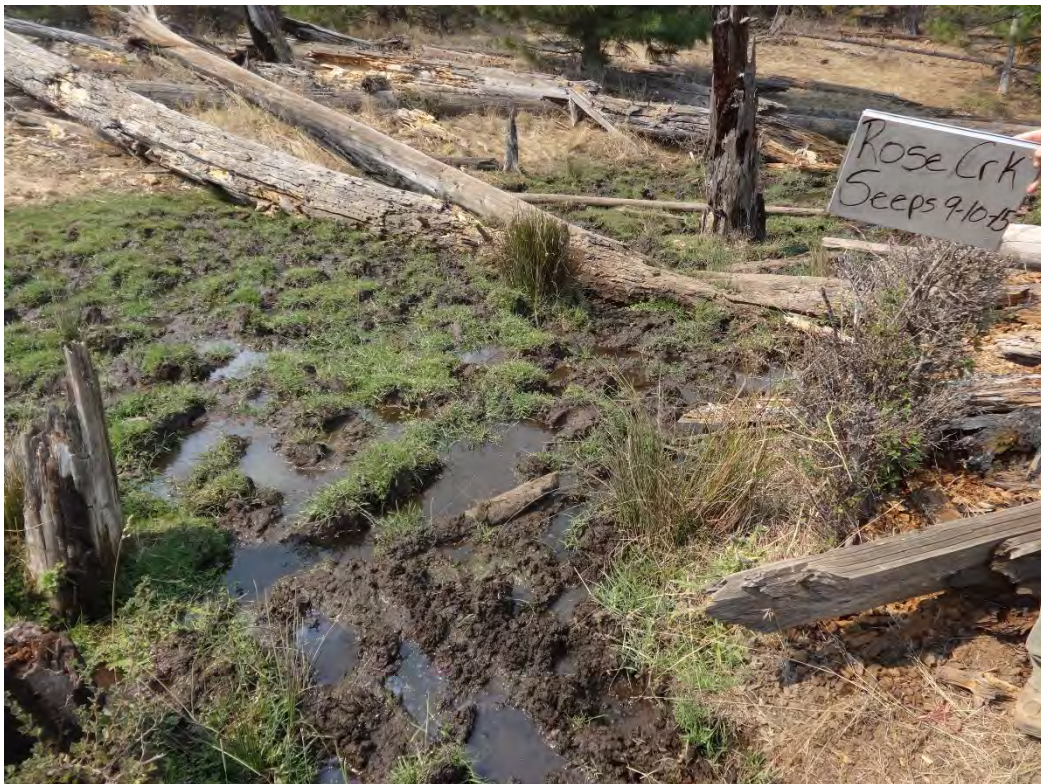
Rose Creek Seeps: Photos of before (top) and after (bottom) grazing in 2015 in the same spot, and shows the intense concentration of livestock in the seeps which are by early summer the only place in the area where green forage is available. Extremely pocked, contaminated, and overgrazed. This is a Special Aquatic Feature and should be protected from livestock due to downward trends.

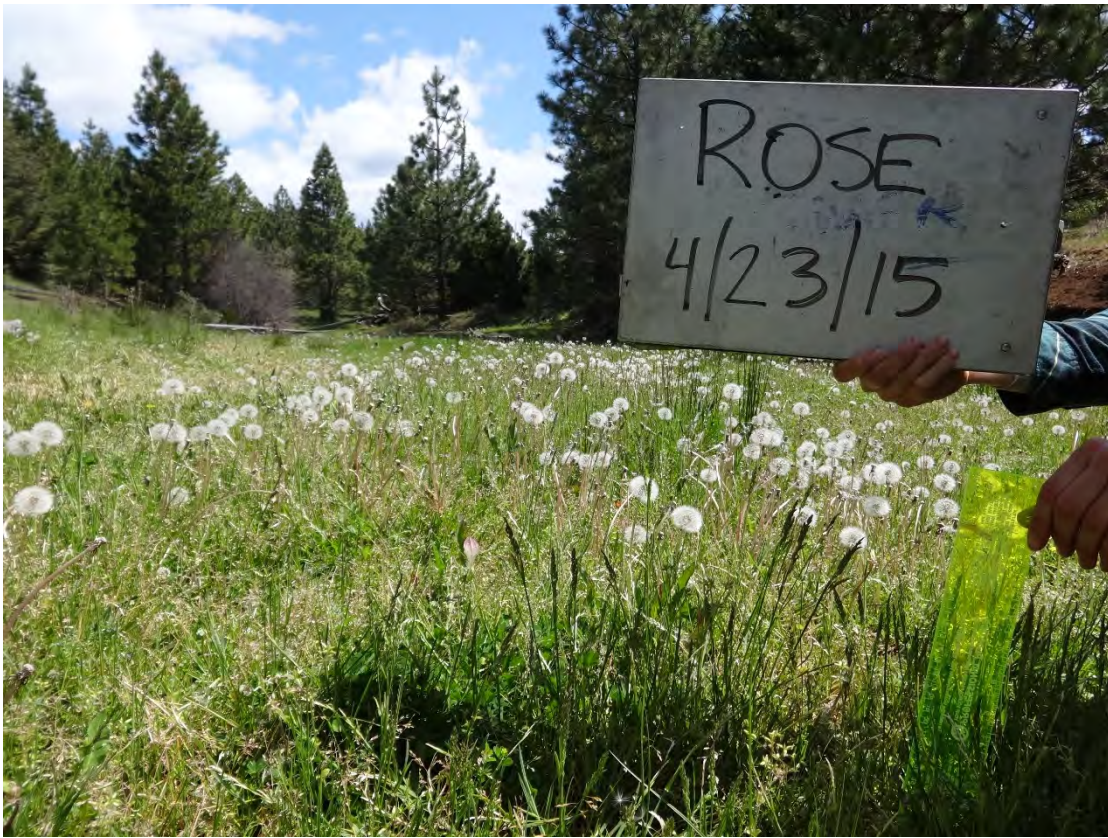
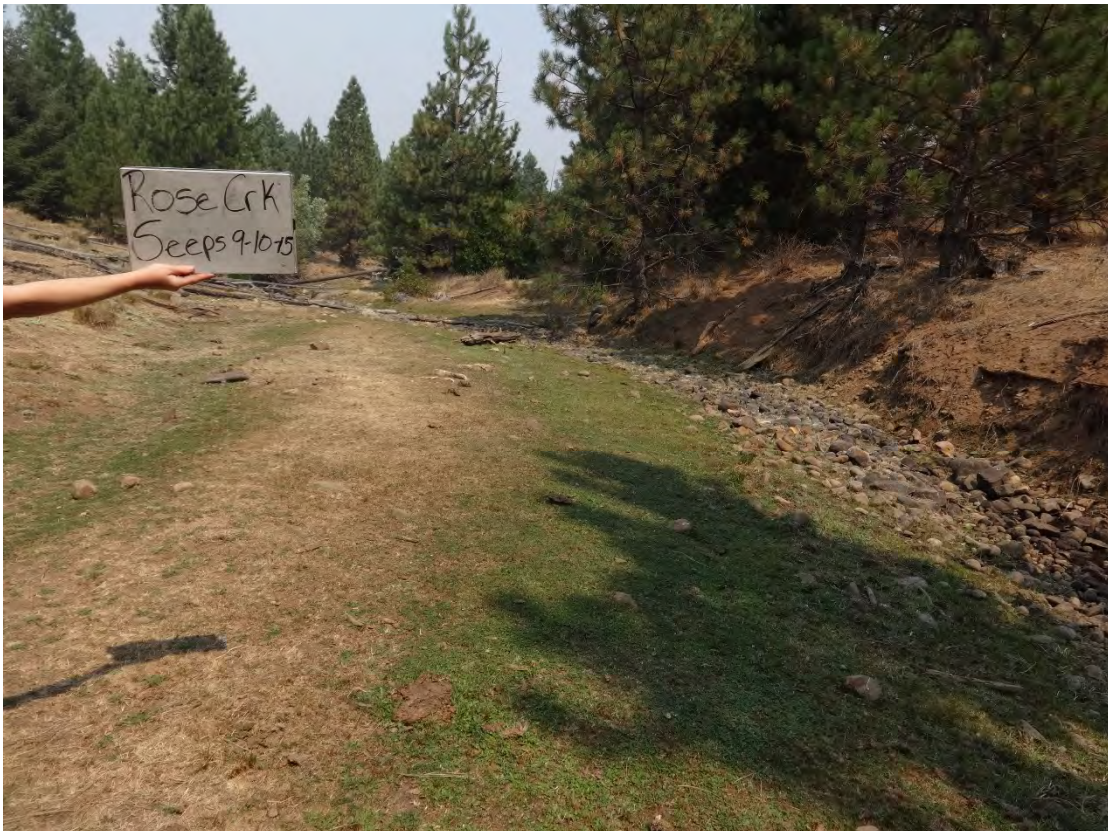
Rose Creek: Before (top) and after (bottom) show the streambank along Rose Creek grazed to dirt- ¼" stubble height , even rushes are heavily grazed.

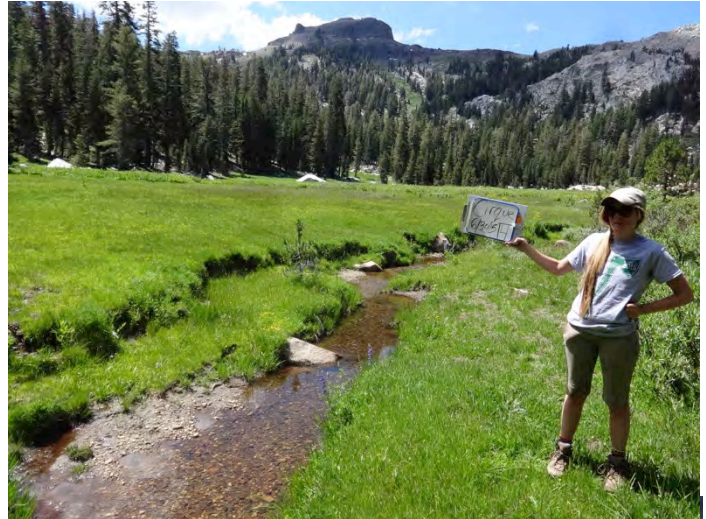
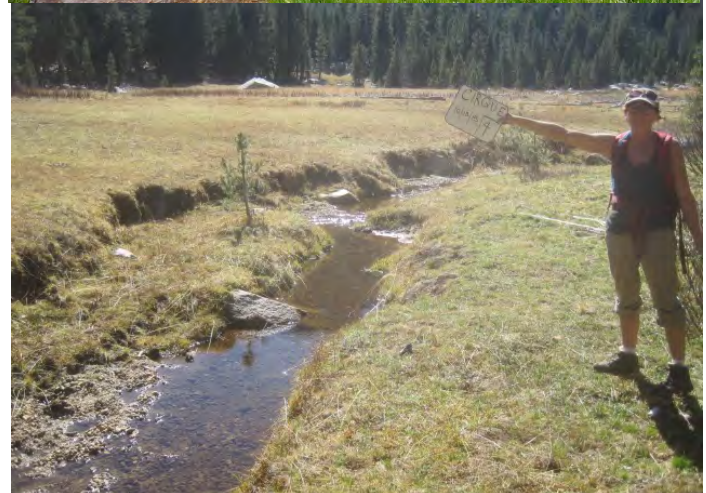
This page: Chiseling, sloughing and overgrazing the streambanks of Pacific Creek is leading to downcutting and channelization in the meadow. Water table is dropping. Top photo is pre-grazing 2015, and bottom photo is post-grazing 2015.

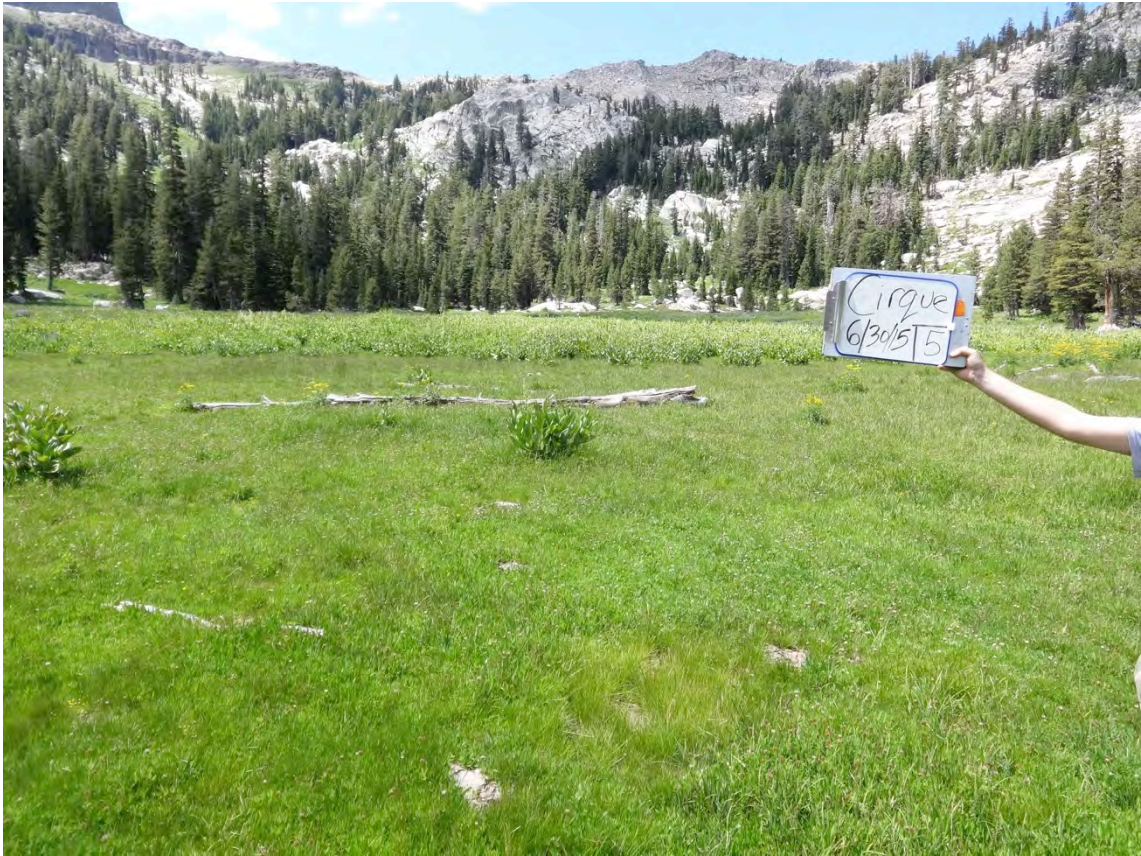
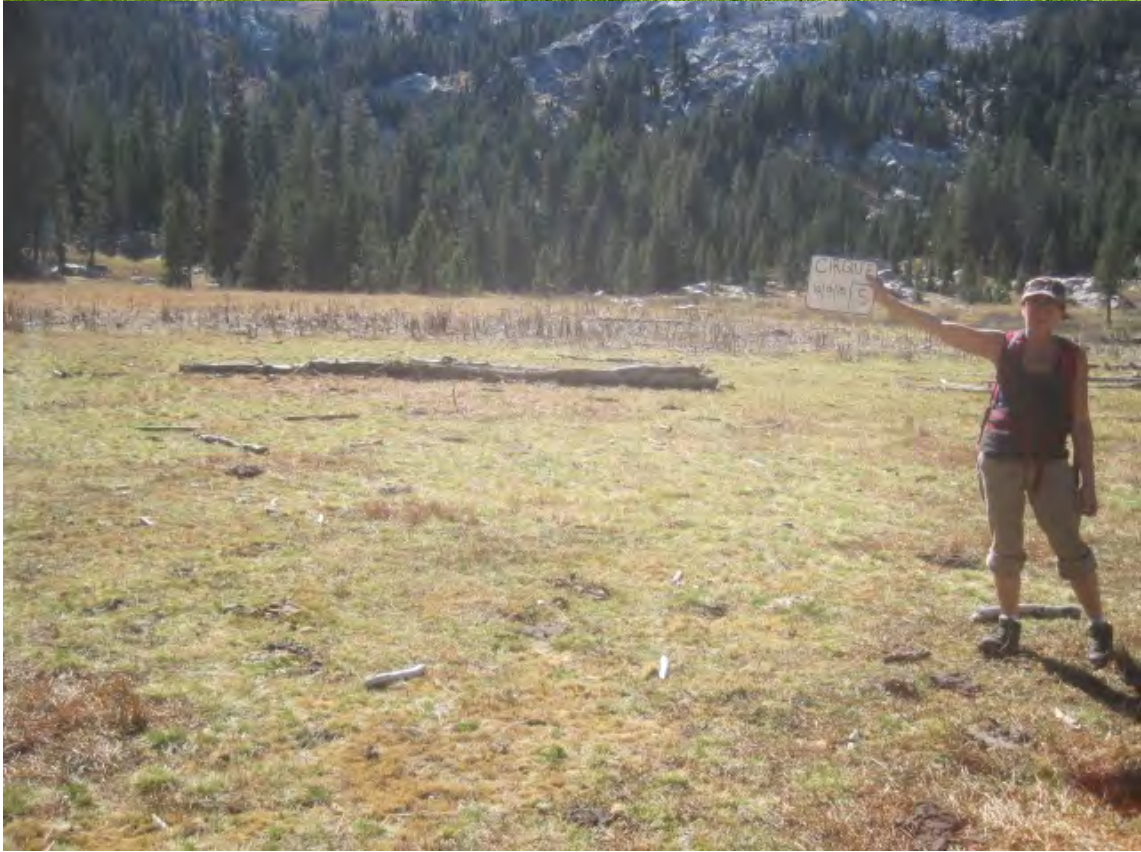
Before and after 2015: Meadow grazed past acceptable utilization levels in mesic areas.

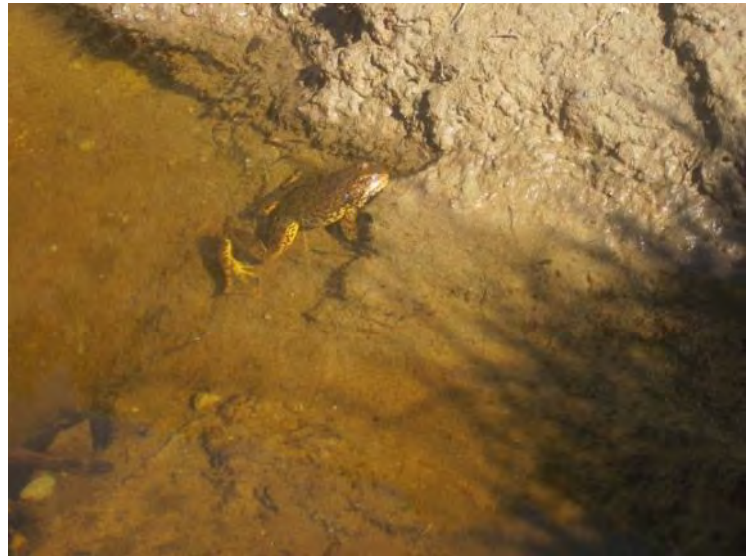
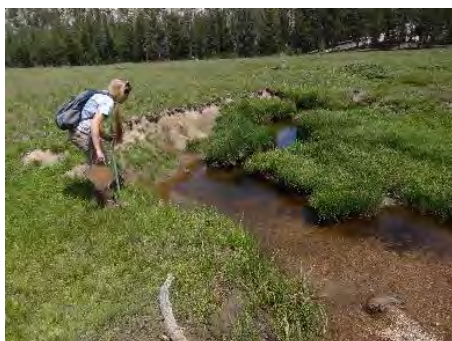
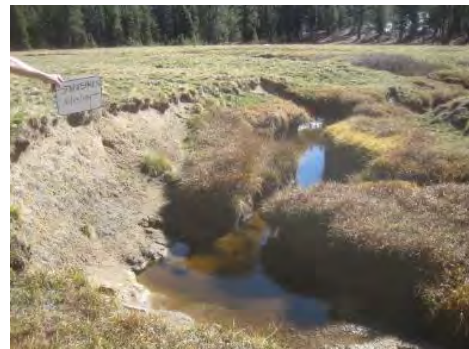
SNYLF Pools in N. Fork Stanislaus headwaters: Although some areas were less utilized by livestock this year, areas that were easy for cows to access were still heavily pocked, streambanks sloughed and forage heavily utilized. Clearly the SNYLF occupying these pools are being affected negatively by livestock presence: manure and sediment contaminating water, loss of vegetative shelter, and degradation of stream stability.

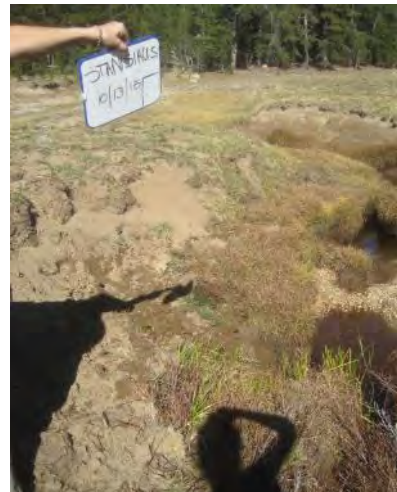
Stanislaus Meadow. Top left and right: before and after grazing in upper part of gathering meadow; shows overutilization and chiseling around wetland area is constricting the channel. Middle left and right; Photo point 2 before and after, in drier meadow habitat. Vegetation grazed past utilization standards. Bottom left; seasonal pond area is heavily pocked. Bottom right; another area of heavy sloughing and streambank degradation along SNYLF occupied pools.

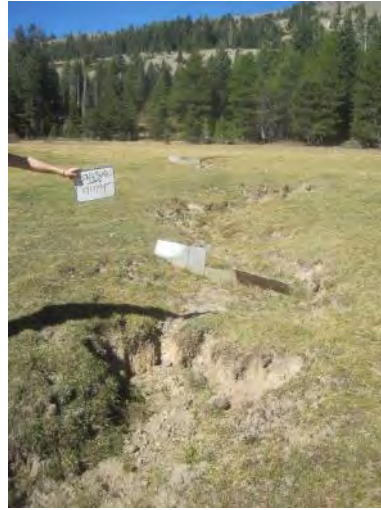
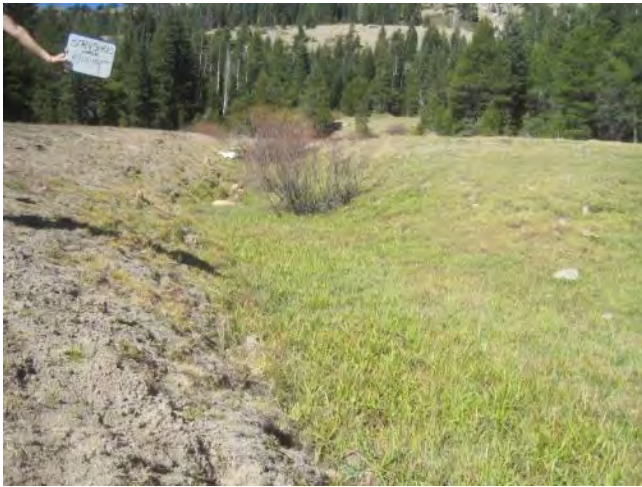
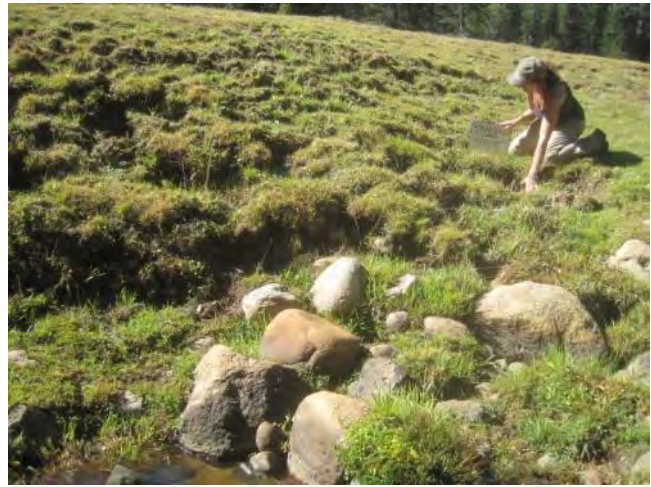
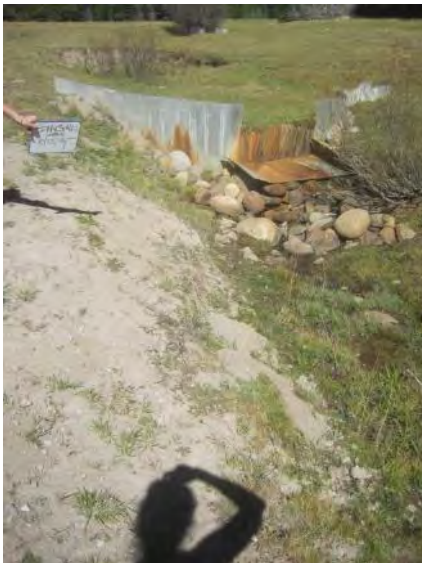
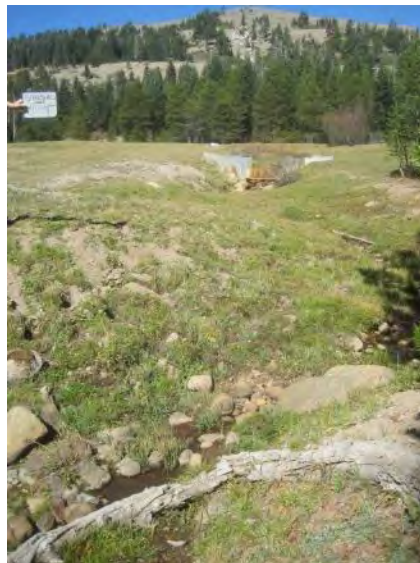
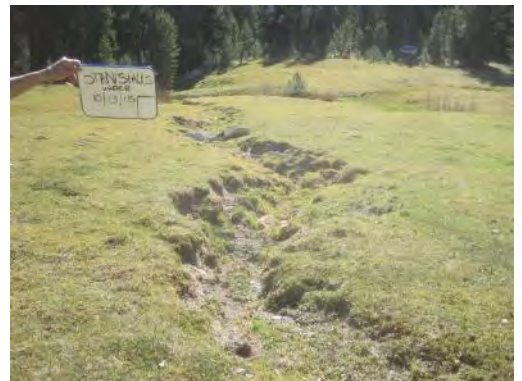
Upper Stanislaus Meadow (at Hwy 4 entrance): As these photos show, this meadow is one cows are allowed to linger in far past utilization standards being met. Wet areas are heavily pocked and chiseled causing dewatering of wetland areas, and channelization along streams. The restoration work that was done in this meadow is losing (and in some places, has lost) its function to stabilize the downcutting and headcutting in the stream channel. CSERC has reported the poor livestock movement and post-grazing conditions at this meadow for many years but the forest is yet to make any positive change to management.
